Response to MDE SWP Comments Related to:

“Area 1, Phase 2 Detailed Development Plan, Parcel 3 Development, Honeywell Baltimore Works Site, Baltimore, Maryland” Resubmitted November 19, 2021 and associated documents (the “DDP”),

CONDITION SURVEY
OF WATERFRONT STRUCTURES

ALLIED-SIGNAL INC. BALTIMORE WORKS
BALTIMORE, MARYLAND

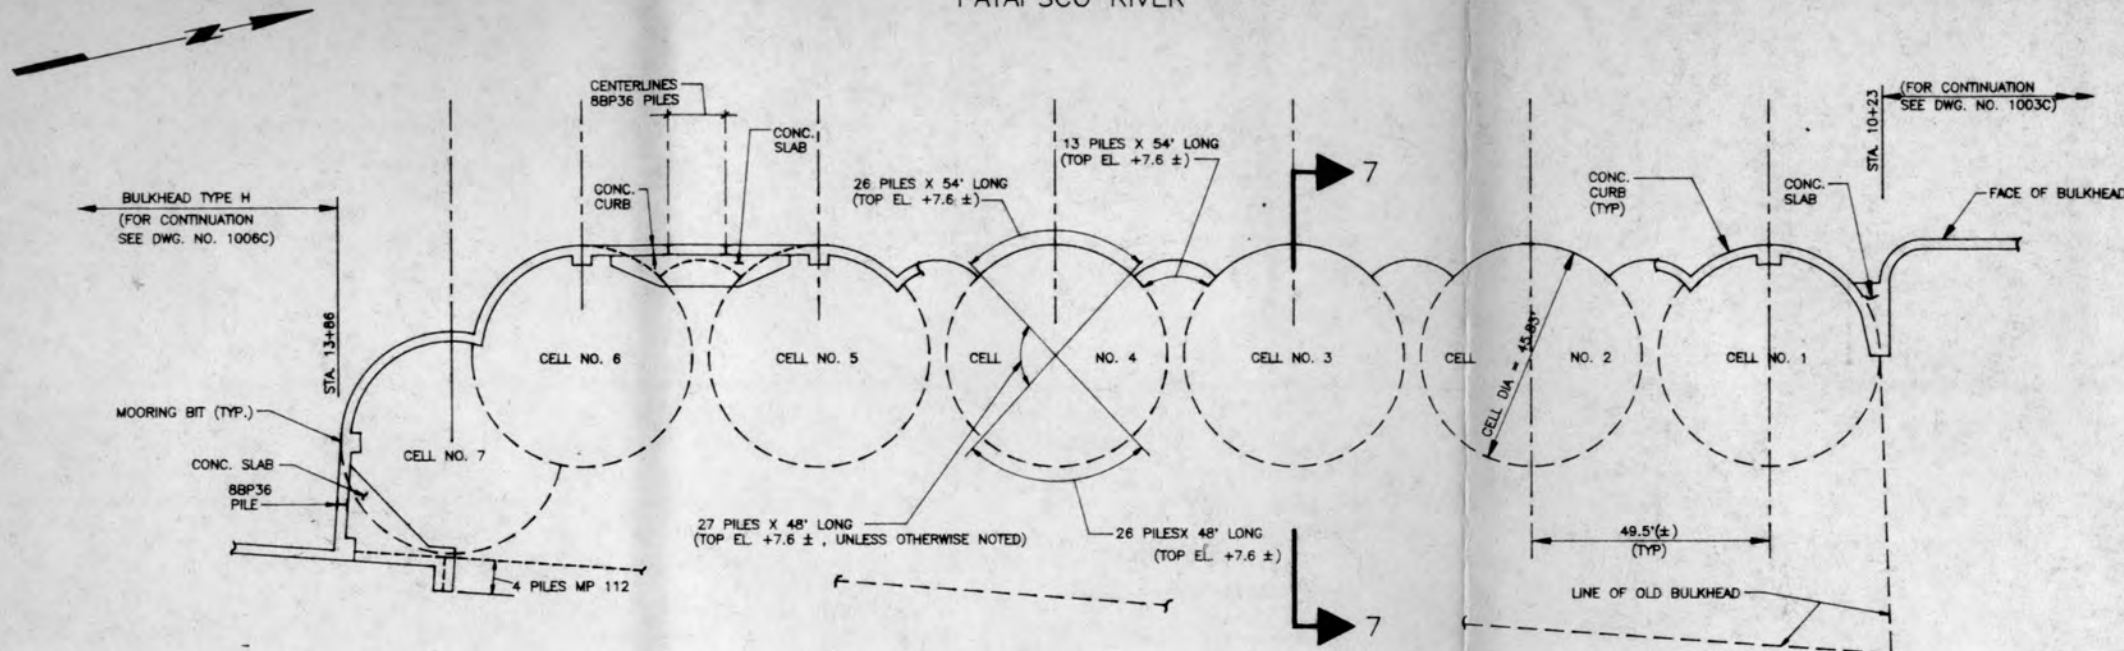
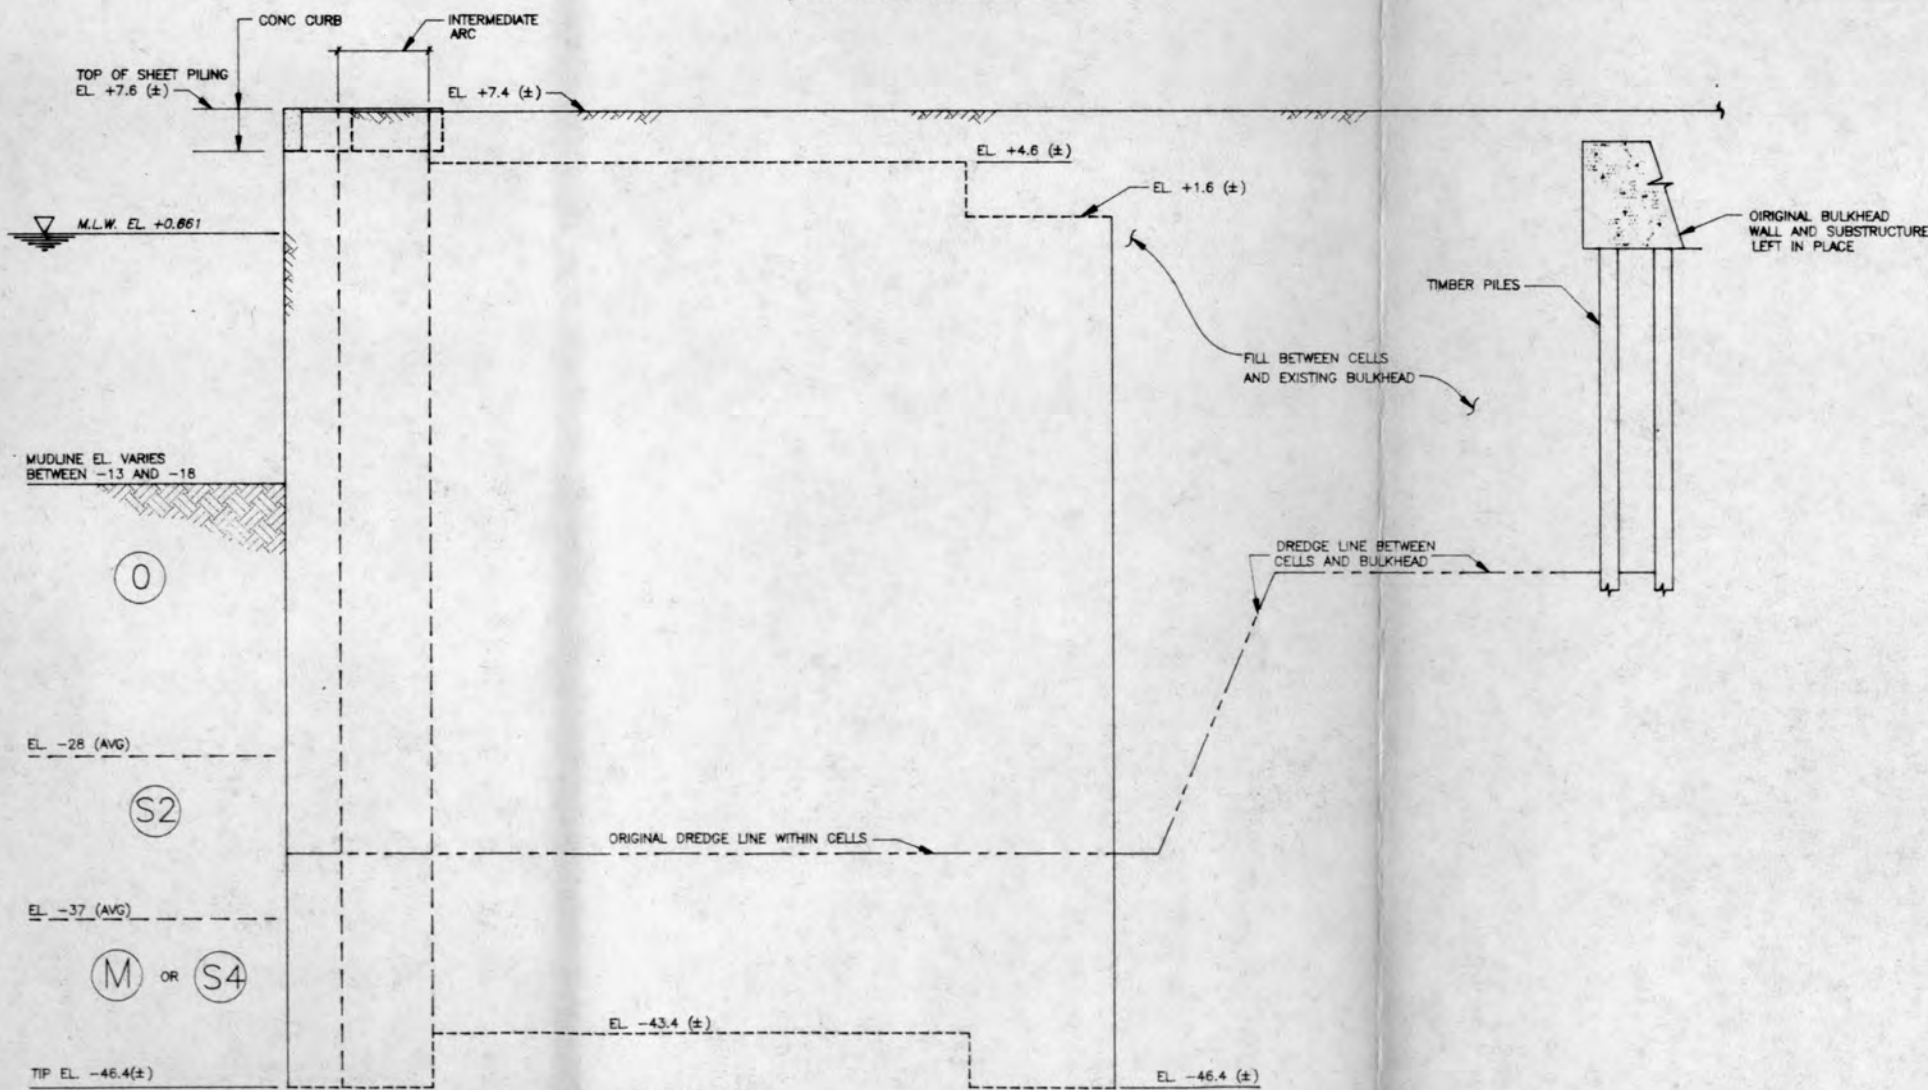
DRAWING NO.
1005C
SHEET OF

The condition survey of the cellular cofferdams consisted of visually inspecting the outboard face of the sheetpiles for their full depth to mudline and performing ultrasonic thickness tests. Ultrasonic tests were performed at several locations above and below water and included areas which were tested during previous investigations. Prior to testing, the metal surfaces were prepared in a similar manner to those at Type F1 bulkhead. The mudline along the face of the bulkhead ranges between 13 and 18 feet below MLW.

At the north and south cells, the diver discovered steel sheeting walls inboard between the cells and adjacent bulkheads. Only the sheeting walls at the south end of the cells are shown on available drawings. It is believed these sheets were installed to function as closure walls to prevent fill from being lost between the two types of bulkhead structures. The closure walls are approximately 18 inches wide and extend from the underside of the slab at grade to about Elev.-4, one foot above the mudline. The diver was able to insert a probe in the void below the sheets for a distance of approximately 10 feet without encountering any other structure. However, no ground depressions or sinkholes exist in the areas immediately behind and above the closure walls.

The steel H-piles which support the concrete deck between Cells Nos. 5 and 6, and No. 7 and Type H bulkhead, are extremely corroded at and above the tidal zone. The piles between Cells Nos. 5 and 6 have lost virtually all their load carrying capacity. As shown in Photograph No. 22, the webs are entirely corroded and the flanges deteriorated to approximately 3 inches in width and less than 1/16 inch thick. The pile supporting the slab at the southeast corner of Cell No. 7 is also corroded but not as severely. The underside of the concrete slabs are in good condition and no significant spalling exists.

BULKHEAD TYPE G
PLAN AND SECTION
