**Maryland Department of Environment**  
**Water and Science Administration**  
**Compliance Program**  
**1800 Washington Blvd, Suite 420**  
**Baltimore, MD 21230-1719**  
**410- 537-3510, 1-800-633-6101**

**Site Name:** Patapsco WWTP  
**Facility Address:** 3501 Asiatic Ave, Curtis Bay, MD 21226  
**County:** Baltimore City County

**Media Type(s):** NPDES Industrial Major Surface Water

**Permit / Approval Numbers:** 15DP0580  
**NPDES Numbers:** MD0021601  
**Inspection Reason:** Follow-up (Non-Compliance)  
**Site Status:** Active  
**Compliance Status:** Noncompliance  
**Site Condition:** Noncompliance  
**Recommended Action:** Additional Investigation Required  
**Evidence Collected:** Photos or Videos Taken, Record Review, Visual Observation  
**Delivery Method:** Email  
**Weather:** Calm, Overcast, Good

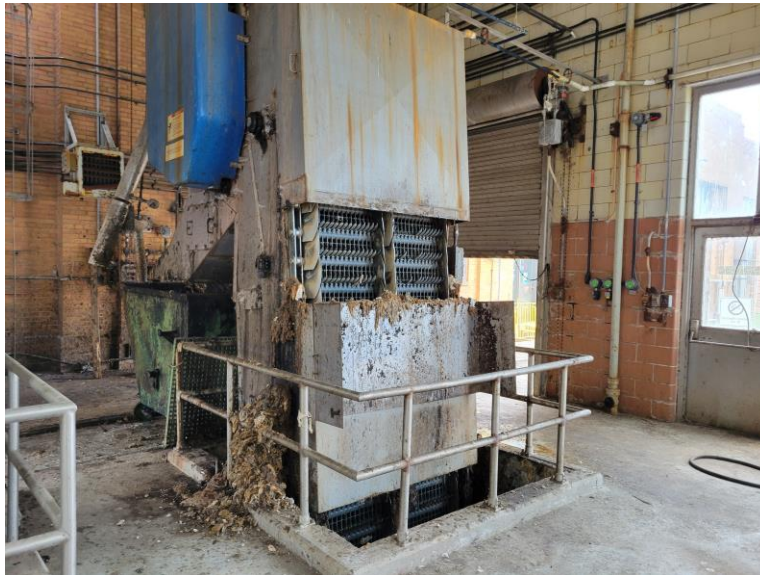
The Industrial Plant Influent (IPI) contains two (2) fine screens and four (4) pumps for conveying flow to the primary clarifiers. The IPI building has approximately 2-3 MGD capacity for industrial influent. Bar screen #1 was not in use during the time of the inspection. The two (2) fine screens in the IPI building receive flow by means of individual channels and gates for flow control. The gate for Bar screen #1 is not functional and needs maintenance. Bar screen #2 was observed to be in operation. Screened and raked material is discharged into rolling dumpsters, one for each fine screen. The dumpsters rest in a concrete channel where they can be winched to the exterior of the IPI building for waste collection. Bar screen #2 was observed as having greasy rags lying on one side and clinging to the metal cladding of the bar screen. BAF filter media was observed on the floor near bar screen #2.

Image 1: IPI Building, Bar Screen #2.

- 1) BAF media and greasy rags were observed inside the IPI building in and around bar screen #2. **Remove all BAF media and greasy rags from the side and floor around bar screen #2 and dispose of them accordingly.**

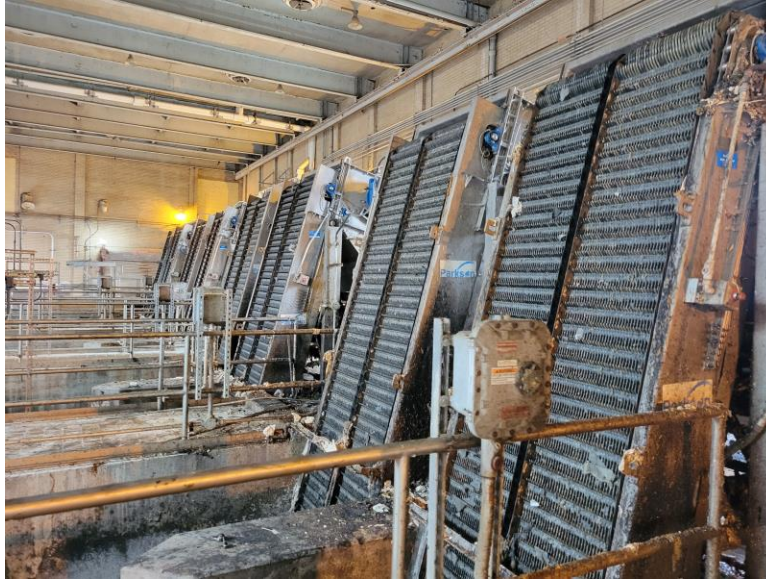
The Fine Screen facility contains eight (8) fine screens divided into two groups of four. Each group of screens has a conveyor and compactor associated with it to carry screened material to the compactor before discharging it to waste dumpsters. At the time of the site visit, it was reported that all eight (8) fine screens are operational. One (1) fine screen (#3) was off during the site visit, the remaining seven (7) screens were in operation. A project for replacing the compactors and conveyor belts for both groups of screens was in its beginning stages at the time of the site visit. The BAF media, rags, and grease observed during the last inspection in the steel channels embedded in the concrete and near the waste dumpsters appeared to have been removed and cleaned on the day of this inspection.

Image 2: Fine Screen Facility.

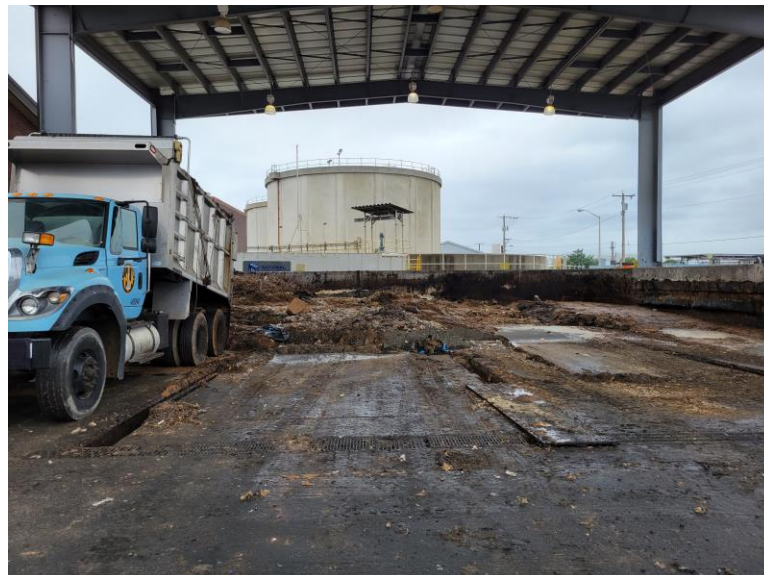
The transfer station has a roof, low wall on three sides, and trench drains in its concrete floor. Grease and grit from the preliminary treatment systems (screening) are stored in the transfer station. Liquid that drains into the trench drains of the transfer station is pumped back into the gravity sludge thickeners (GSTs). Dried waste and grit are taken to the Quarantine Road Municipal Landfill for disposal.

Image 3: Transfer Station.

On this day, the screens for the trench drains were removed and the drains were being cleared. Through the process of operating trucks and equipment in the transfer station, heavy grease tracks were observed outside of the covered area of the transfer station on the asphalt surface.

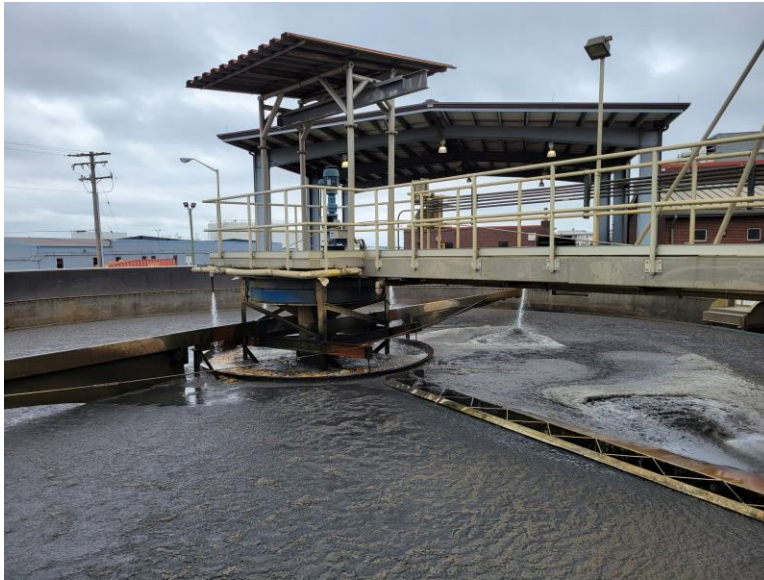
There are three (3) 65-ft diameter gravity sludge thickeners (GSTs) in the sludge handling area of the plant. The GSTs are numbered #1, #2, and #4. GSTs #1 and #2 are built on grade and GST #4 is elevated above grade. The skimming arms of GST #1 and #2 are missing significant portions of the rubber flaps which should extend down to the liquid surface to effectively remove surface scum. Currently, staff spray water on the surface of GST #1 and #2 in order to manually remove surface scum. Repairs for the skimming arms are reportedly planned and a vendor has been selected to complete the repairs.

Image 4: GST #1.

At the time of the site inspection, GSTs #1 and #2 had significant amounts of floating sludge outside of the V-notch weirs. The scum trough on GST #1 was clear and the scum trough on GST #2 had a buildup of sludge on the surface but was clear and operational. Vegetation was observed growing along the scum trough on GST #2. Synagro was reportedly pulling from GST #2 at the time of the inspection for sludge processing. GST #4 was nearly empty. Anthony Merrill reported that GST #4 was drawn down for cleaning to put it into service. Anthony Merrill reported that they continue to have issues with Synagro shutting down due to mechanical issues.

- 2) The GSTs are overloaded with sludge and solids and are not able to function as designed. Both skimmer arms in GST #1 and GST #2 are in need of repair. The function of the GST is to allow for most of the biosolids to settle at the bottom and for a relatively solids-free supernatant to rise to the top. The high concentration of biosolids in GST effluent can negatively impact the pure oxygen reactors' ability to remove BOD and can cause nitrification issues within the plant. **Operate and process sludge in a manner consistent with the function and design of the equipment.**

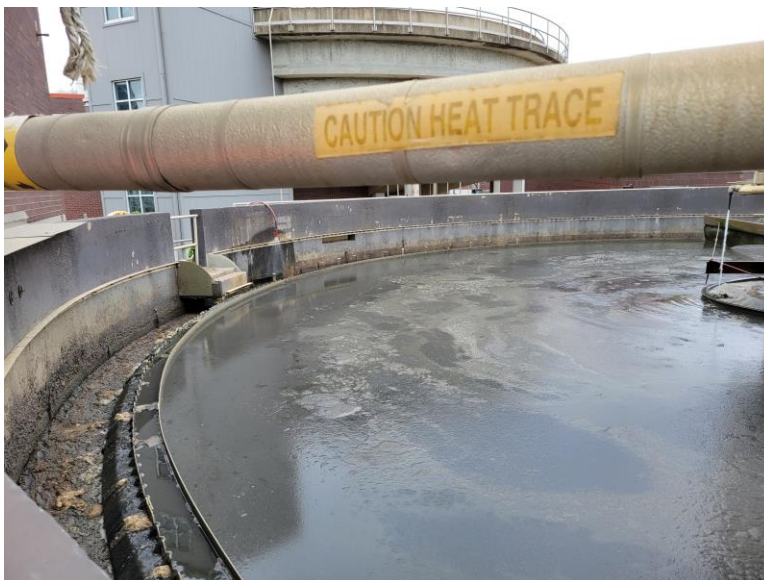
Image 5: GST #2.

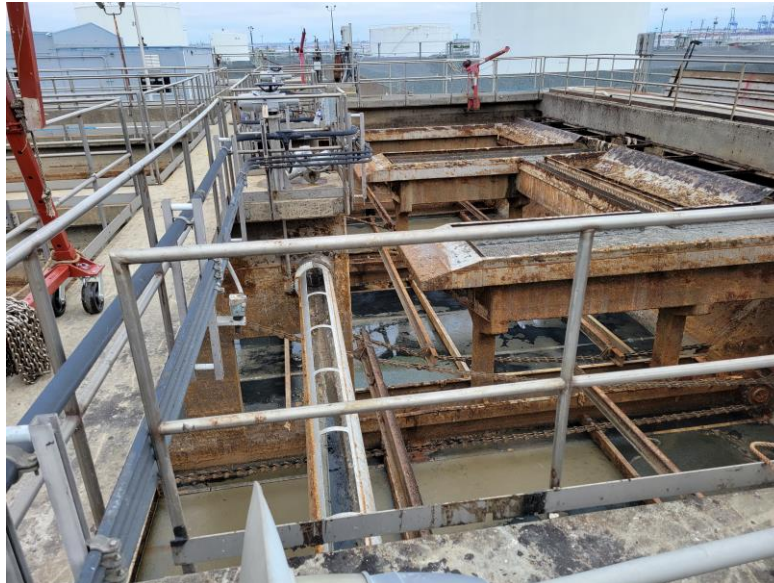
At the time of the site inspection, PSTs #2, #4, #5, and #6 were in service. Routine maintenance was being completed on PST #3. PST #1 is down for the installation of new troughs and actuators. Baffles will also be replaced in PST #1. Following the completion of these repairs on PST #1, Anthony Merrill reported the same repairs will be completed on #3 followed by #2, #4, #5, and #6. PST #2 was observed as having a light layer of floating solids at the surface on the effluent end that two operators were skimming off. PSTs #4, #5, and #6, were observed to be functioning normally with no visible floating solids on their respective effluent ends.

Image 6: PST #1, new troughs and actuators installed.

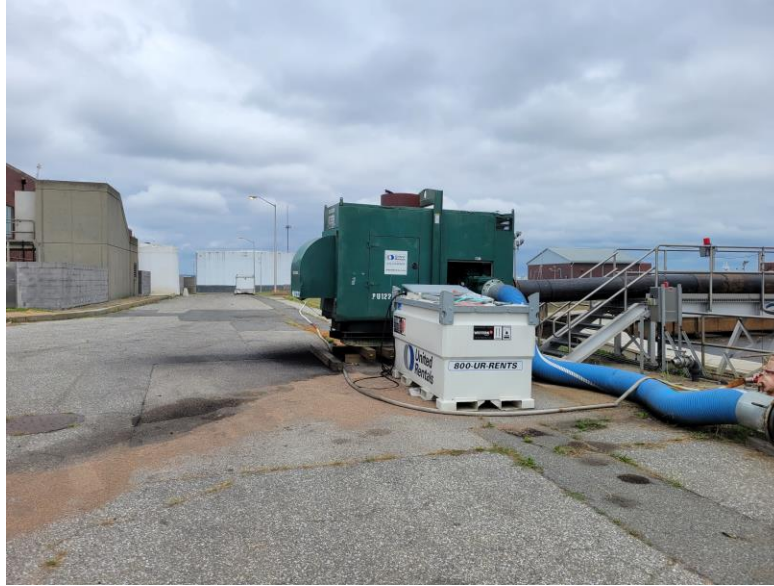
Between the High Purity Oxygen Aeration Reactors and Secondary Treatment Clarifier #3, adsorbent material is still present on an asphalt-paved drive originating at a United Rental temporary pump and continuing south down the drive for approximately 60 feet. During the last site inspection, the adsorbent material was reportedly the result of a spill of one (1) gallon of diesel fuel from a United Rental technician while the technician was replacing the pump with another temporary pump. Kevin McFadden stated that he would have the absorbent material swept up right away.

Image 7: Temporary United Rental Pump, adsorbent material.

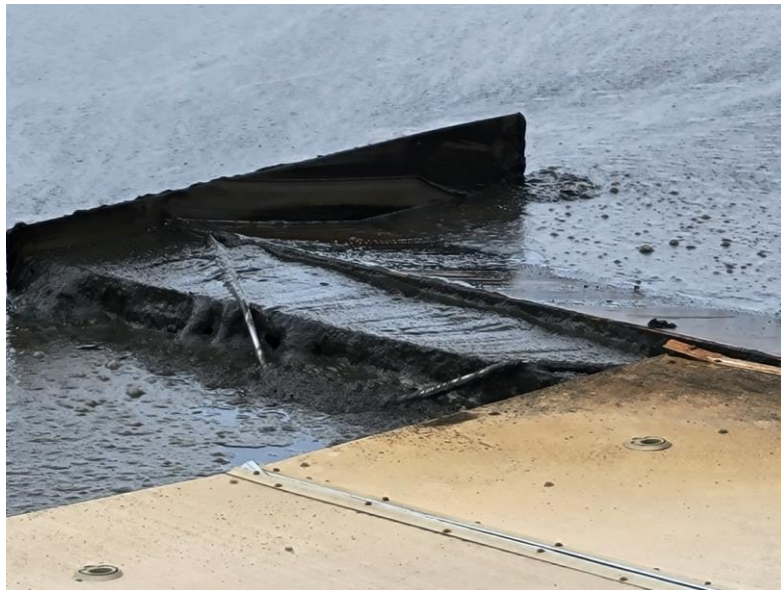
The scum trough for secondary clarifier #1 overflows to a sunken concrete-lined overflow pit adjacent to the clarifier. On this day, the overflow pit was observed as containing a small volume of water – no BAF media was observed in the pit. BAF filter media was observed on the ground around the entrance stairs to the clarifier access walkway. The scum trough for secondary clarifier #1 was clogged.

Image 8: Secondary Clarifier #1, clogged scum trough.

- 3) BAF media was observed on the ground by the access walkway stairs at Secondary Clarifier #1. **Remove all BAF media from the ground by the access walkway stairs at Secondary Clarifier #1 and dispose of it accordingly.**

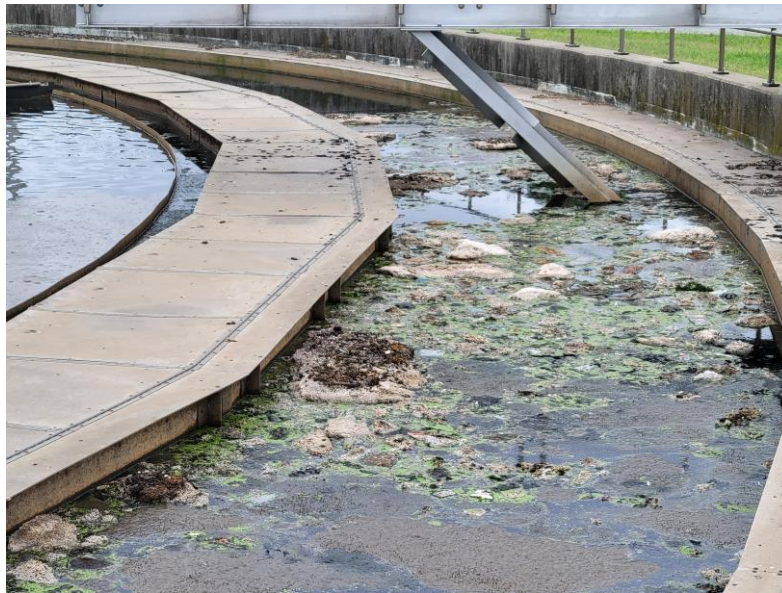
Secondary clarifier #5b was observed in operation with water being applied to the surface to breakup surface scum. One arm of the skimmer for clarifier #5b appears to be bent near the middle causing the top edge to drift below the surface allowing scum to pass over. The scum trough was observed to be clear. A large amount of debris was observed floating between the inner weir and outer edge of the clarifier. Kevin McFadden reported that this was the result of stopping the clarifier to repair one side of the skimmer arm. He stated he would have the debris removed.

Image 9: Debris observed in Clarifier #5b.

- 4) The secondary clarifiers are not being maintained in a condition to operate effectively. One of the two skimmer arms in Secondary Clarifiers #4, #5a, #5b, and #6b are not functioning as designed. Vegetation was observed growing in Secondary Clarifier #5a. A large amount of debris was observed floating in Secondary Clarifier #5b. The scum trough in Secondary Clarifiers #1, #2, #4, and #5a were clogged and not functional. **Repair and maintain the secondary clarifiers to ensure that they are functioning per design. The skimmer arms should be fixed to ensure that the entire length of the skimmer arm is on the water surface and extending to the baffles, allowing for solids on the water surface to be skimmed into the scum troughs. Remove all vegetation and trash from the clarifiers. Implement routine maintenance to prevent the excessive building of sludge and solids in the scum troughs.**

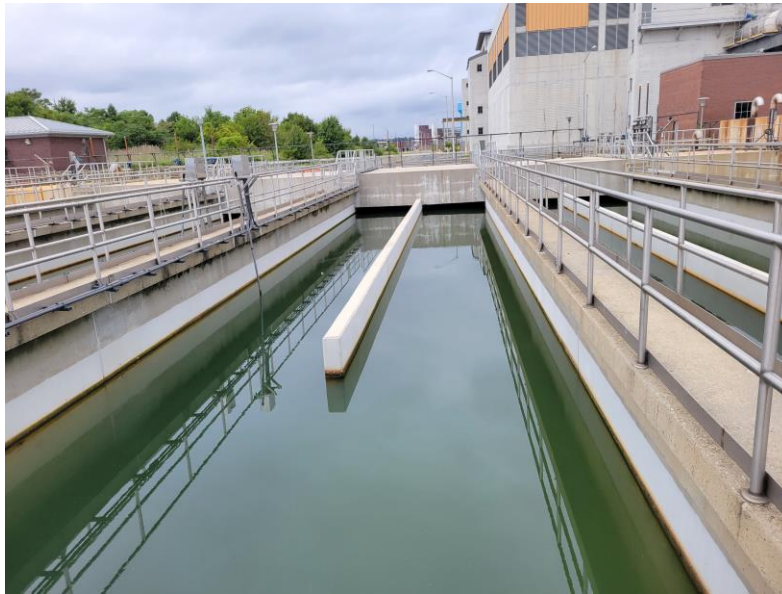
The wastewater treatment plant has four (4) chlorine contact chambers with scum troughs and mixers. All four (4) chlorine contact chambers were operating at the time of the site inspection. Contact chambers #2 and #3 have a mixer out of service which is causing excessive foam to develop on the surface. The foam is being collected by the scum troughs in each chamber. The broken and floating booms and baffles that were installed in the chlorine contact chambers have been removed for safety reasons.

Image 10: Final pass of Contact Chamber #1.

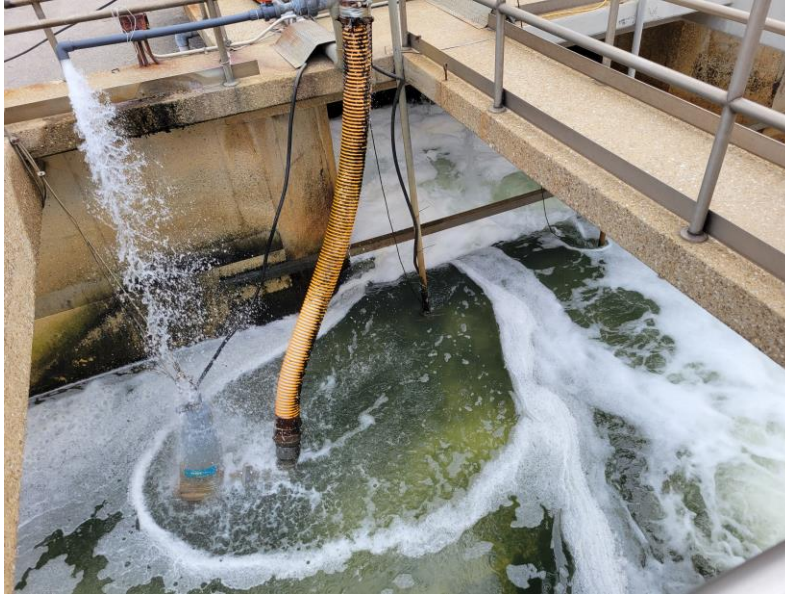
Foam was observed on the surface of the final discharge channel which appeared to disperse rapidly. BAF media and FOGs were not observed to be leaving the site via the effluent channel.

Image 11: Final Effluent from Chlorine Contact Chambers.
