Maryland Department of Environment
Water and Science Administration
Compliance Program
1800 Washington Blvd, Suite 420
Baltimore, MD 21230-1719
410- 537-3510, 1-800-633-6101

Site Name: Patapsco WWTP
Facility Address: 3501 Asiatic Ave, Curtis Bay, MD 21226
County: Baltimore City County

Media Type(s): NPDES Municipal Major Surface Water

Inspection Date: May 06, 2021
Site Name: Patapsco WWTP
Facility Address: 3501 Asiatic Ave, Curtis Bay, MD 21226

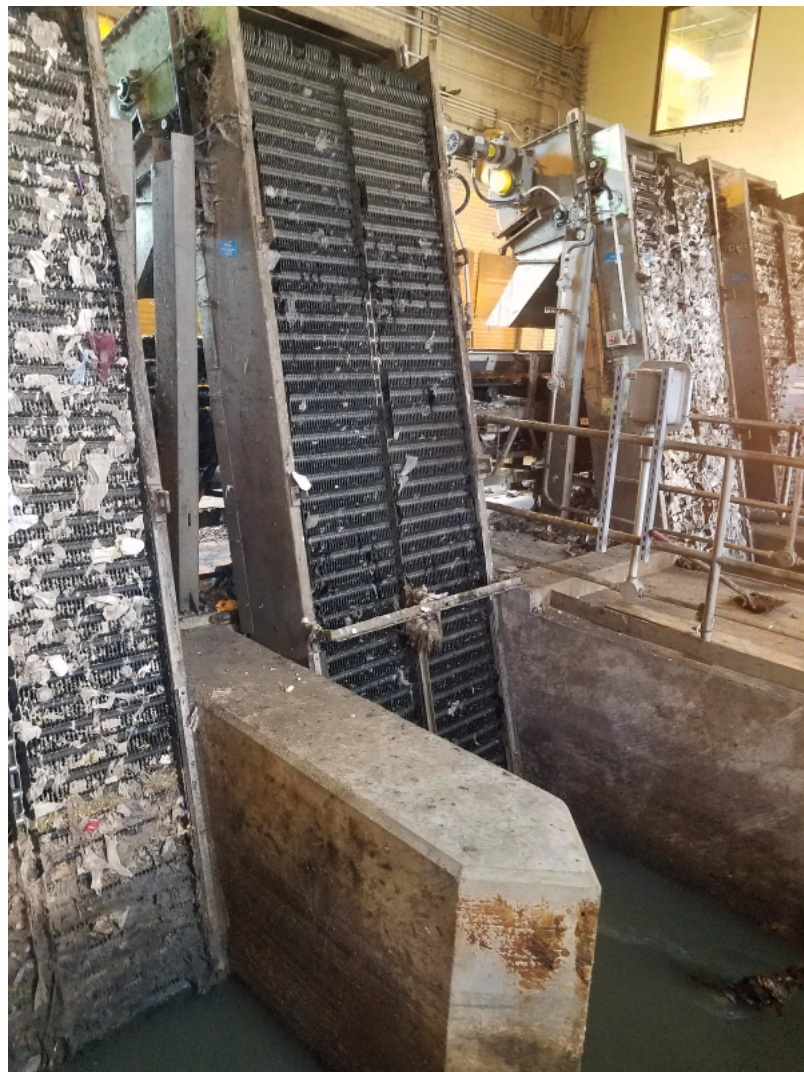
The facility has eight screening units, and three units are online at a time for the fine screening of the wastewater. I found that a few of the screening units were filled with trash and other debris that would prevent proper operations of the screening units. The active units should be routinely scraped down and the units that are not being used should be manually scraped, as necessary, immediately after being taken out of service. These units should be ready to be put back on-line at any time.

Bar Screens for Fine Screening 5/6/2021

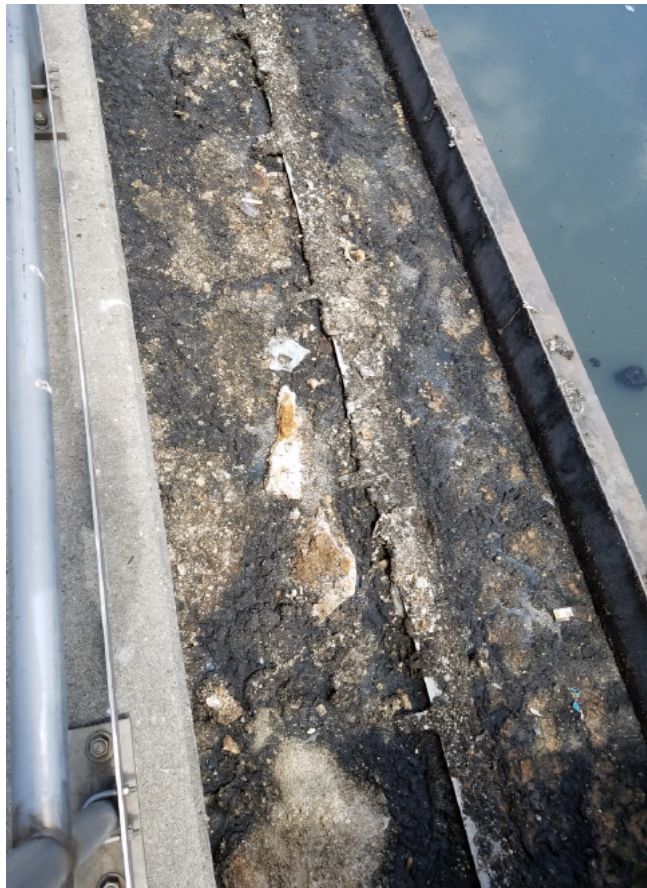
Because of the excessive amount of sludge/FOG mixture in the scum troughs, some of the scum troughs may not be able to be turned thus causing a backup of sludge/FOG mixture. This backup will eventually cause the PST to fail. Currently of the 18 PSTs only 5 are functional at this time and if the problems are not quickly resolved, these systems will also fail in time. According to Mr. Jackson and Mr. Johnson, the scum pumps are not functioning on some units. I explained to them that the facility's spare parts inventory should include various type of pumps and parts required for routine repairs. I was told that since the ransomware breach there has been problems with accessing the spare parts inventory.

PST Scum trough with excessive amount of FOG 5/6/2021

- J. With respect to item 10 above, the FOG skimming devices on the PSTs are not functioning properly, the permittee's operational and maintenance staff should make a concerted effort to ensure that there are no releases of floating scum and FOG as I observed during this inspection. The scum troughs on the PSTs should be checked and manually turned as appropriately. Excessive amounts of grease should be removed and disposed of properly. The scum collection pit(s) should be checked and pumped or drained, as necessary. The scum logs at the chlorine contact basins should be monitored and adjusted to ensure that they are at water level and able to effectively collect the floating FOG and scum. The scum, FOG and other floatable substances should be routinely skimmed-off and the collected materials

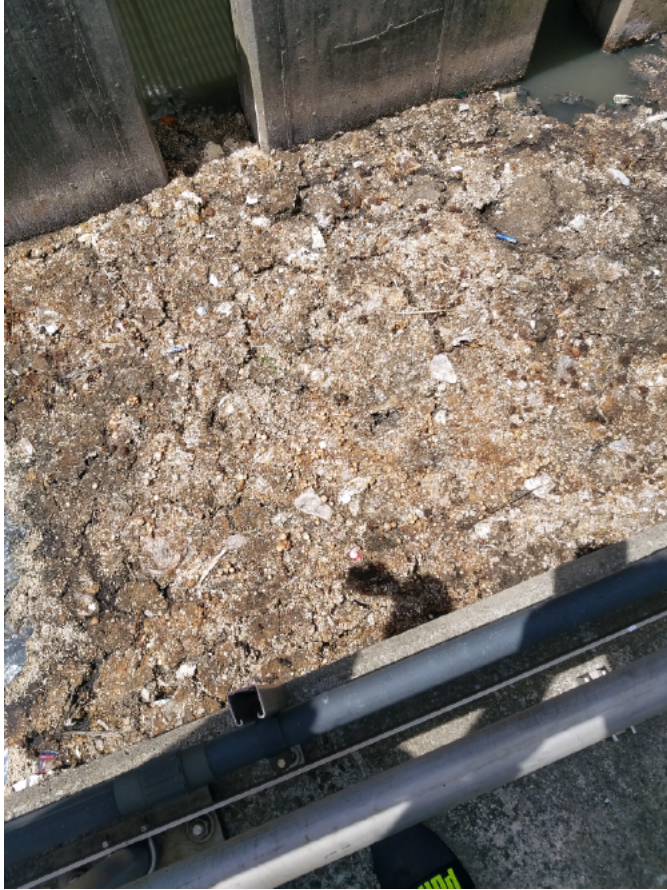
PST Scum trough with excessive amount of FOG 5/6/2021

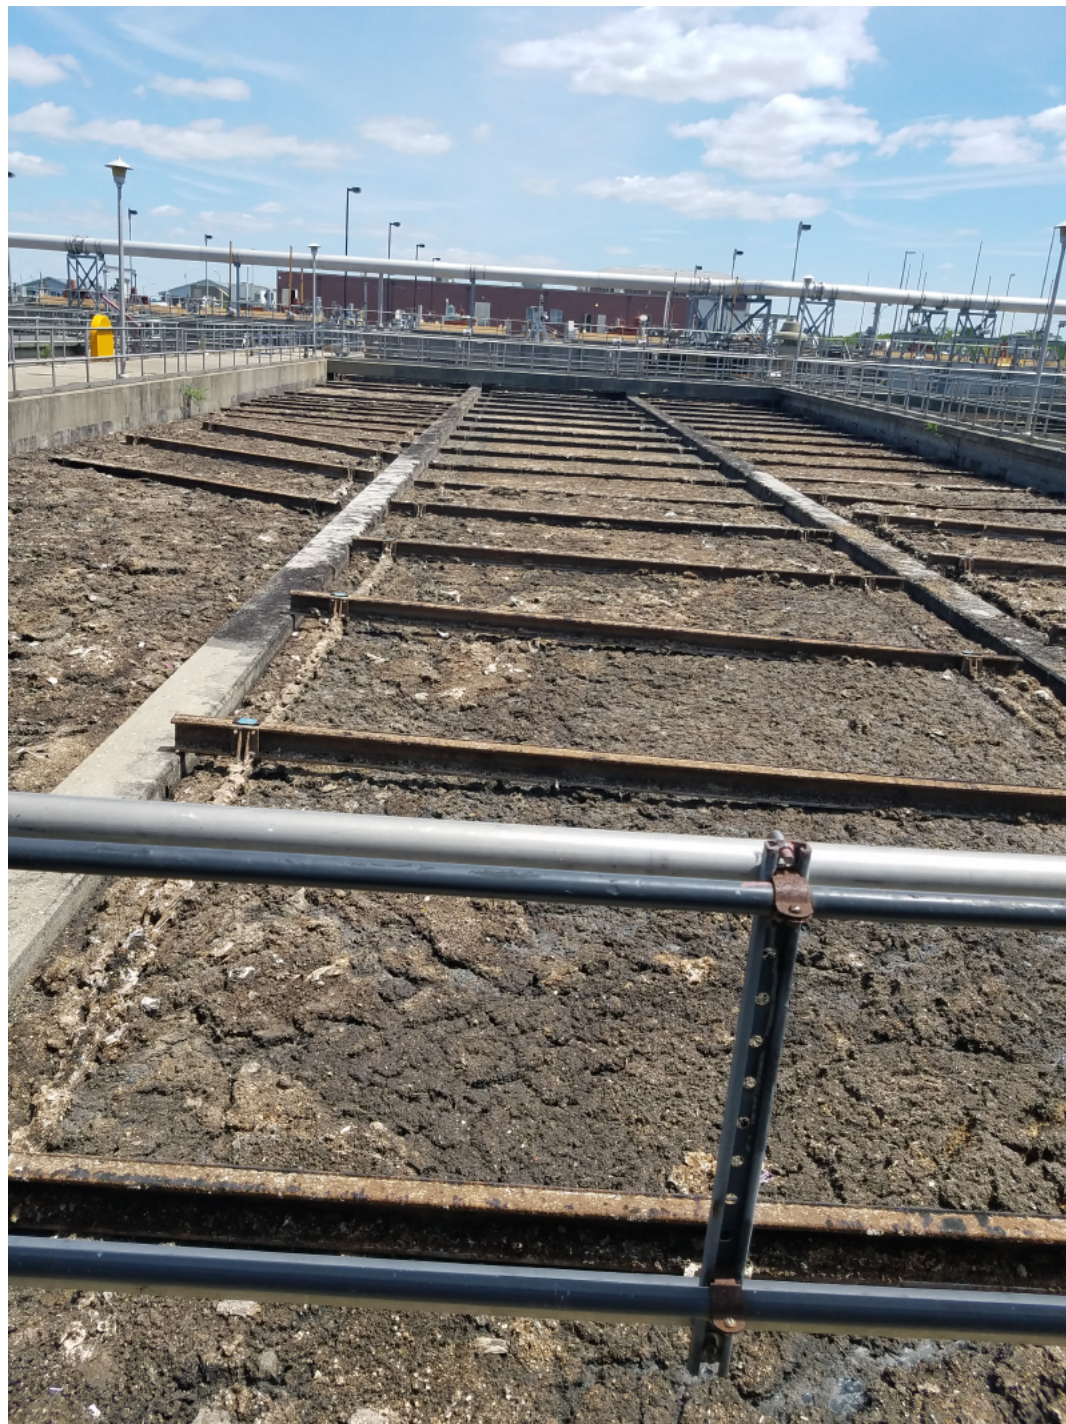
The wastewater is then sent to primary settling tanks (PST) for initial settling of the solids. The plant has eighteen primary settling tanks. The system was designed so that the bottom sludge from the PSTs is gathered by screw collectors. This wasted sludge and FOG collected in the scum troughs or skimming troughs would then be sent to the gravity thickeners. However, due to improper maintenance and equipment failures the system is not functioning as originally designed. These problems were addressed in the permittee's 2017 FOG Mitigation Plan but not resolved. I observed that there was a significant amount of FOG in each of the skimming troughs on the functioning PSTs. The actuators are not functioning, which prevents the troughs from turning to release the collected FOG. I observed this problem during a previous inspection, and at that time I observed that the troughs were being manually turned and the collected FOG flowed to a grease collection pit. During this inspection this was not being done and the FOG and scum was not being removed from the troughs. The excessive collection of FOG and scum at the PSTs indicate a major treatment design problem that requires an engineering solution. However, because to the excessive amount of grease in the scum troughs and the number of out of service PSTs, there is reason to assert that the PSTs have not been maintained effectively to ensure proper function and operation.

PST not operational due to solids and FOG 5/6/2021

- G. With respect to item 7 above, within 90 days of the receipt of this report, the permittee should develop a site-specific BMP to address the problem caused by poorly functioning and inoperable equipment. This BMP should include procedures, preventive maintenance, spare parts inventory, and other appropriate measures for solving specific problems with the management and processing of FOG.

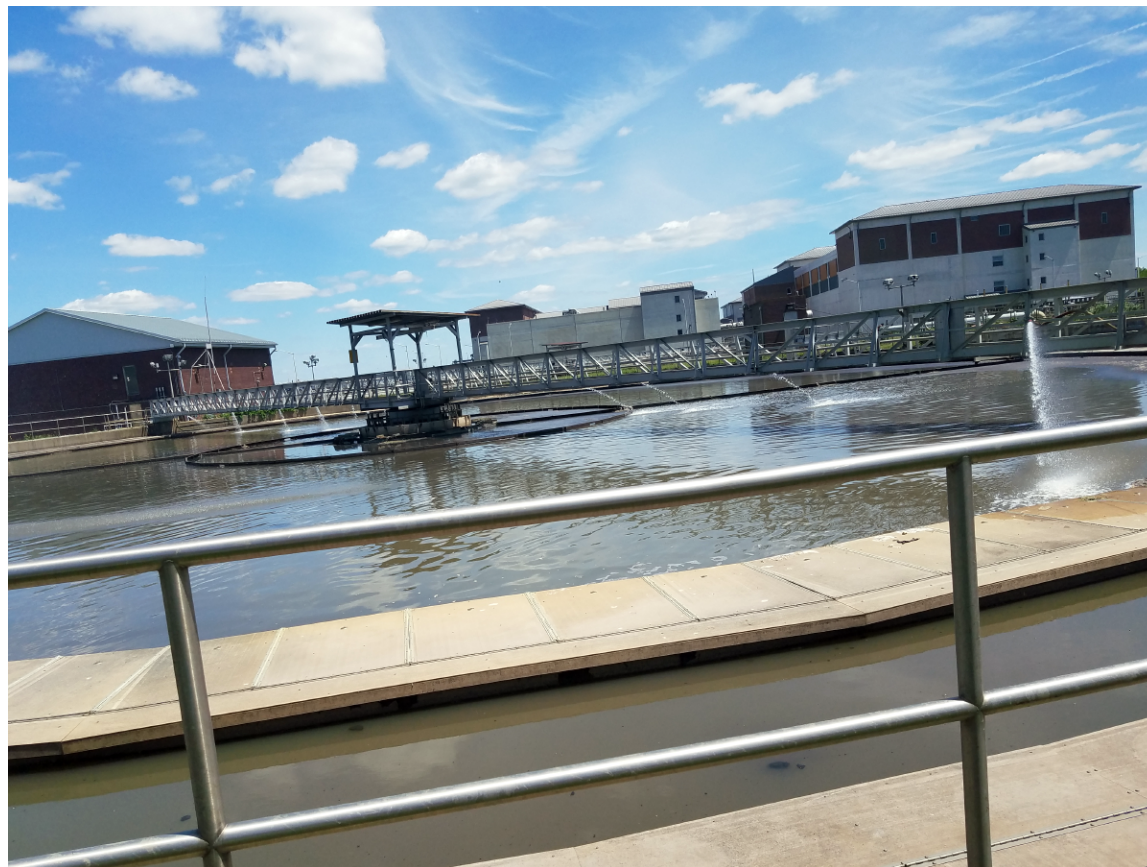
The next stop was at the #1 secondary clarifier, which was functioning satisfactorily.

Secondary Clarifier #1 5/6/2021

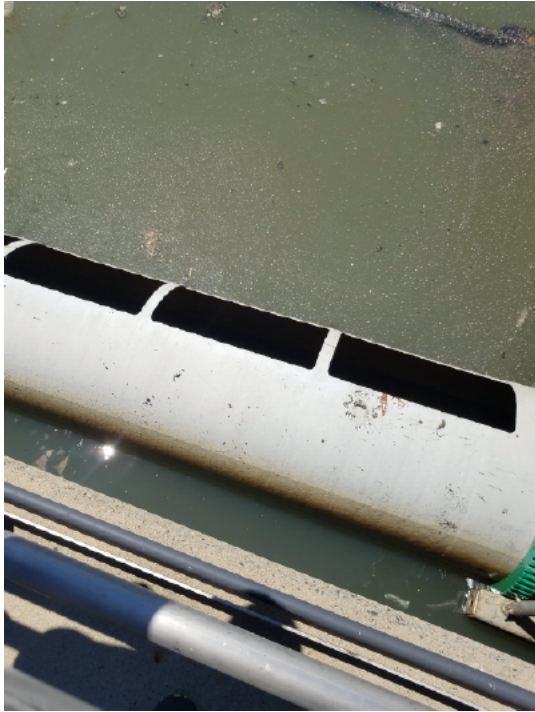
Next, I inspected the chlorine contact basins prior to the final discharge. There are 4 contact chambers and 3 of the 4 are currently online. Each contact chamber has 3 scum logs or troughs to remove floating scum. Moreover, because of fluctuations in flow, the level of the scum logs must be adjusted according to the water level in the contact chambers. When we arrived at the chlorine contact chambers, I observed that the skimming ports for the scum logs for the in-service chlorine contact chamber were above the water level. This is a violation of Special Condition M, d. of the permit, which requires that “During normal flow condition, the permittee shall either raise the water level or lower the scum logs in the contact chamber to optimize the FOG removal efficiency”

Scum log above water surface 5/6/2021

The permittee should consider installing an engineered collection system designed to collect and transfer the collected scum and FOG from all scum logs in the chlorine contact basins to the collection pits.

- K. With respect to item 11 above, during normal flow condition, the permittee shall either raise the water level or lower the scum logs in the contact chamber to optimize the FOG removal efficiency. Floating oils spill booms should be placed in the contact chambers where the scum logs are not used to prevent the discharge of FOG.
- L. With respect to item 12 above, within 30 days of the receipt of this report, the permittee should submit to the Department a report detailing all specific measures and actions taken to ensure compliance with the FOG Mitigation Plan since the issuance of the permit through December 31, 2020. Then, the permittee shall begin submitting on an annual basis at the end of each calendar year all measures taken during the year to comply with the FOG Mitigation Plan.

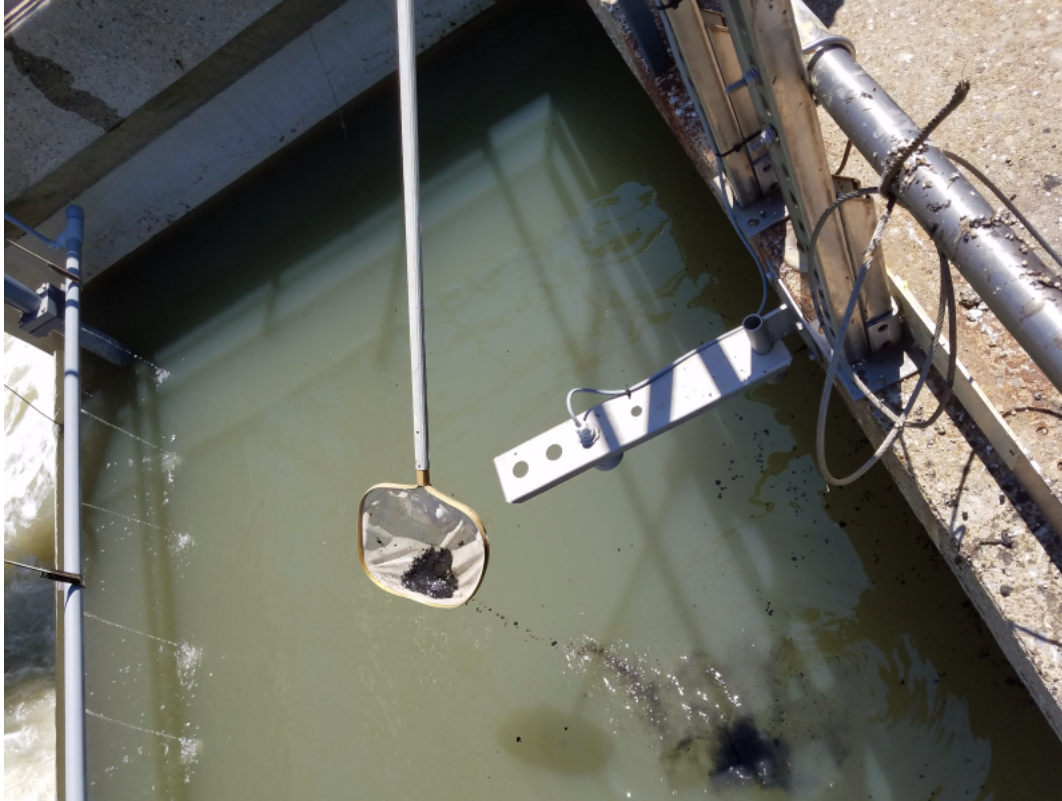
Floating scum being discharged before scum log was lowered 5/6/2021

10. FOG particles are being discharged to the surface waters of the State.
11. The permittee is not complying with the FOG Mitigation plan and Special Condition M of the permit by not raising the water level or lowering the scum logs as necessary to ensure capturing FOG and other floating scum.

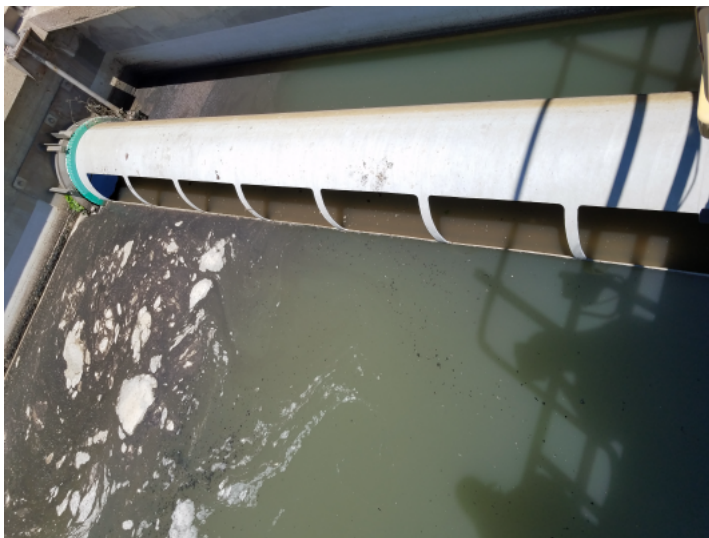
Scum log lowered at my request 5/6/2021
