Maryland Department of Environment
Water and Science Administration
Compliance Program
1800 Washington Blvd, Suite 420
Baltimore, MD 21230-1719
410- 537-3510, 1-800-633-6101

Site Name: Back River WWTP
Facility Address: 8201 Eastern Ave, Baltimore, MD 21224
County: Baltimore County

Start Date/Time: January 26, 2023 08:45 AM
End Date /Time: February 10, 2023 04:41 PM

Permit / Approval Numbers: 15DP0581
NPDES Numbers: MD0021555
Inspection Reason: Follow-up (Non-Compliance)
Site Status: Active
Compliance Status: Noncompliance
Site Condition: Noncompliance
Recommended Action: Additional Investigation Required
Evidence Collected: Photos or Videos Taken, Record Review, Visual Observation
Delivery Method: Email
Weather: Clear Average

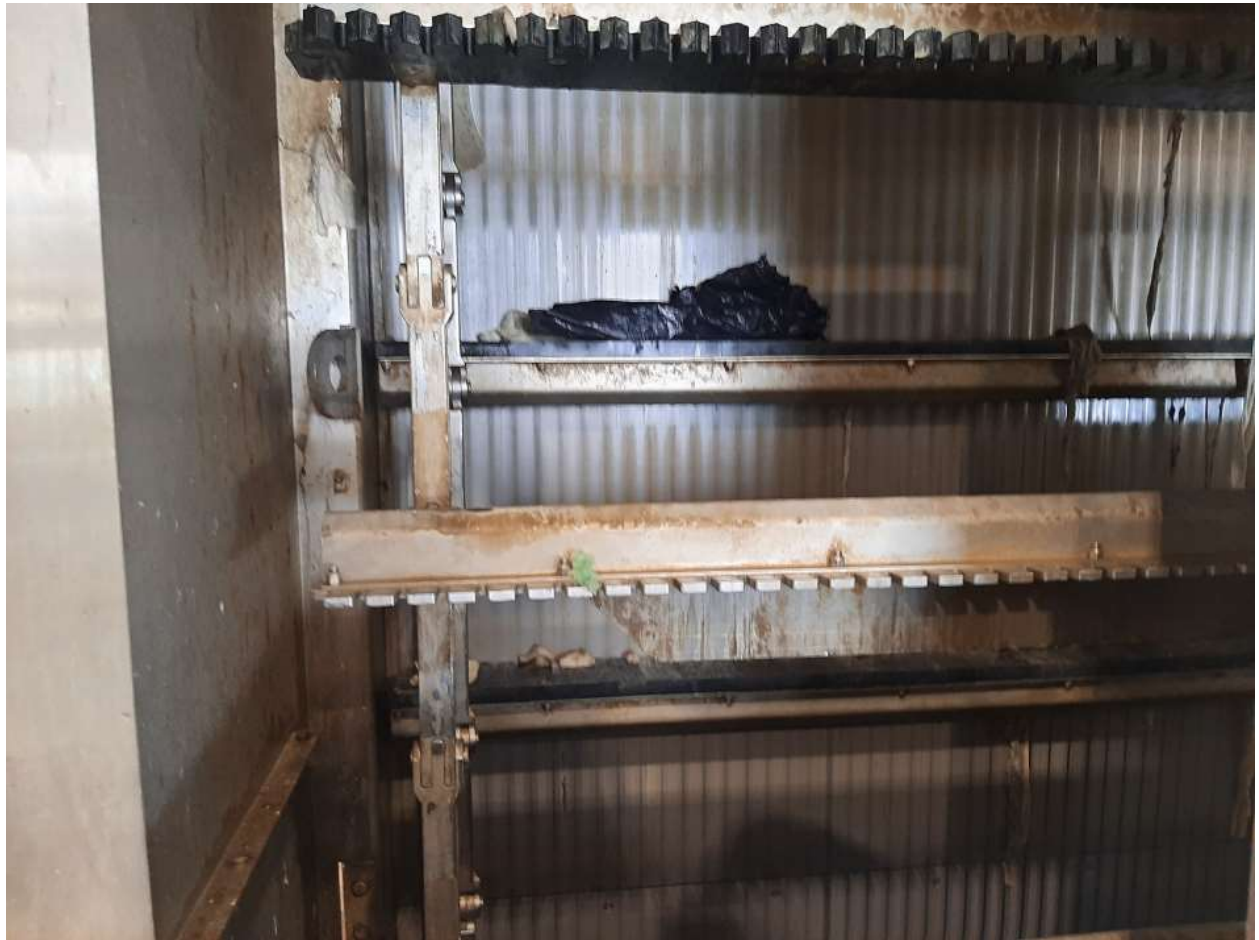
During this inspection, no problems were observed with the active coarse screening unit.

1/26/23 Active coarse screening unit

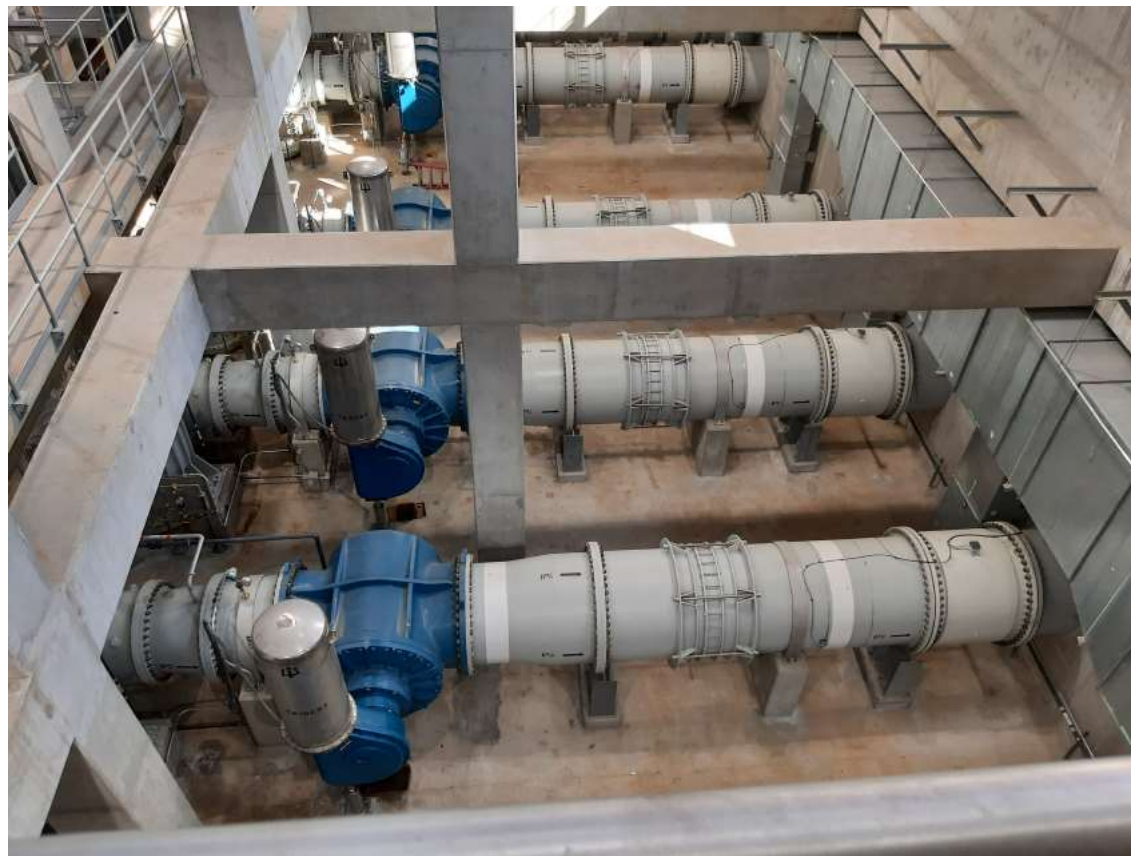
1/26/23 Picture shows Pumps #1-4. Today, 2 were being used for the headworks operation. Pumps #1- #4 have pumping capacities of 100 MGD each and pumps #5 - #8 (not shown) have pumping capacities of 120 MGD each.

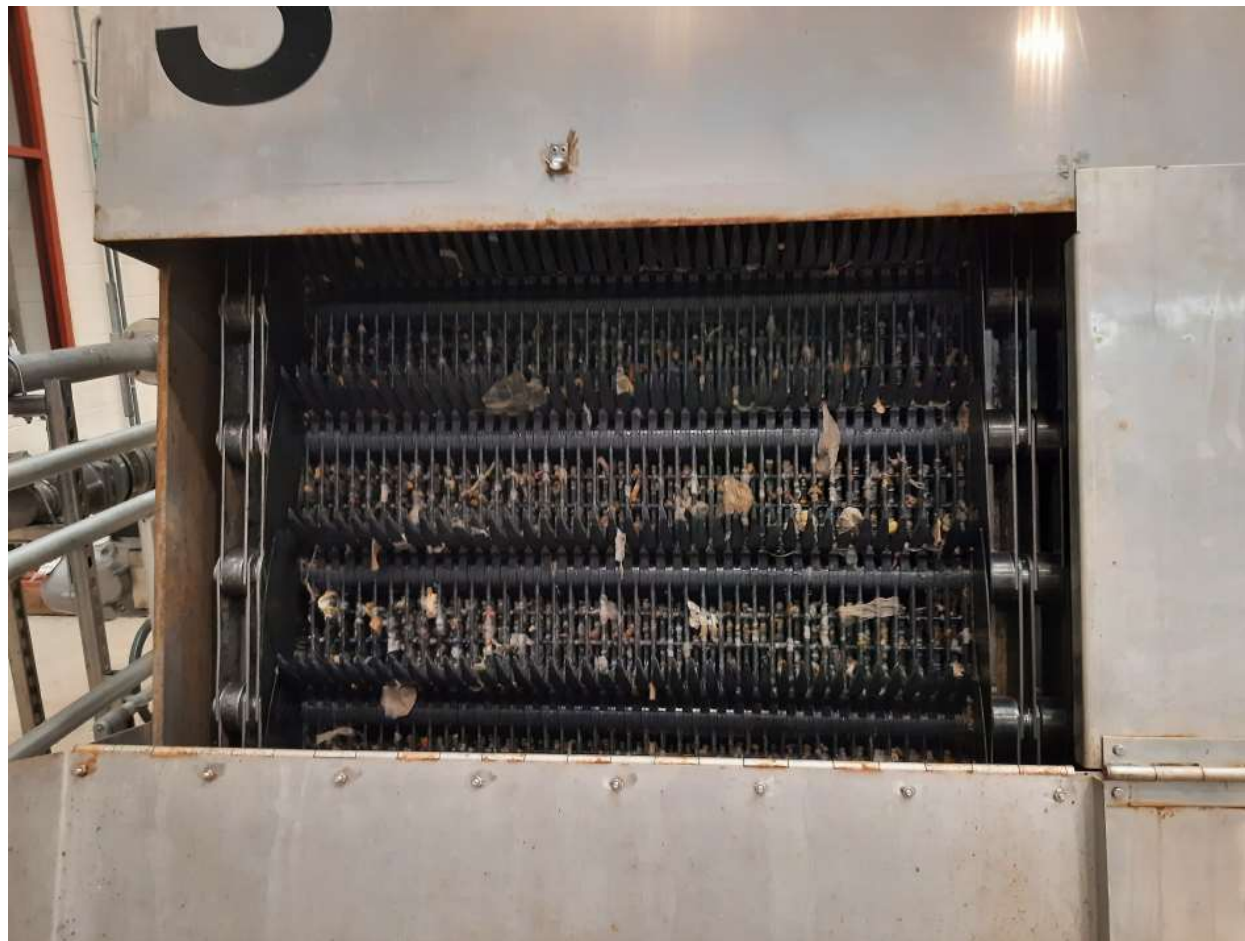
1/26/23 Fine screening unit in service.

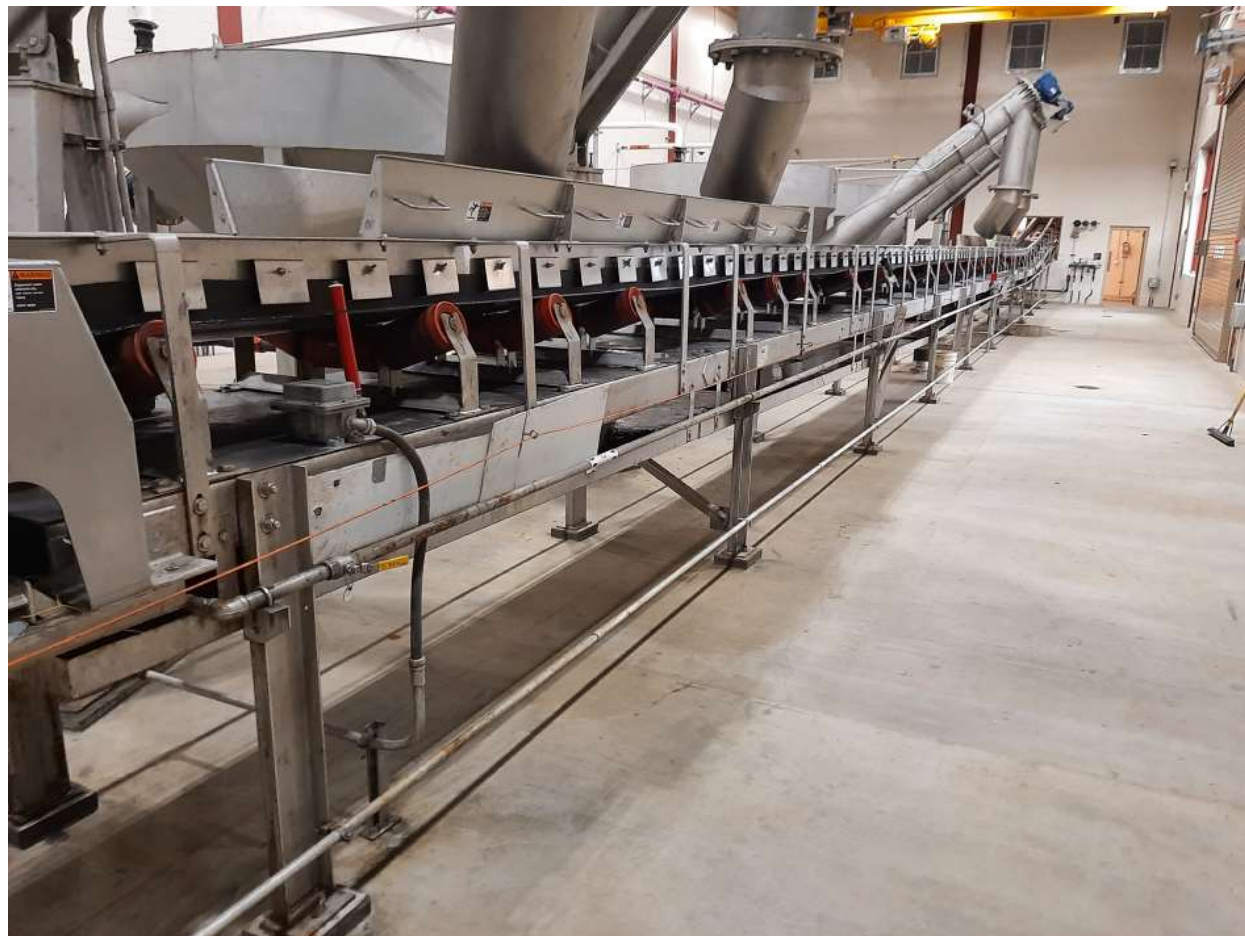
1/26/23 Grit removal area

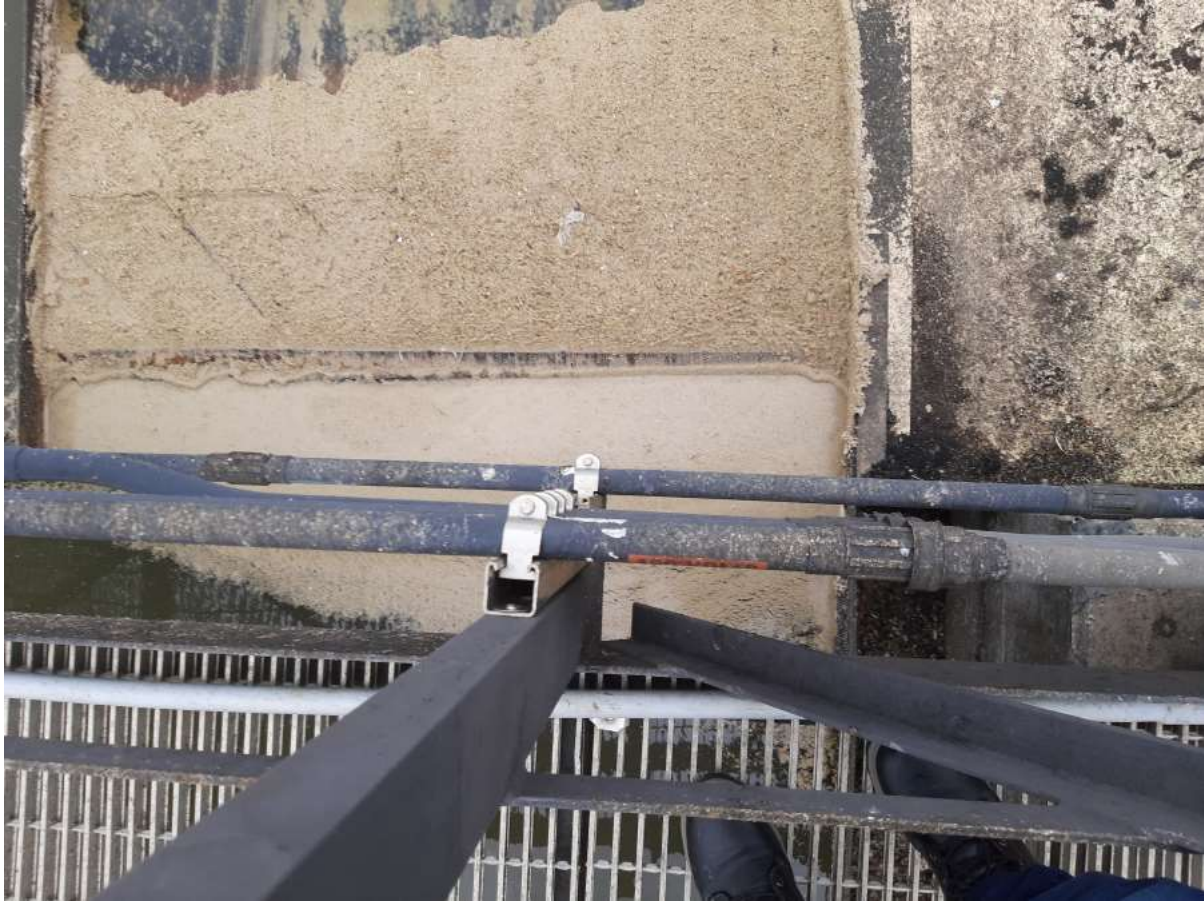
1/26/23 PST # 11 scum trough clogged with floating FOG and scum. The scum trough should be cleaned out and scum pit pumped out as necessary.

2. The scum troughs on PST #1, #7, #8 and #11 are clogged with scum and require routine maintenance. This is a violation of General Condition B3 of the NPDES permit. This condition has been observed and reported routinely during previous inspections.

- B. With respect to item #2 above, the Back River WWTP shall immediately maintain the PSTs as required to keep them functioning properly to comply with the requirements under General Condition B3 of the NPDES permit. Within 5 days of the receipt of this report, the scum pits shall be pumped out as necessary and the scum troughs shall be cleaned. Going forward, the scum troughs on the PST shall be routinely inspected and the scum pits pumped out as necessary to keep the scum trough openings clear.

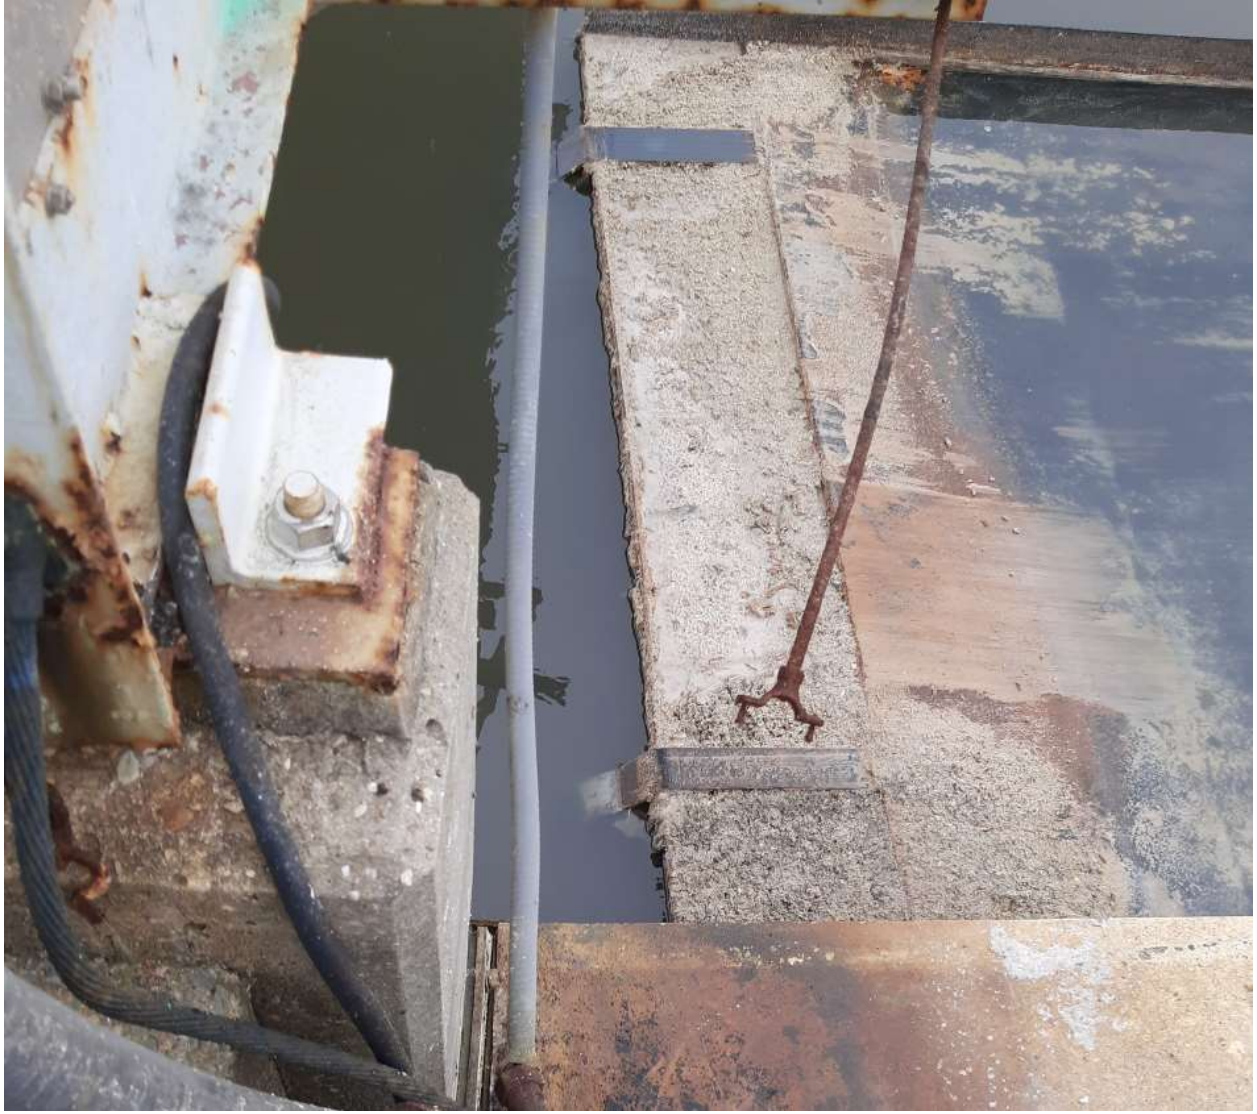
1/26/23 PST #8 scum trough clogged with FOG and scum. The scum trough should be cleaned out and scum pit pumped out as necessary.

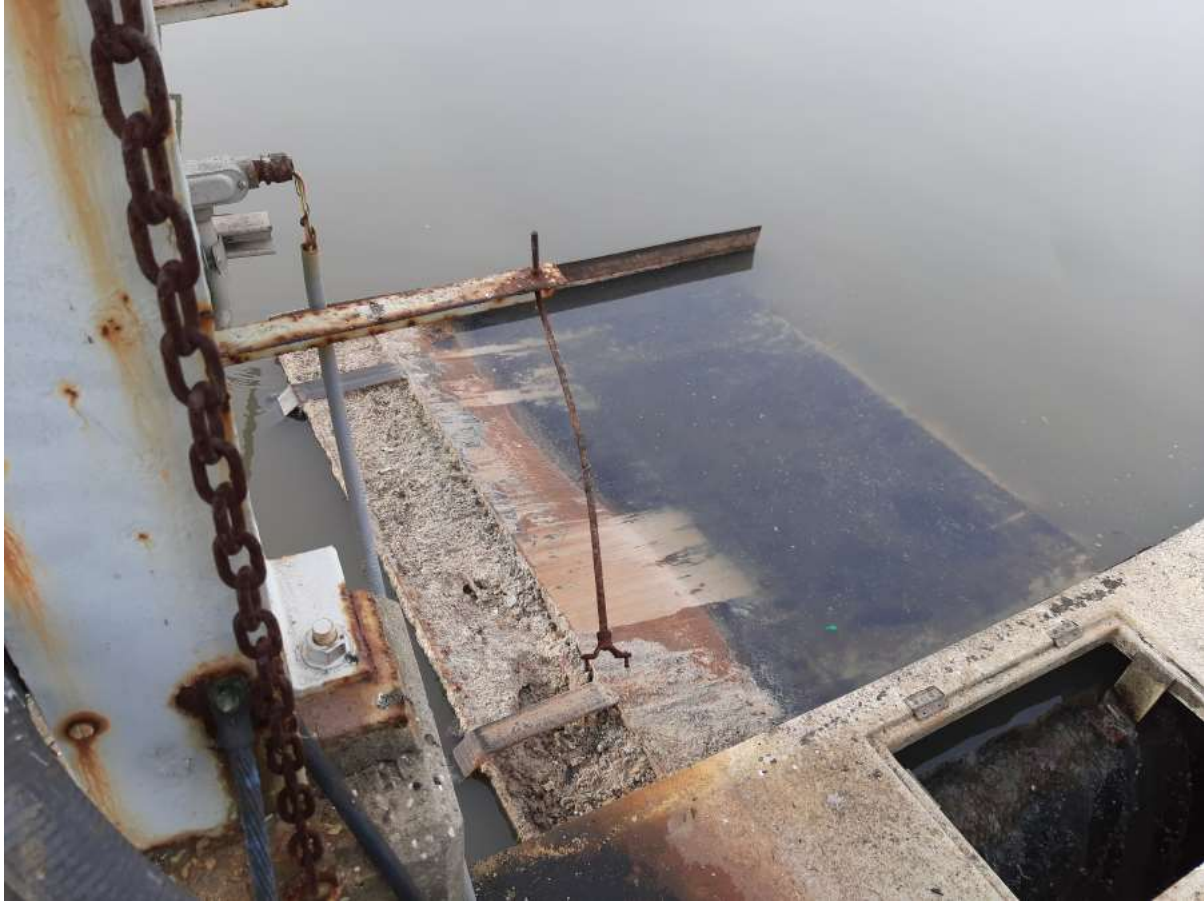
Picture of PST #8's clogged scum trough during 12/14/22 inspection. Clogged scum troughs are a persistent problem.

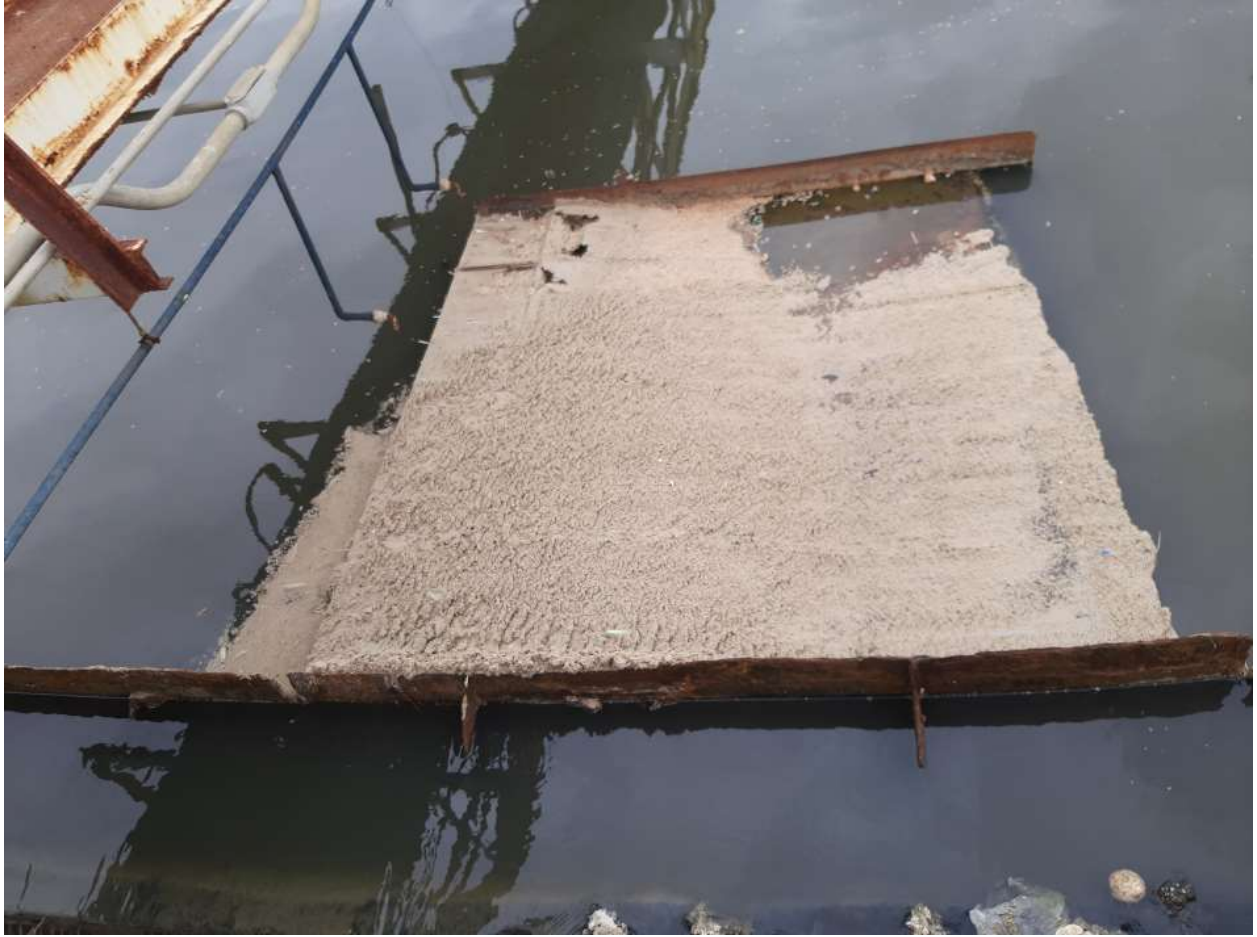
1/26/23 PST#1 scum trough clogged with FOG and scum. The scum trough should be cleaned out and scum pit pumped out as necessary.

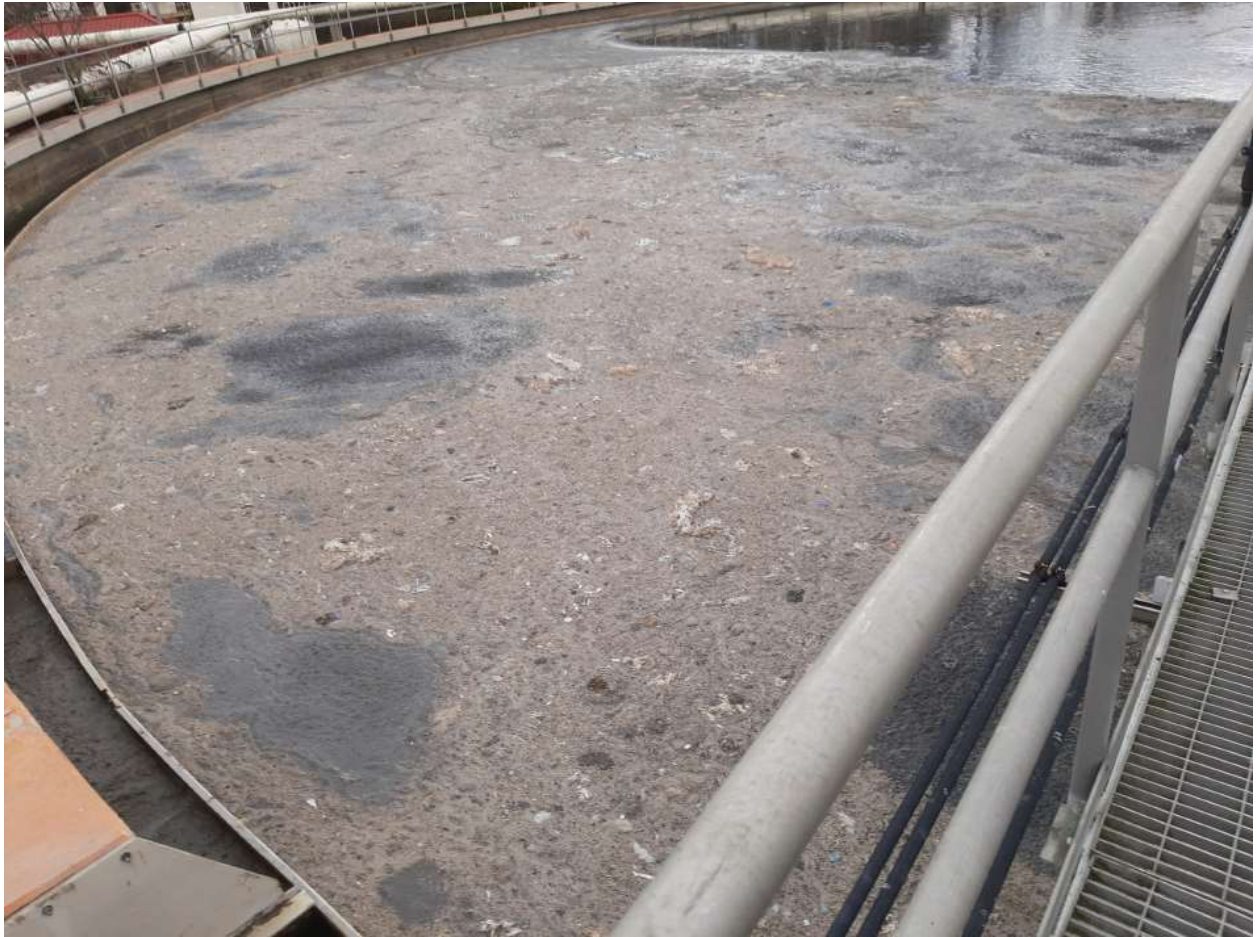
1/26/23 PST #5 – This PST is being used as a flow through unit. It is nonfunctional so no treatment is provided to the wastewater entering this PST. This PST is scheduled to be put back into service by the fall of 2023.

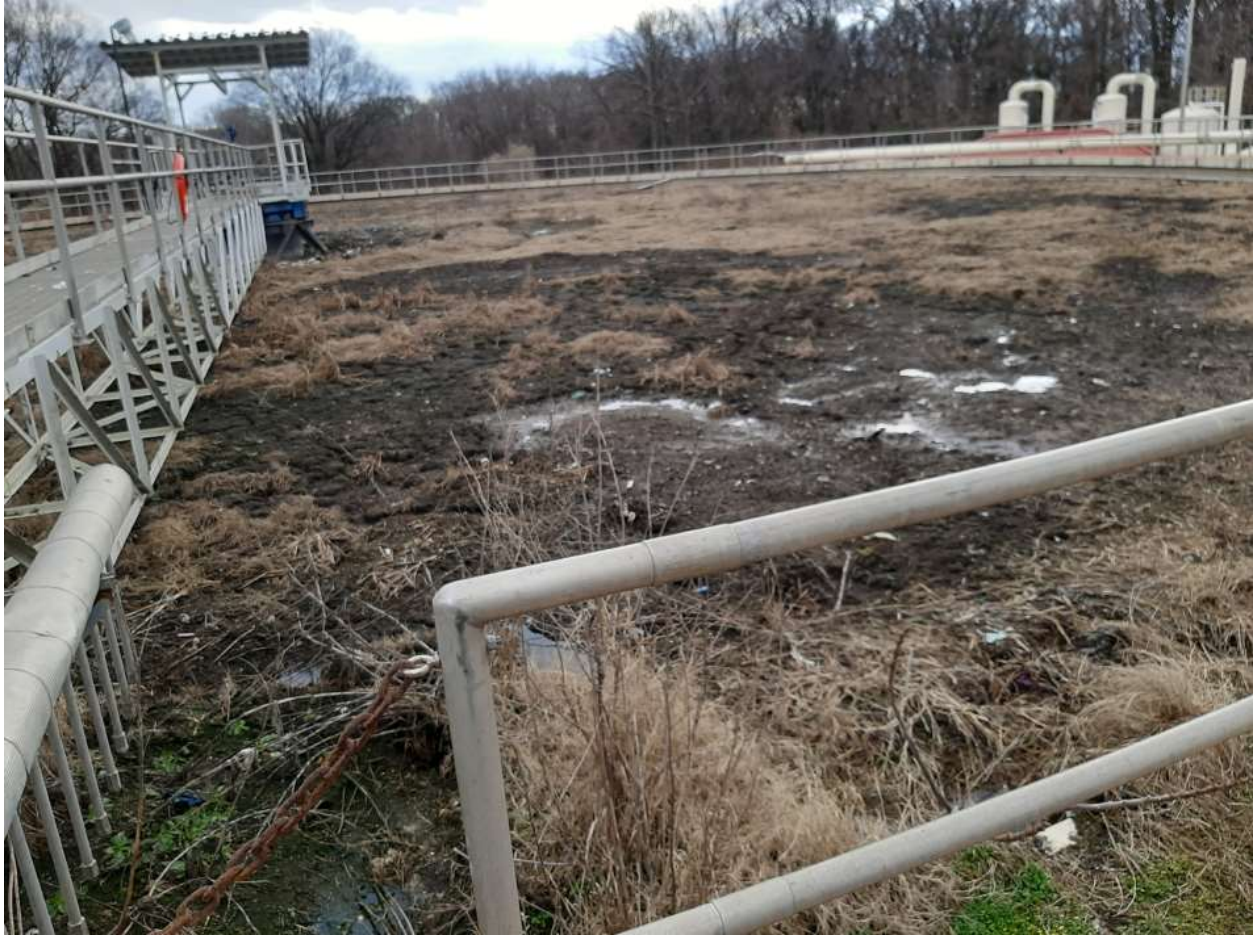
1/26/23 PST #6 needs to be cleaned then assessed. Baltimore City DPW is awaiting odor control device installation before proceeding with cleaning and repairs.

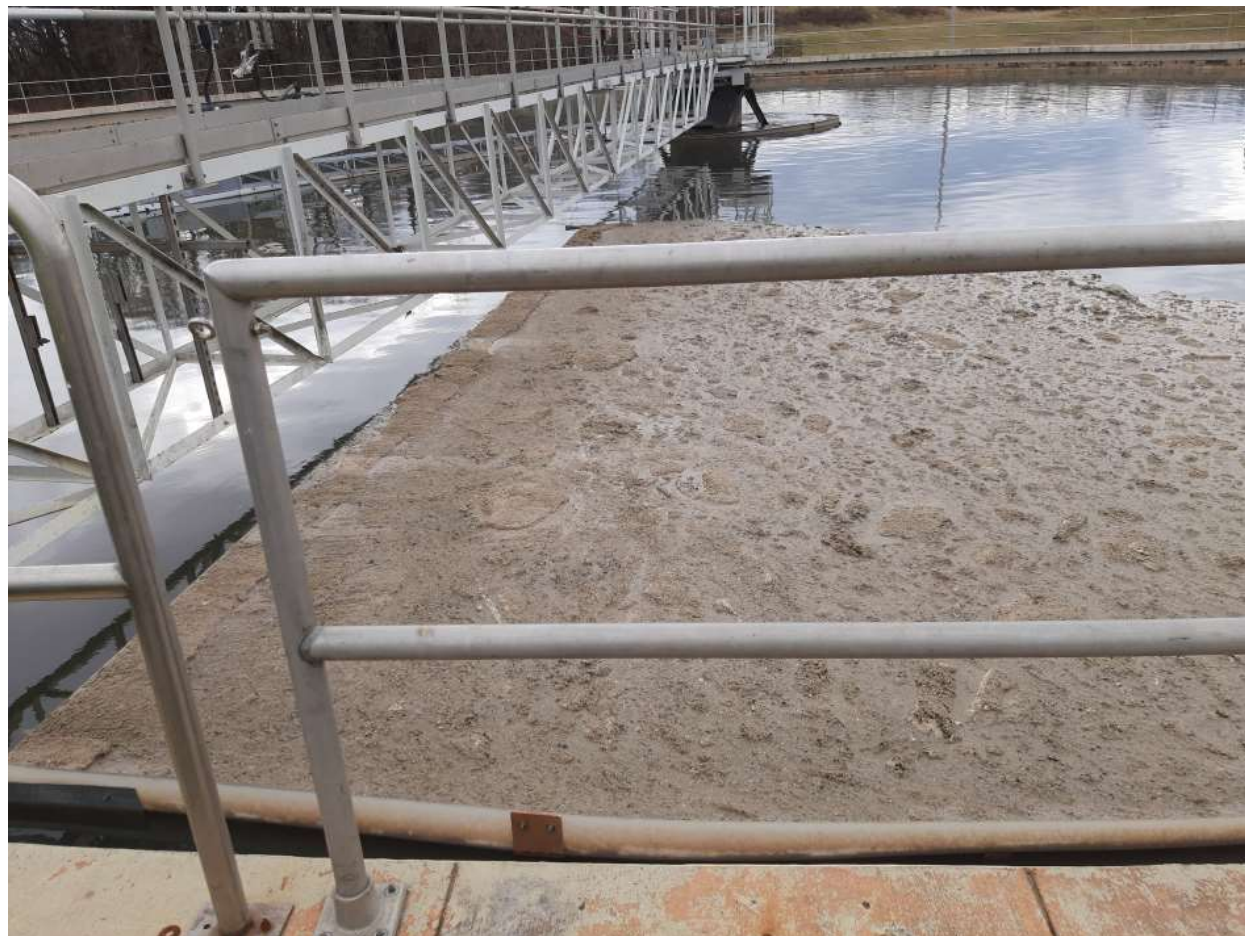
1/26/23 PST#7 showing a heavy layer of scum and clogged scum trough. In addition, the stilling well is not level, and the scraper arm requires adjustments to function properly.

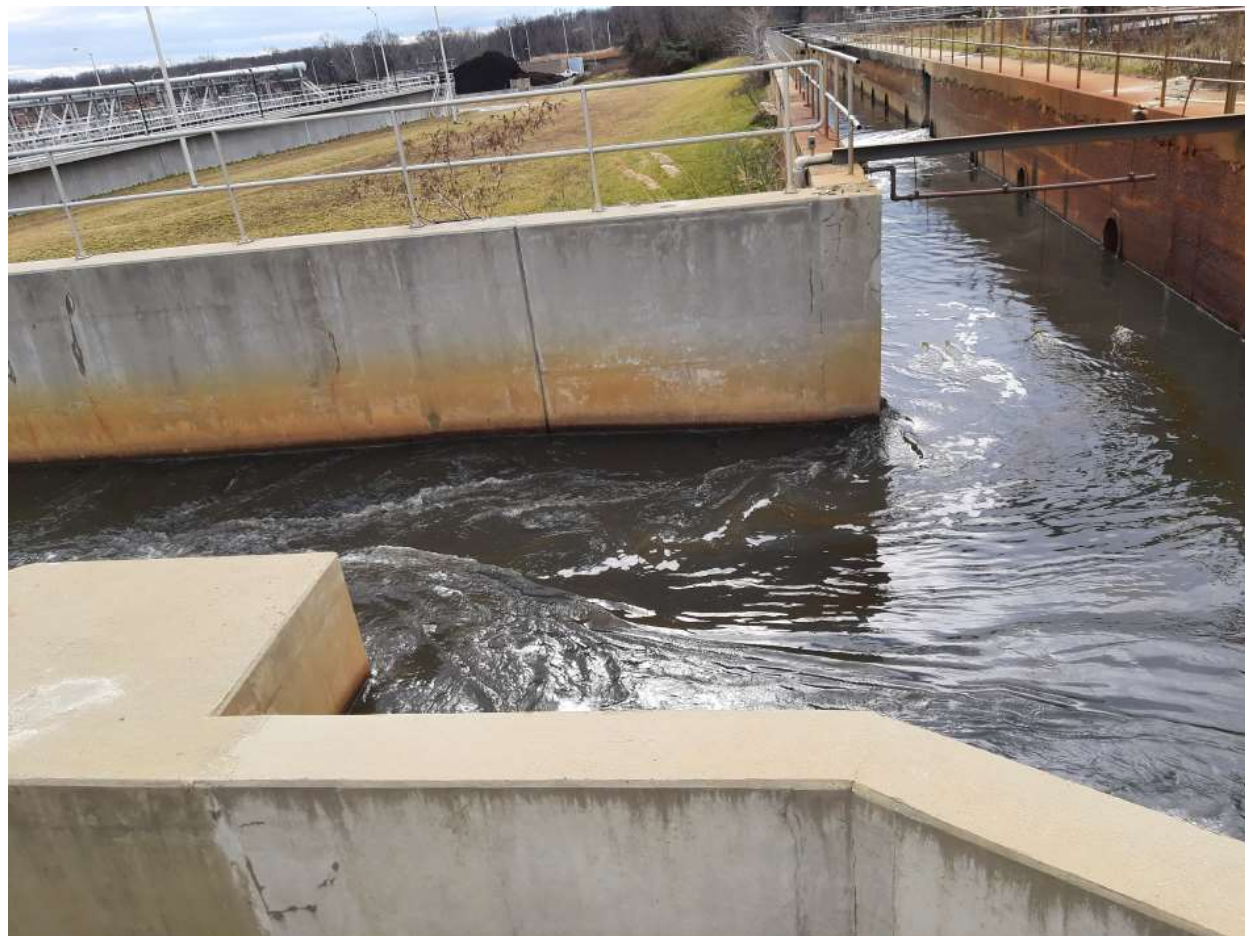
1/26/23 Effluent from the PSTs flowing to the activated sludge plants. Ferric chloride is added at this point for the treatment of phosphorous.

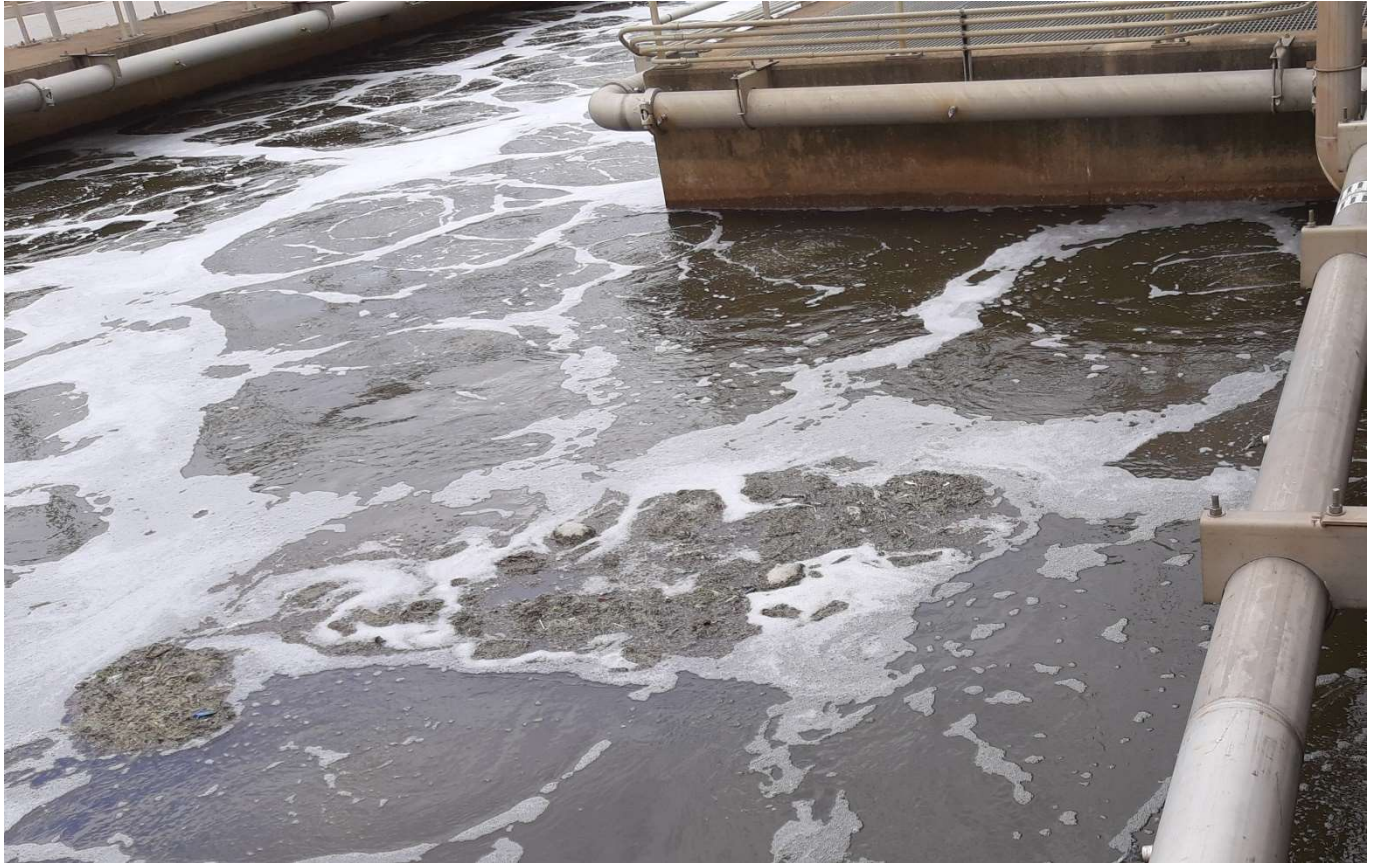
1/26/23 Reactor in the Activated Sludge Plant #3.

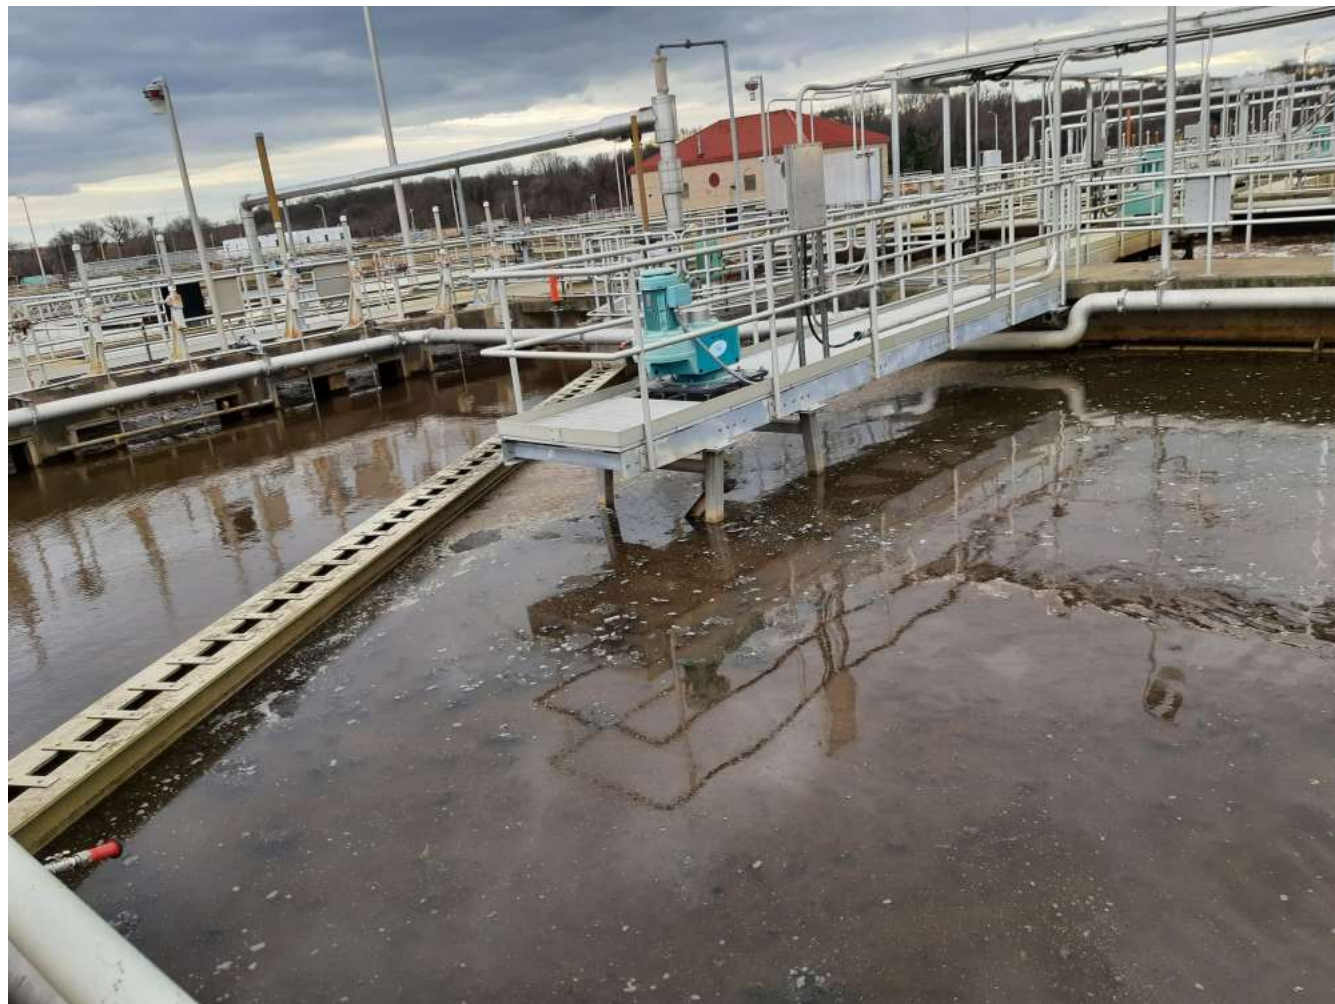
During previous inspection, I observed that some of the mixers in the biological reactors and clarifiers were either not functioning or barely turning at Activated Sludge Plants #2 and #3. The mixers in these areas require maintenance. Some of the mixers in the reactors were not functioning as designed because rags were wound around the mixer shafts impeding operation and the many of the reactor basins need to be cleaned of solids and vegetation. During my discussion with Turner, he informed me that Badger, an independent contractor, is scheduled to remove the vegetation from the reactors. During previous inspections, I observed that many of the mixers were not functioning due to various reasons. As of January 23, 2023, the status of the mixers are as follows:

1/26/23 Activated Sludge Plant #3. Mixer problems in this reactor.

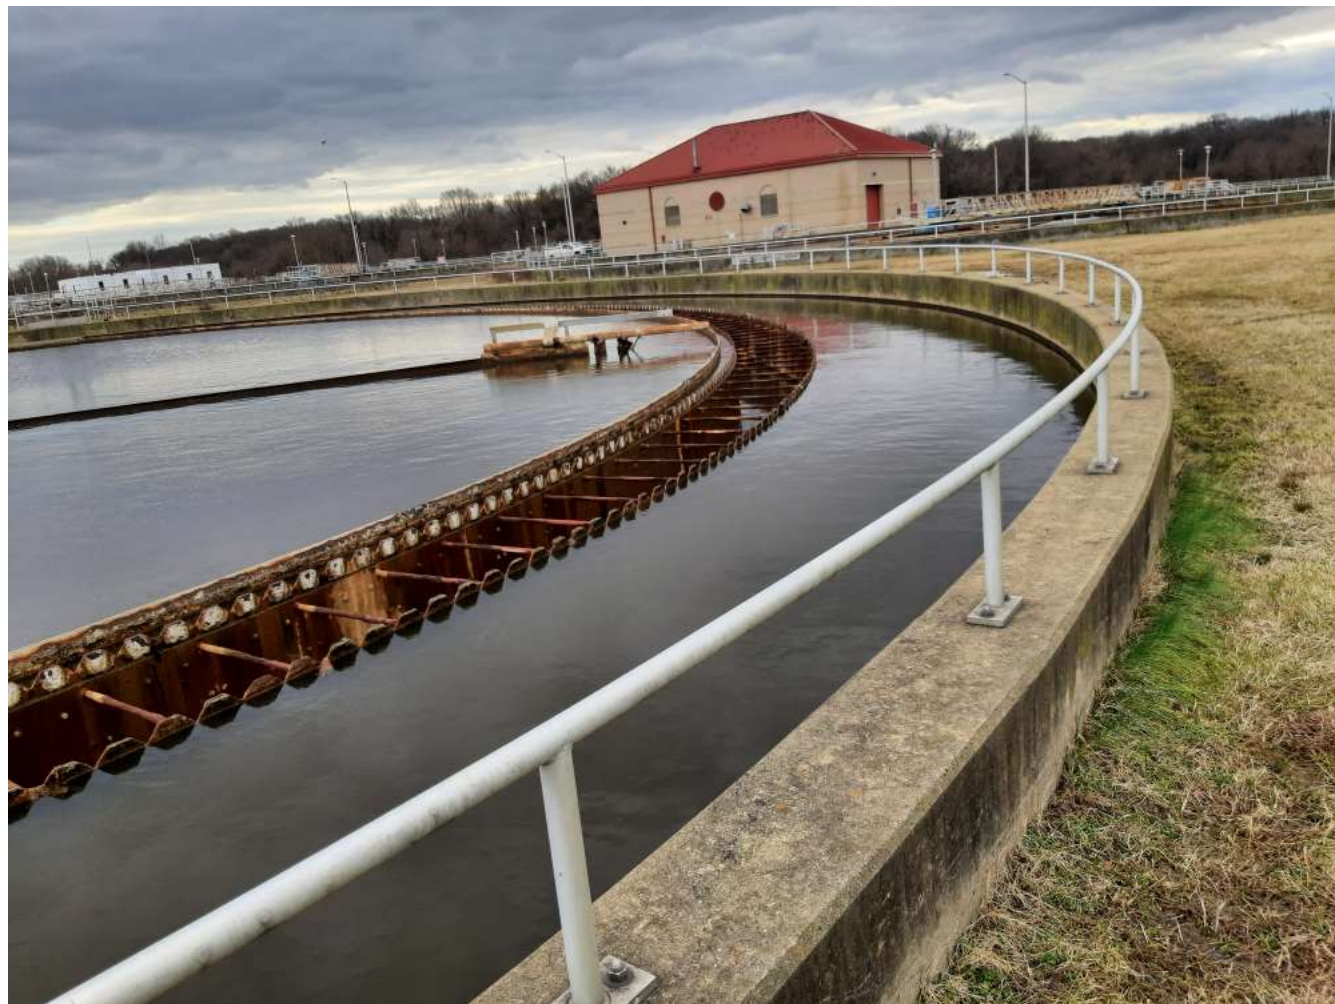
During an evaluation of the secondary clarifiers a few maintenance problems were observed. The skimming arm on secondary clarifier #14 A was missing the skimming flap and the weir on secondary clarifier # 9 was bent. I observed that the vegetation and algae had been removed from the clarifiers in service that I inspected. At this point, routine maintenance, is required to prevent regrowth.

1/26/23 Secondary clarifier 14A – Missing skimmer flap.

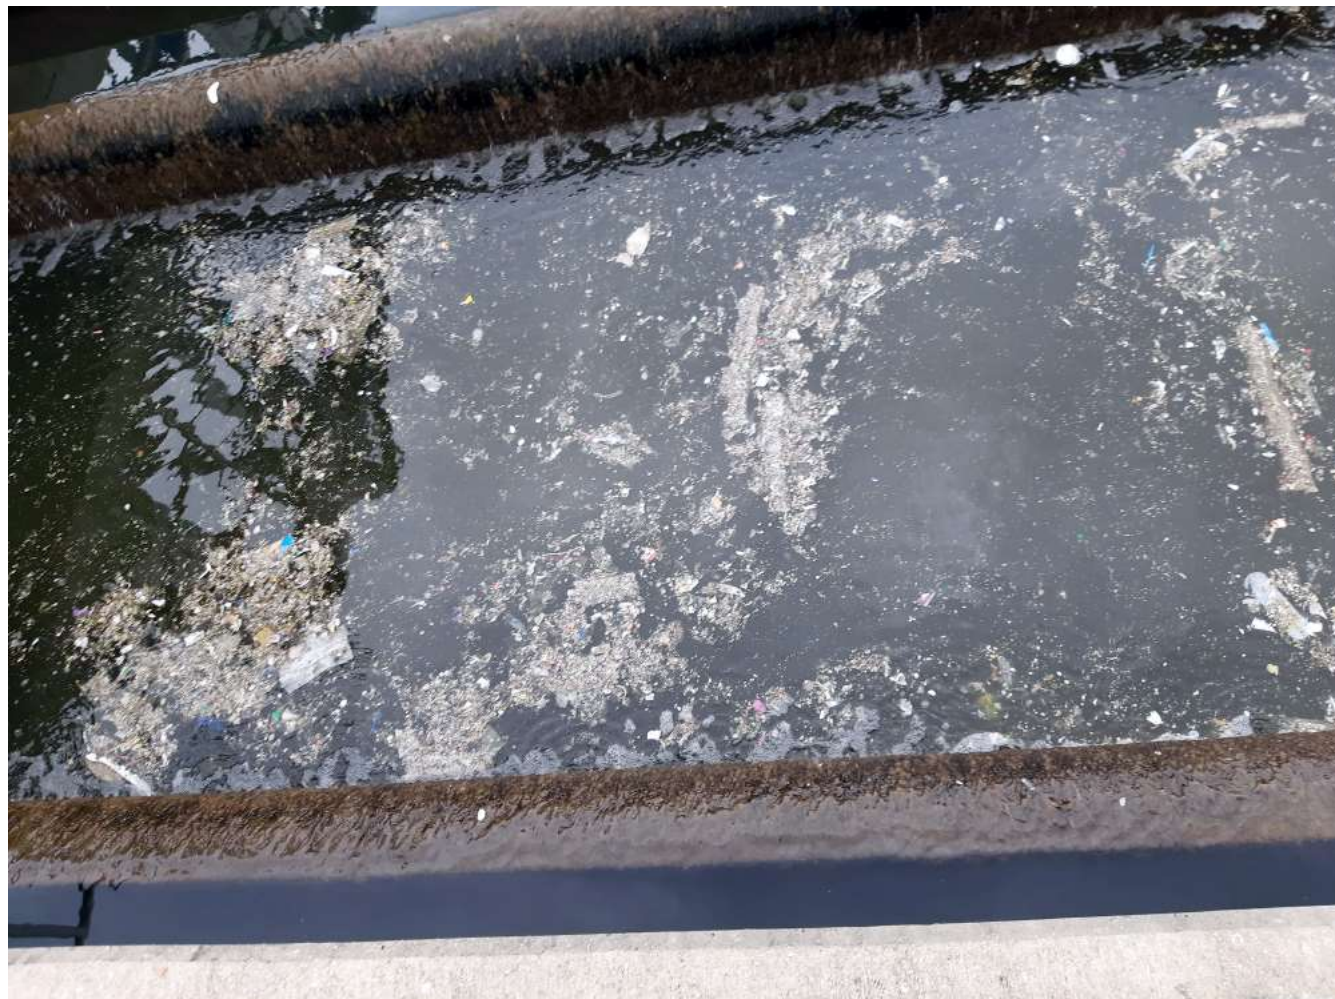
During an inspection of the filters in quads #1 and #2, I observed floating solids in some of filters and entering the filters from the incoming flow. There was a considerable amount of floating solids in the filter at the end of the quad. I asked Foreman, to accompany me to the filters at the end of the quad. After viewing the filter, Foreman told me that the solids in these filters were remnants from three recent events during this month where the incoming solid concentrations (TSS) coming from the effluents from secondary clarifiers were over 200 mg/L. According to Foreman, the DNF

are not designed to handle TSS concentrations above 10 mg/L and they have been conducting extra backwashing to try to remove the excess solids in the DNFs. Later, when I spoke to the Turner, he stated that there was a problem with one of the secondary clarifiers that caused the solids spike to the DNFs that Foreman described.

1/26/23 Solids and trash floating on water surface in the DNFs.

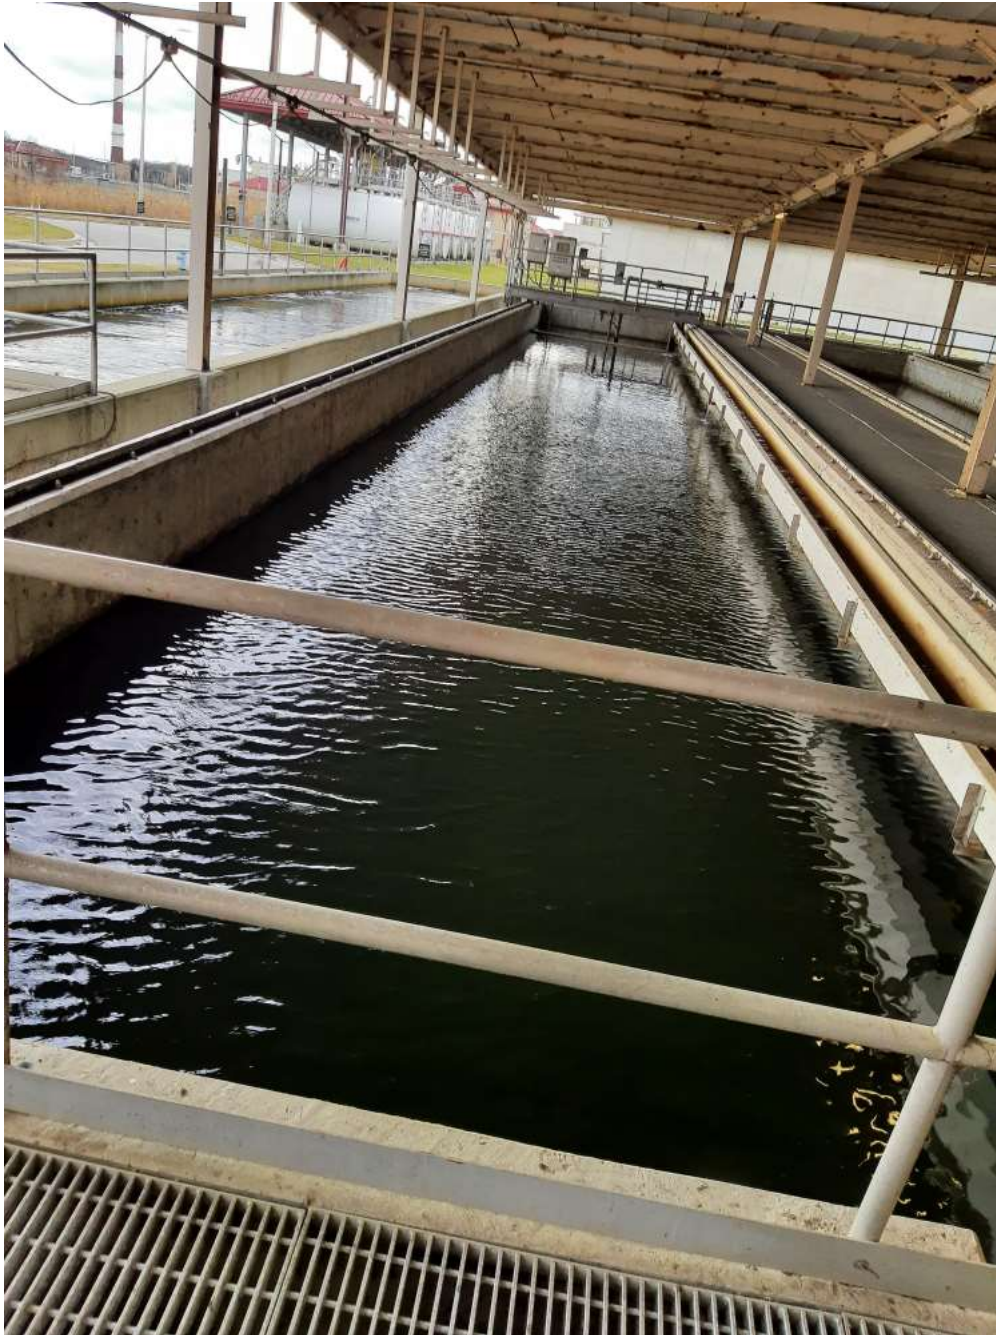
1/26/23 Sand Filter
