Maryland Department of Environment
Water and Science Administration
Compliance Program
1800 Washington Blvd, Suite 420
Baltimore, MD 21230-1719
410- 537-3510, 1-800-633-6101

Site Name: Back River WWTP
Facility Address: 8201 Eastern Ave, Baltimore, MD 21224
County: Baltimore County

Start Date/Time: January 26, 2023 08:45 AM
End Date /Time: February 10, 2023 04:41 PM

Permit / Approval Numbers: 15DP0581
NPDES Numbers: MD0021555
Inspection Reason: Follow-up (Non-Compliance)
Site Status: Active
Compliance Status: Noncompliance
Site Condition: Noncompliance
Recommended Action: Additional Investigation Required
Evidence Collected: Photos or Videos Taken, Record Review, Visual Observation
Delivery Method: Email
Weather: Clear Average

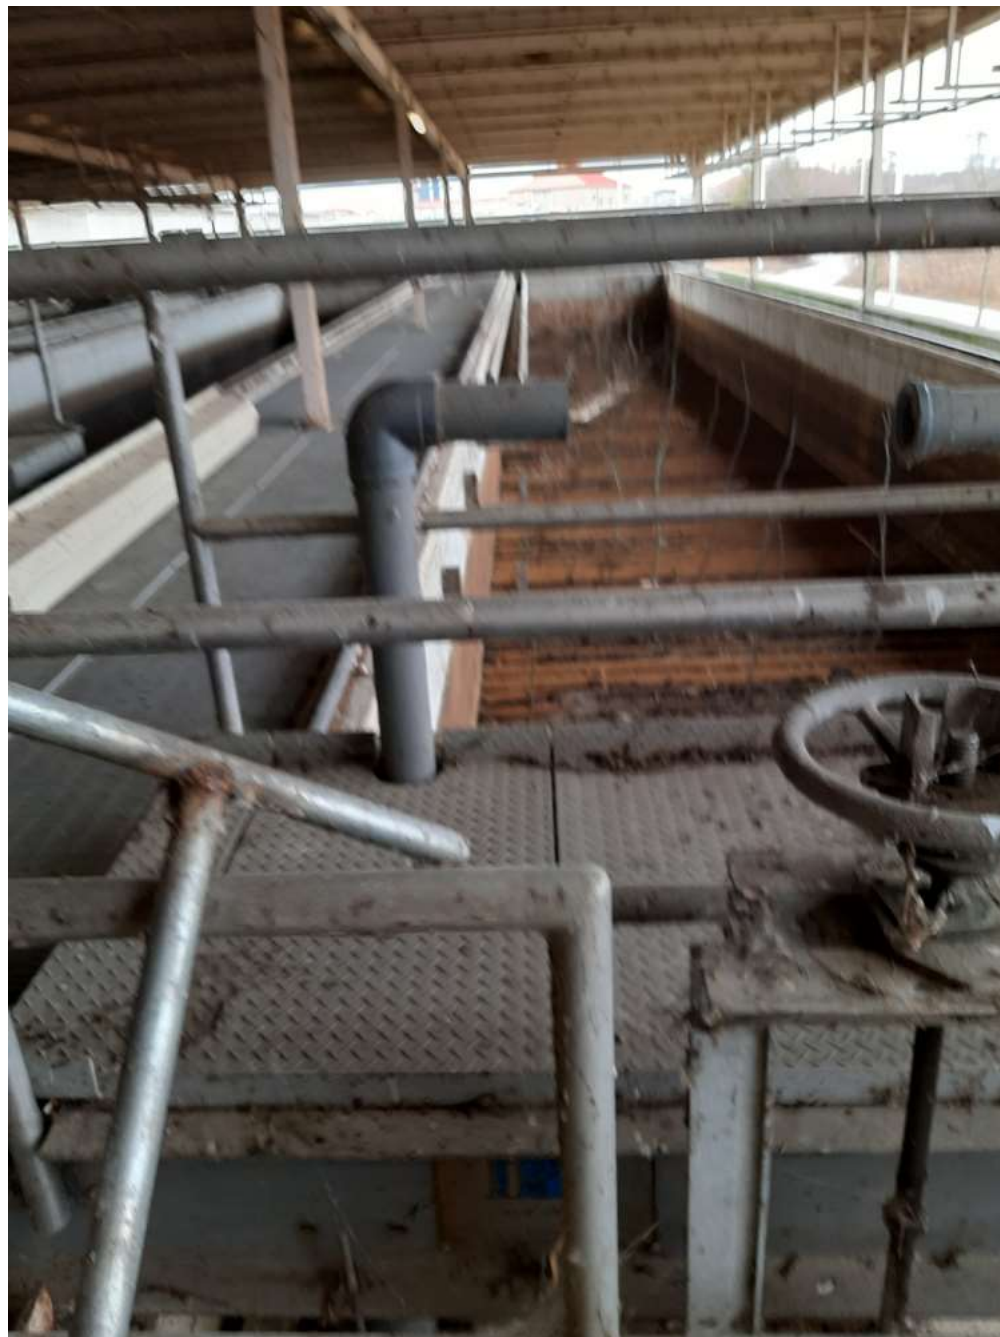
1/26/23 Sand filter down and needing repairs.

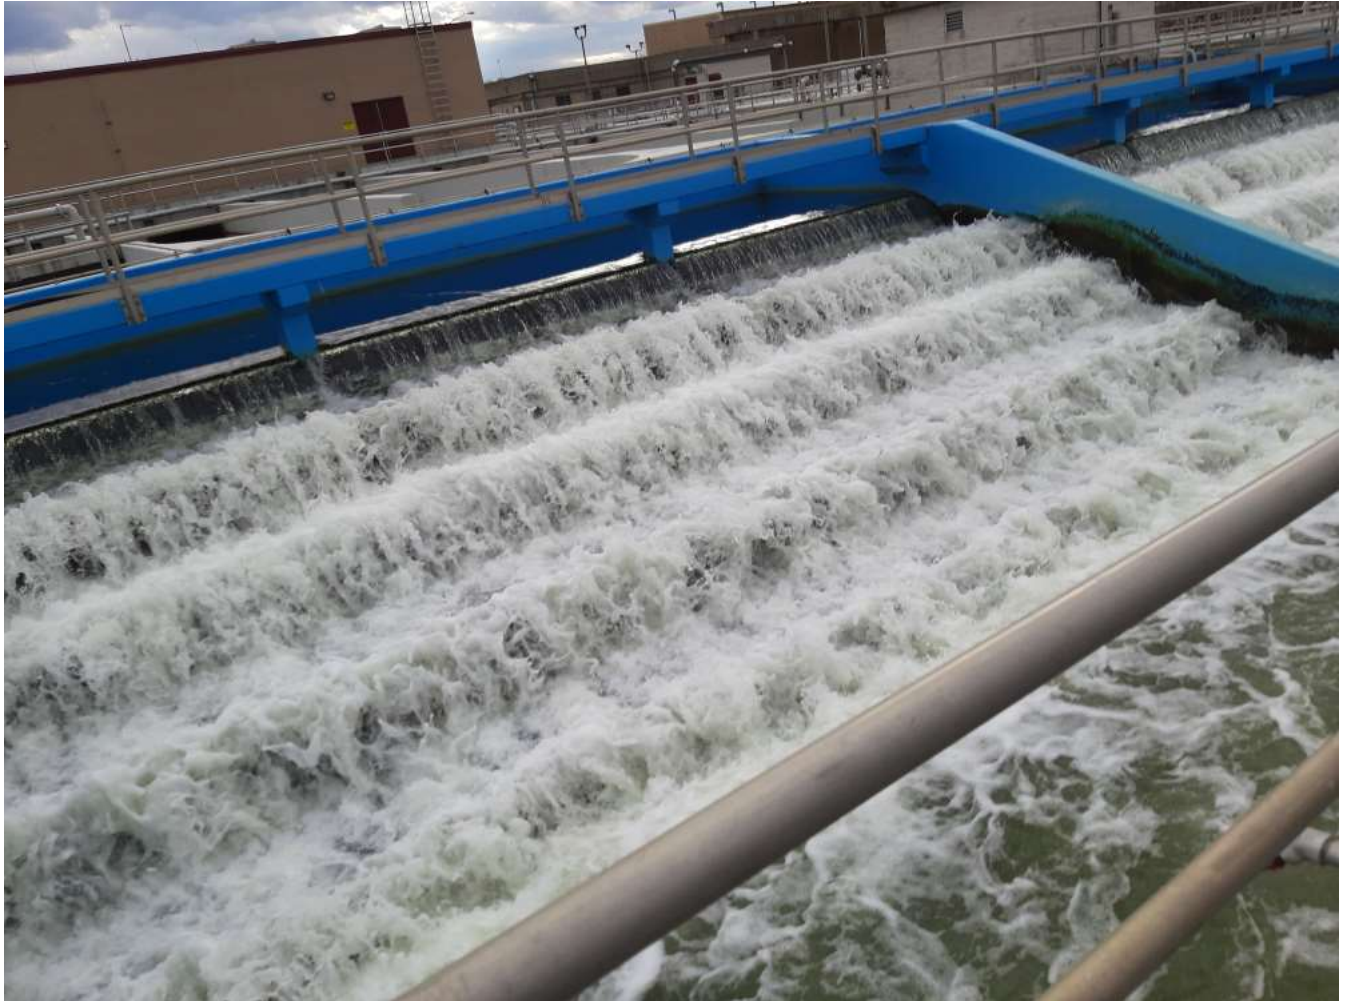
Next, I inspected the final effluent at the step aeration system and at the sampling station. During an evaluation of the final effluent, I observed that the effluent was clear with no visible particulates.

1/26/23 Final Effluent at the step aeration system

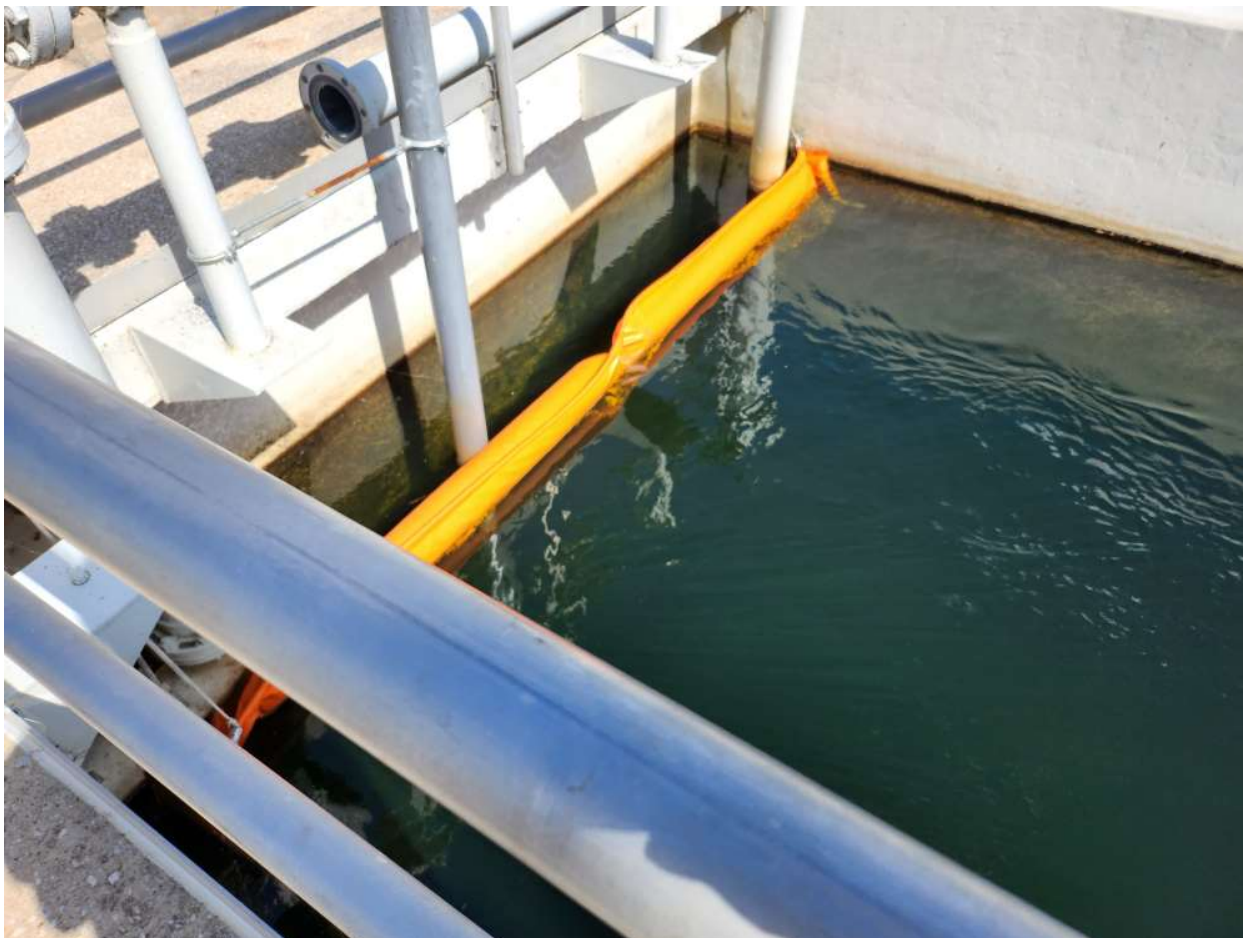
1/26/23 The floating boom at the left channel CCC used to prevent floating solids from entering the final discharge canal.
