Maryland Department of Environment
Water and Science Administration
Compliance Program
1800 Washington Blvd, Suite 420
Baltimore, MD 21230-1719
410- 537-3510

Site Name: Patapsco WWTP
Facility Address: 3501 Asiatic Ave, Curtis Bay, MD 21226
County: Baltimore City

Inspection Reason: Follow-up (Non-Compliance)

Inspection Findings:

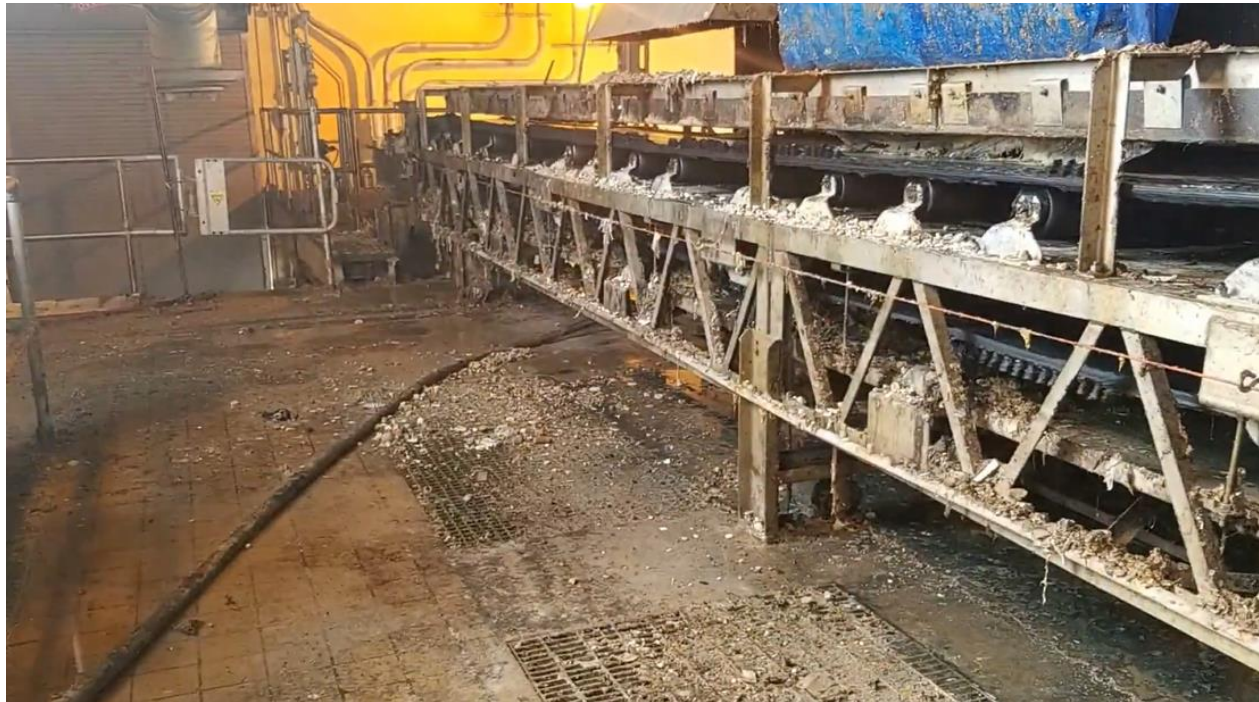
influent building, and two bar screens has been removed from the combined influent building previously. Mr. Chris Saunders stated that the two removed bar screens are currently being replaced and the one that is out of service will be refurbished next. Mr. Chris Saunders and Mr. Neal Jackson also stated that Parkson Corporation is fixing the bar screens and replacing the belts, and the facility will get skirts for the belt press. Grits screened out of sewage by bar screens are placed into a dumpster that is at the end of the belt press. During the time of this inspection, grits and rags were observed to have previously been fallen off the conveyor belt, with some being stuck on the conveyor belt system and some on the ground within the combined influent building (shown in the picture below). Implement routine maintenance of the belt press system to reduce the accumulation of grits and debris on the ground and the conveyor system.

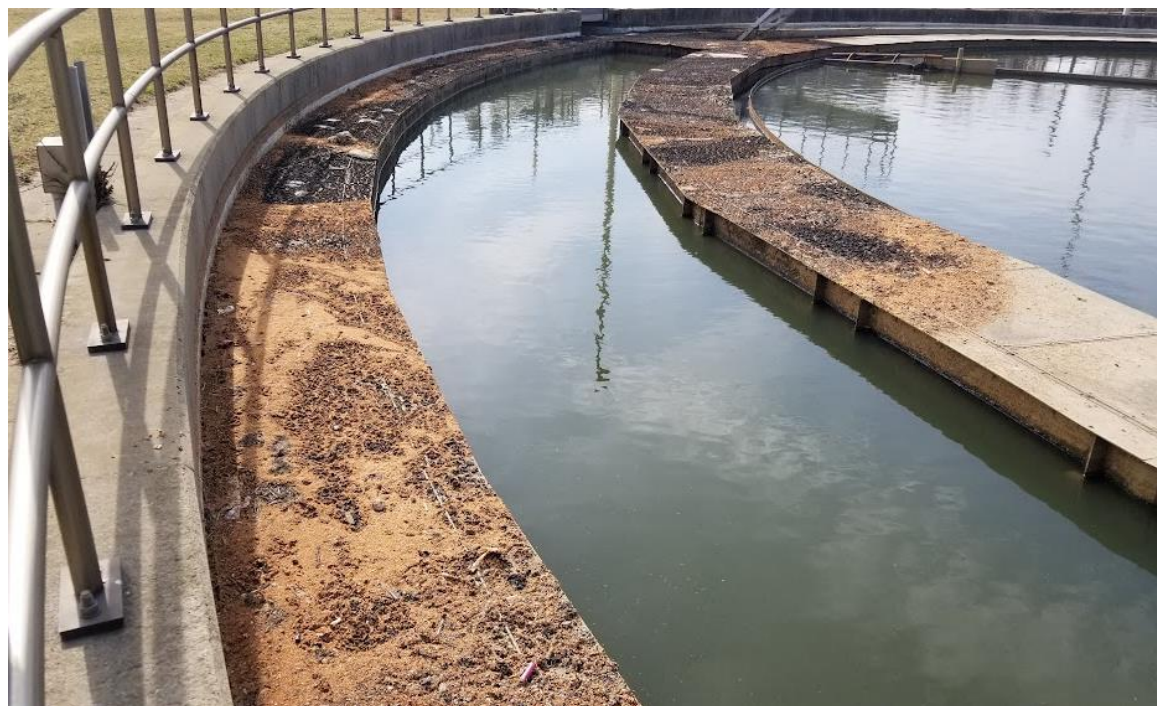
The facility has eight clarifiers. Inspection of Clarifiers # 3, 4, 5a, 5b, 6a, and 6b was conducted. The surface of the clarifiers that are in operation are being sprayed with water to break up the scum. Clarifier #3 is currently not being operating and is used as a mudwell to contain backwash water of the denitrification filters. Wastewater from Clarifier #3 will then flow back into the PST. Scum was observed on the surface of Clarifiers 5a and 5b, next to both sides of the launder cover. Mr. Neal Jackson stated that there was no scum removal from the clarifiers because of a repair to a broken effluent water line that was discovered on 2/19/2023. Mr. Neal Jackson contacted MDE by phone on 2/21/2023 about this broken effluent water line, which resulted in 500 gallons of treated effluent entering a storm drain. Scum was not observed on the water surface with Clarifiers # 6a and 6b. Orange solids were observed on the launder covers of Clarifier #6b (picture shown below).

Mr. Neal Jackson attributed the presence of these orange solids from high flows coming into the plant. These orange solids should be removed from the launder covers.

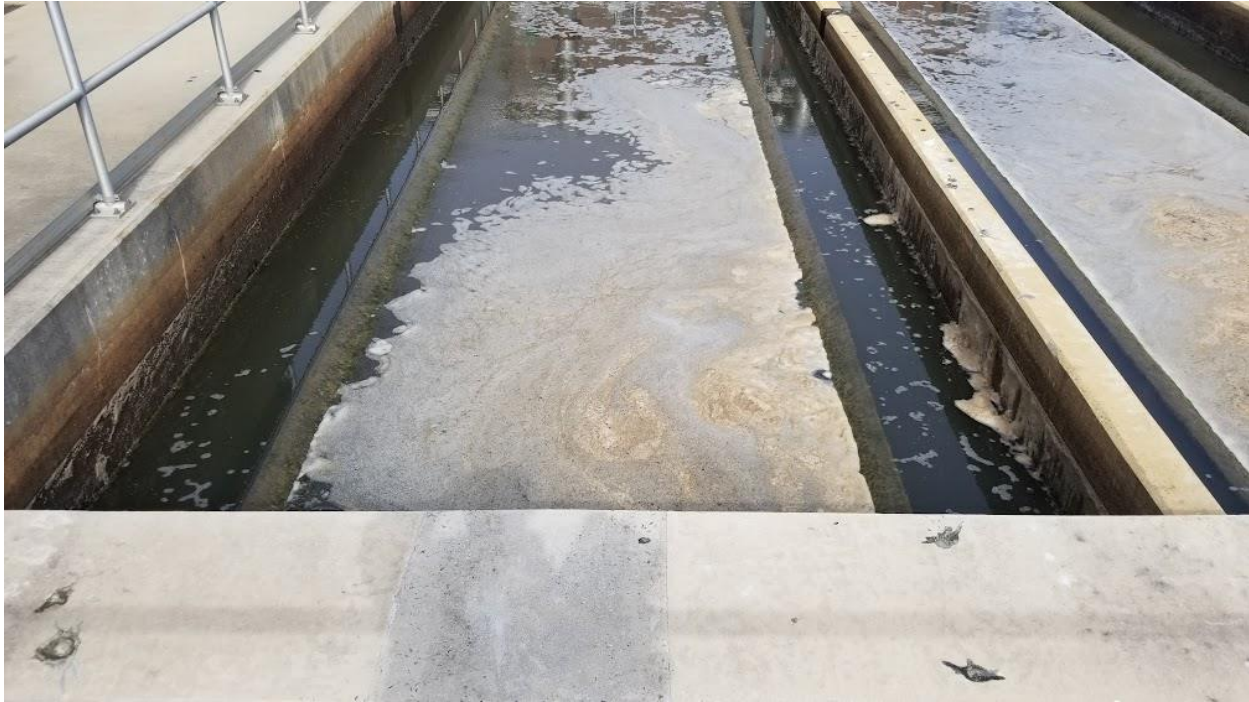
The denitrification system has 34 individual filters. During the time of this inspection, filters # 1, 6, 33, and 34 are out of service. Methanol is added into the water before flowing into the denitrification filters. Water enters the denitrification filters from the top after overflowing the concrete weir walls. Water then exits the denitrification filters by flowing through the sand filter. Sand filters are located at the bottom of each individual filters. During the time of this inspection, the water surface was observed to be on the same level as the top of the concrete weir at Filter #18 (picture shown in next page).

I was informed by Mr. Chris Saunders and Mr. Neal Jackson that the sand filters are back washed automatically. Before leaving the denitrification system, the water level was observed to be below the top of the weir at filter #18.

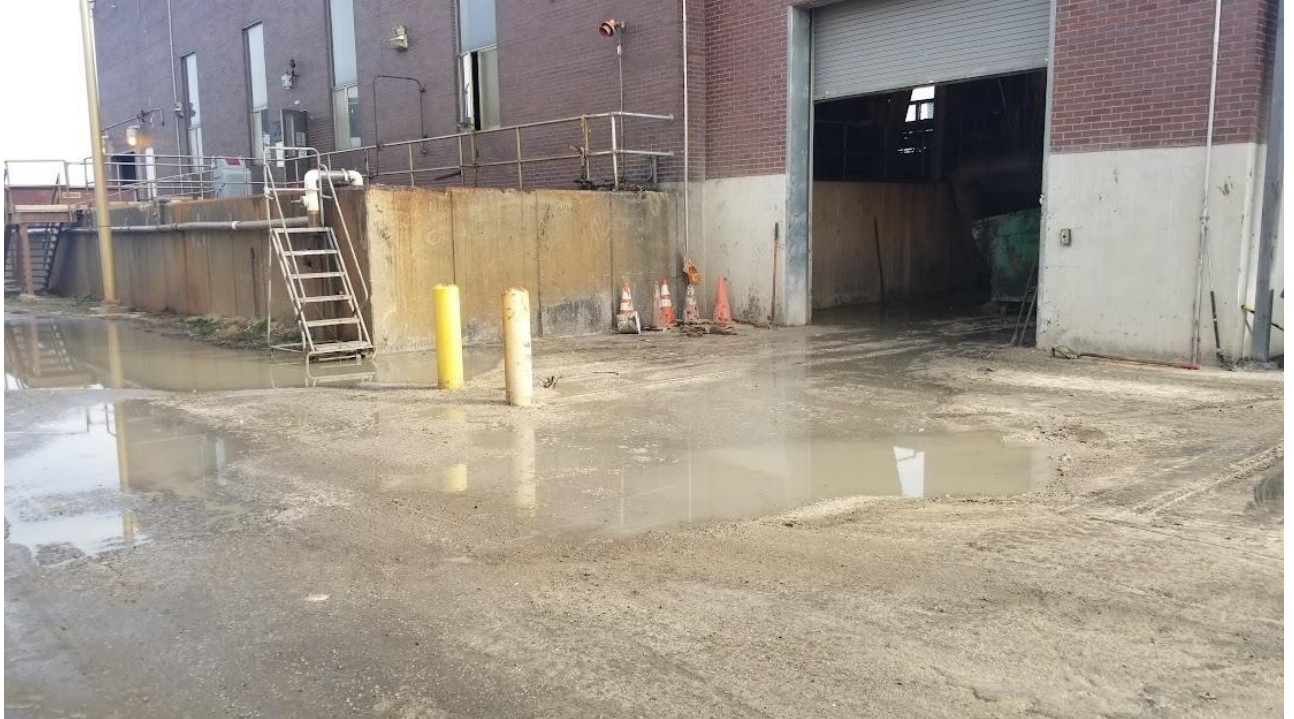
- 1) There are multiple puddles of brown liquid next to the entrance to the combined influent building where dumpsters with screened grit are taken into and out of the building (picture shown in next page).

Mr. Neal Jackson stated that the presence of this liquid is due to the staff of the wastewater treatment plant spraying the ground surface within the combined influent building with water, resulting in some of this liquid to flow out of the building. The brown liquid is in the position likely to flow into a storm drain during a rain event. **Remove all brown liquid from the ground, possibly by vacuuming. Ensure that wastewater is contained and not puddled outdoor.**

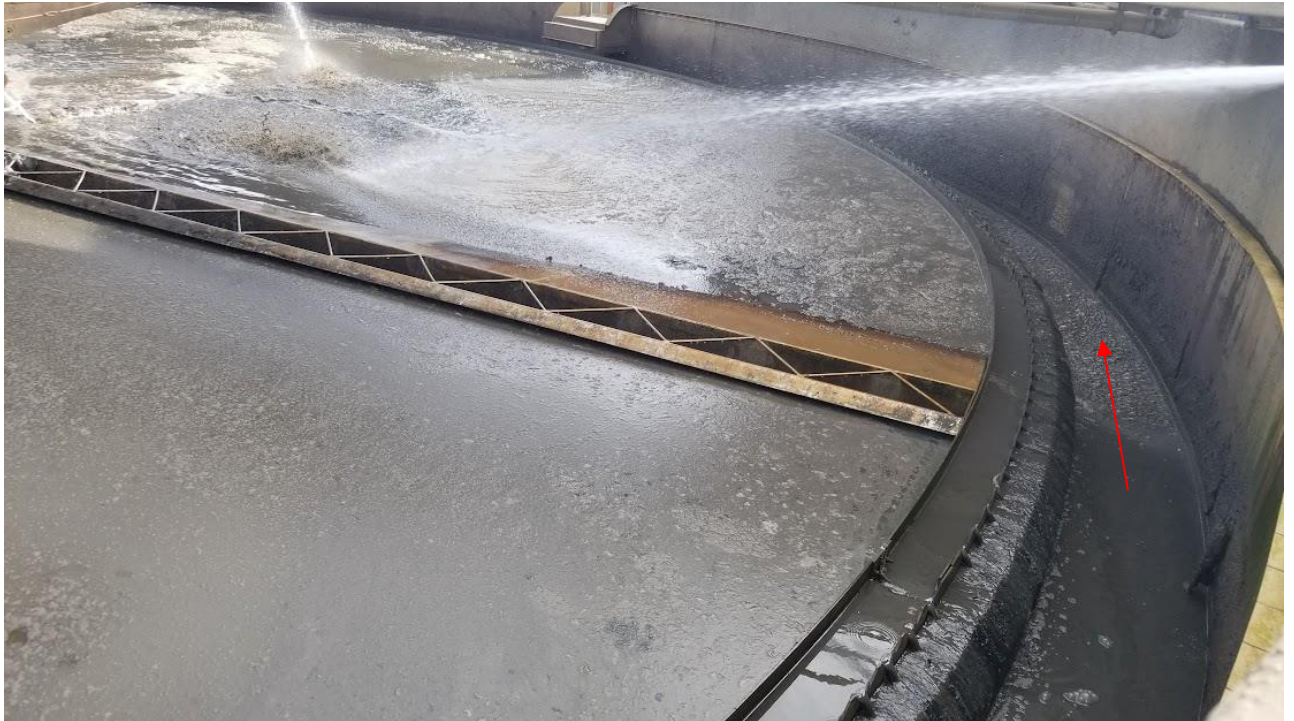
- 2) The GSTs are overloaded with sludge and solids and is not able function as designed. The function of the GST is to allow for most of the biosolids to be at the bottom of the GST and for a relatively solids-free supernatant to be at the top. The high concentrations of biosolids in GST effluent can negatively impact the pure oxygen reactors' ability to remove BOD and can cause nitrification issues within the plant. Pictures of GST #1 are shown in Figures 2a, 2b, and 2c. Pictures of GST # 2 are shown in Figures 2d, 2e, and 2f.

Figure 2a: Sludge at the surface of GST #1 and next to the outer side of the weir (pointed with a red arrow).

The Patapsco WWTP shall operate and process sludge in the GSTs in a manner that functions per designed. Rags and solids should be removed from the GSTs regularly.

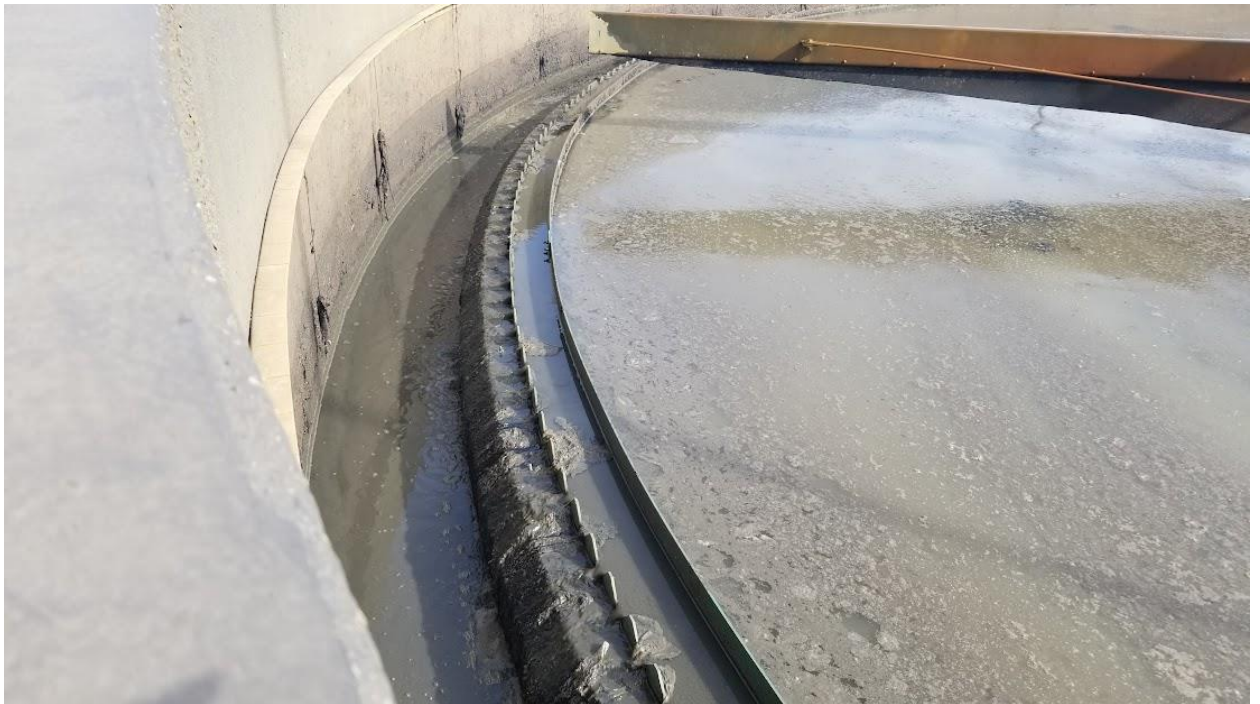
Figure 2b: Sludge next to the outer side of the weir within GST #1. Rags next to the V-notch weir. Scrapper arm is above the water surface level.

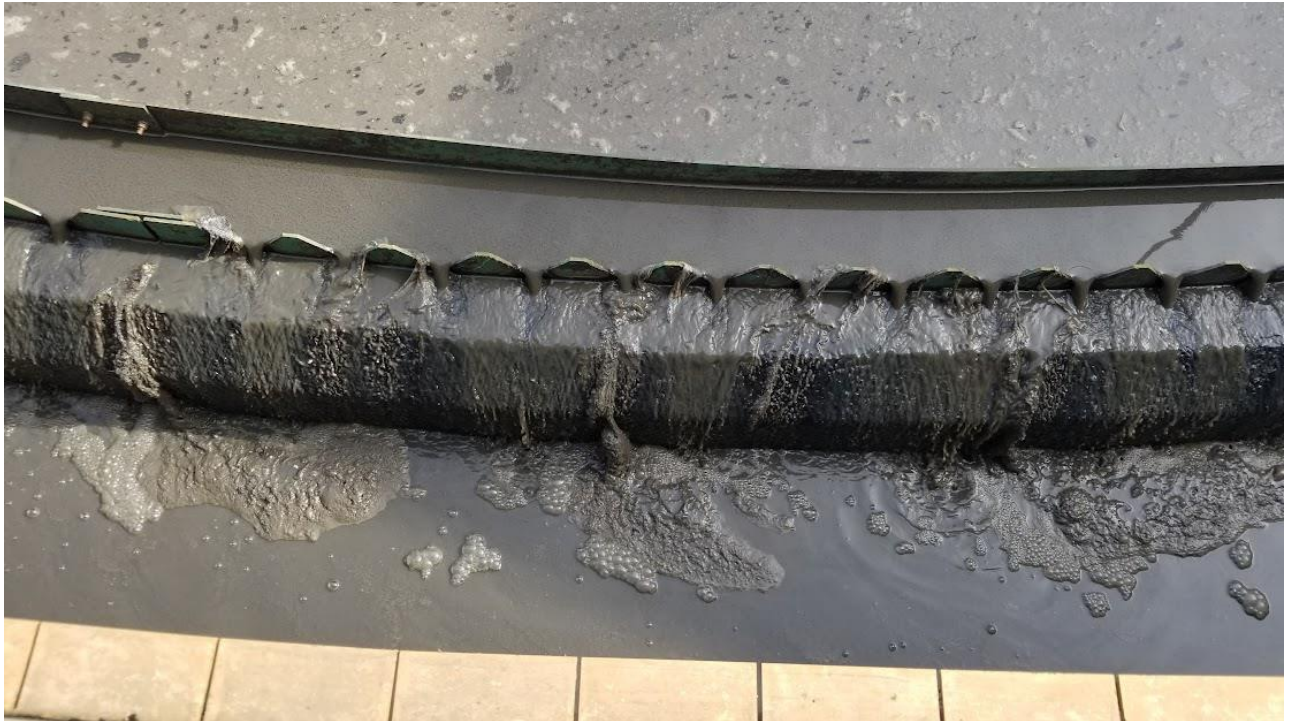
Figure 2c: Close up view of the sludge that have previously been spilled out of the V- notch weir within GST #1.

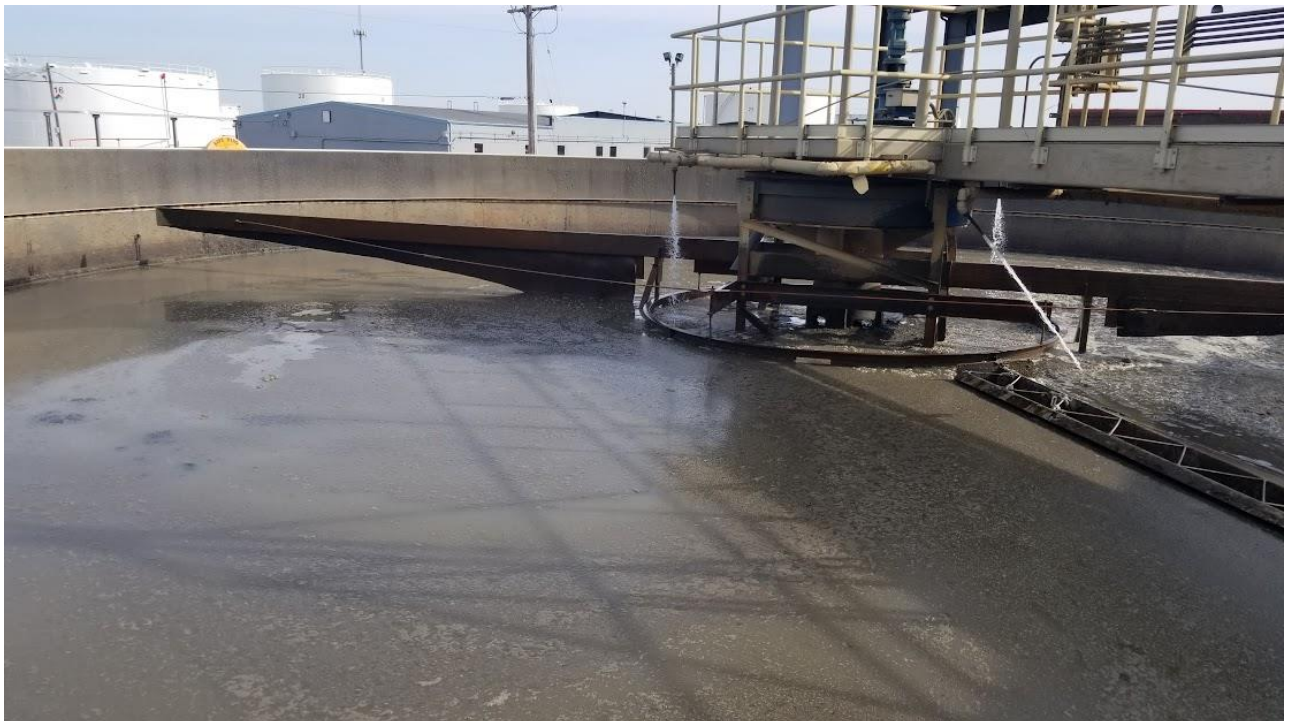
Figure 2d: Scrapper arm above the water surface within GST #2.

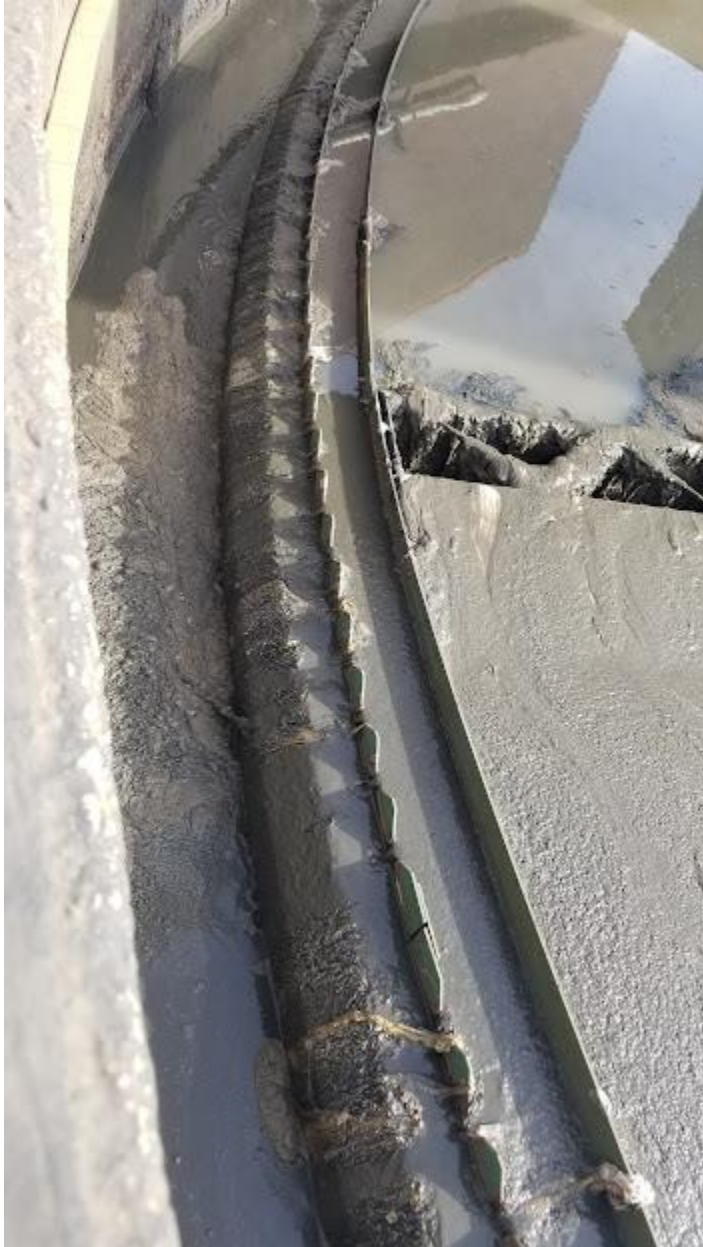
Figure 2e: Sludge that have previously been spilled out of the V- notch weir within GST #2.

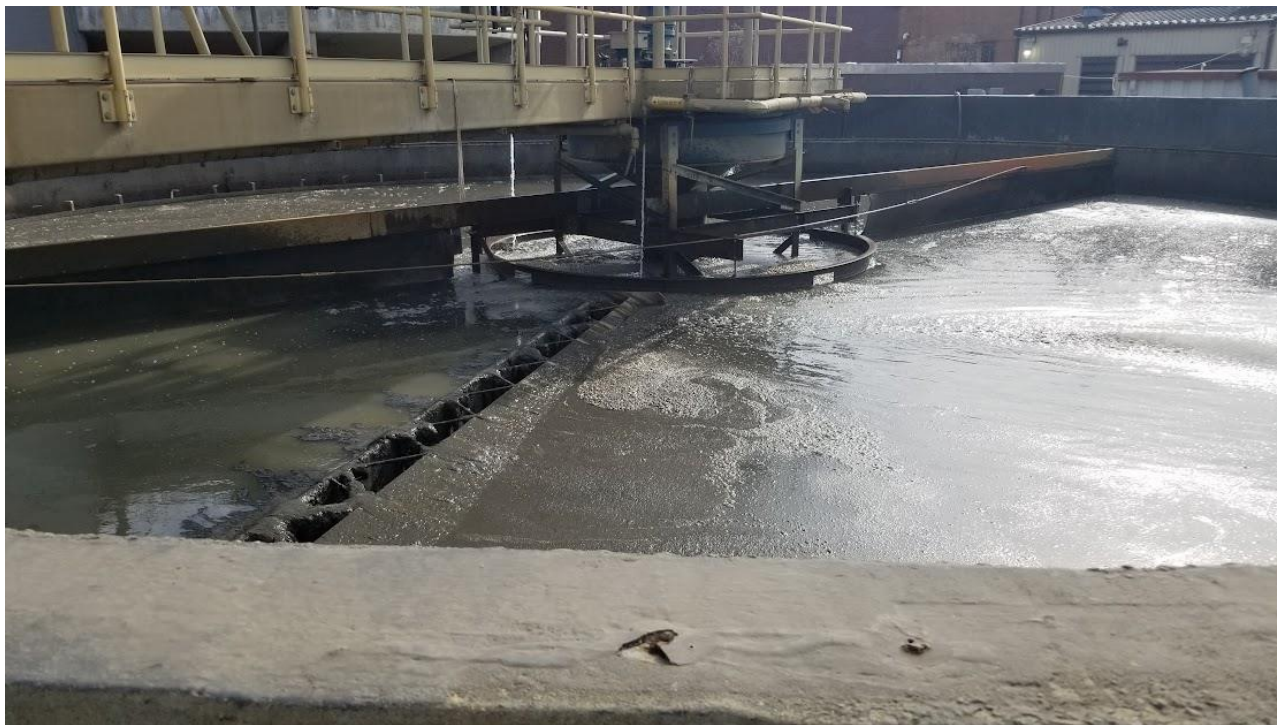
Figure 2f: Sludge at the surface of GST #2.

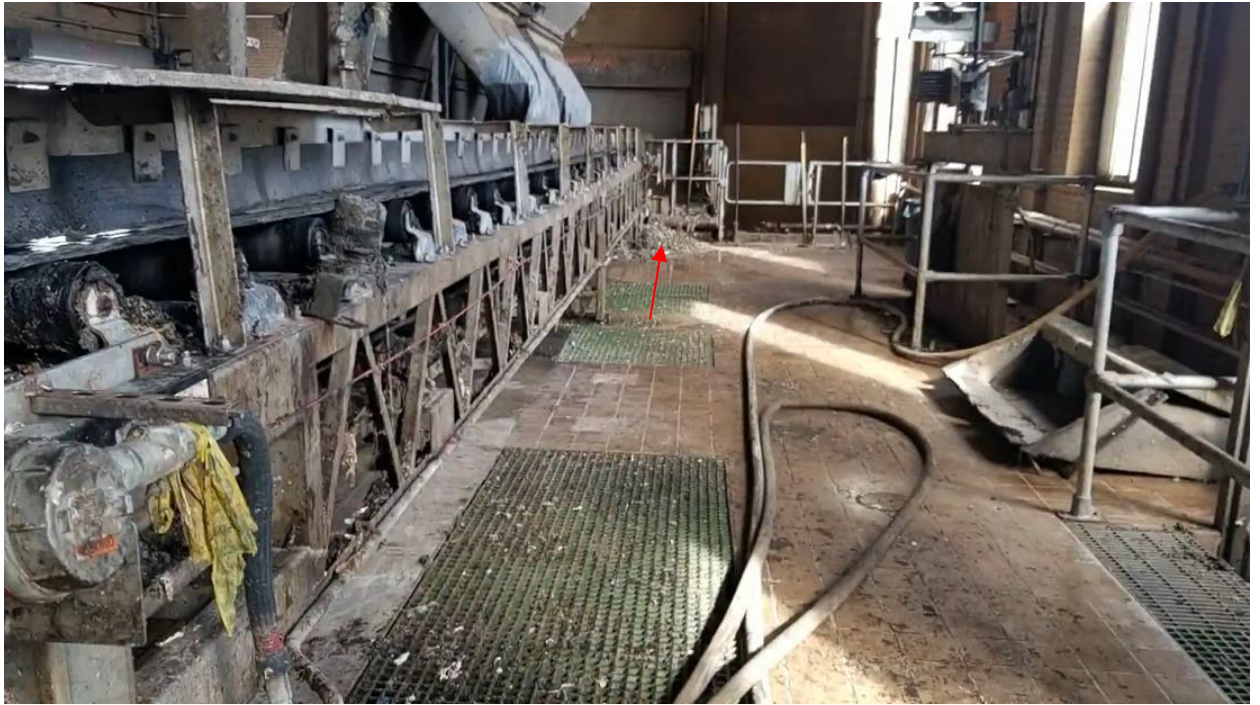
- 3) The belt conveyors are not being functioned per designed. A pile of solids (pointed with a red arrow) was observed on the ground and looks to have been fallen out of the belt press within the combined influent building (picture found in the next page). Although the belts were observed to be running and screened debris are being transported into the dumpster by the belt press, the missing skirts causes the some of the debris to fall out of the conveyor belts and impacting the ability of the conveyors to transport all trash into a dumpster. Also, the accumulation of debris on and around the belts causes some of the mechanical parts to be clogged.

Implement better maintenance and housekeeping measure to clean up and prevent trash from falling off the conveyor belt system. The Patapsco WWTP shall implement a plan to keep rags, paper, plastics, and other debris from clogging the transport belt. The plan should also include procedures for regular manual cleaning of the belt transport system.

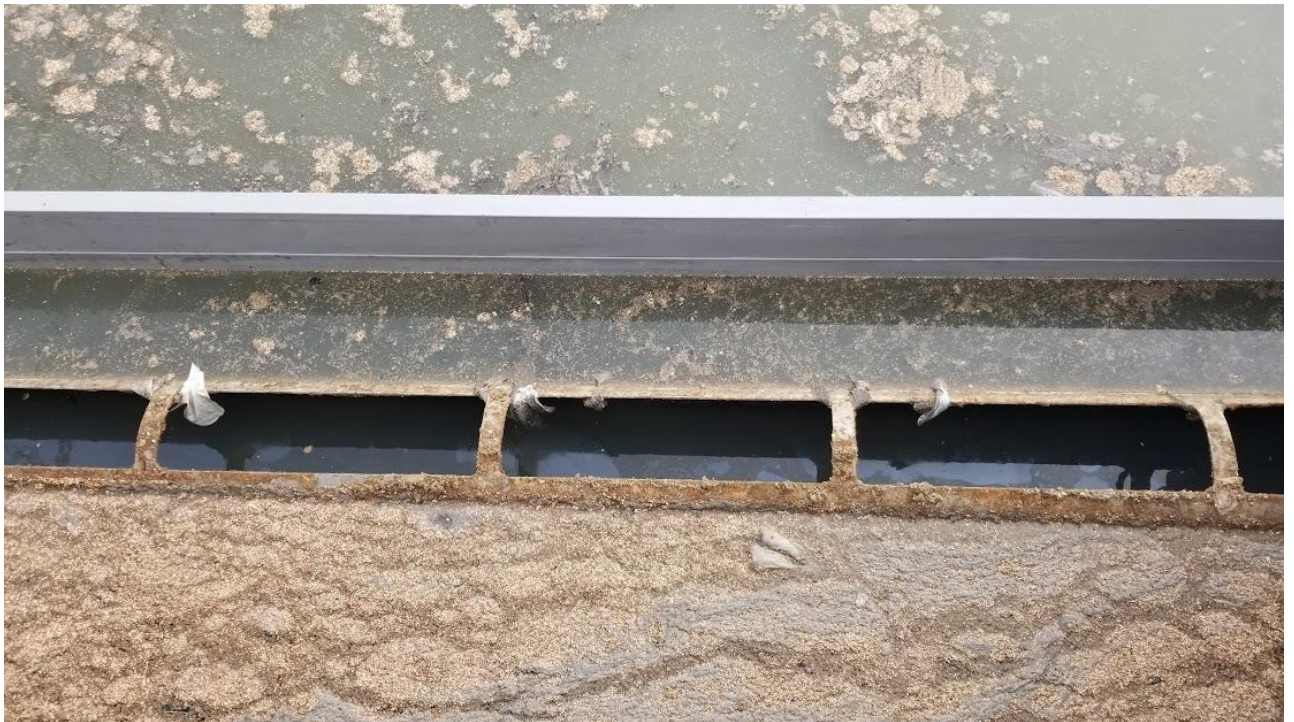
- 4) Rags and escaped media from the BAF, comingled with scum on the water surface were observed by the effluent side of PST #1 (picture below). Media comingled with scum is shown at the bottom of the picture.

The PST should be maintained to prevent and minimize potential problems and maintenance issues further downstream of the plant by ensuring that larger solids (i.e. rags) are removed from wastewater. Implement a plan to clean up all escaped media from the BAF and prevent media from escaping the BAF.

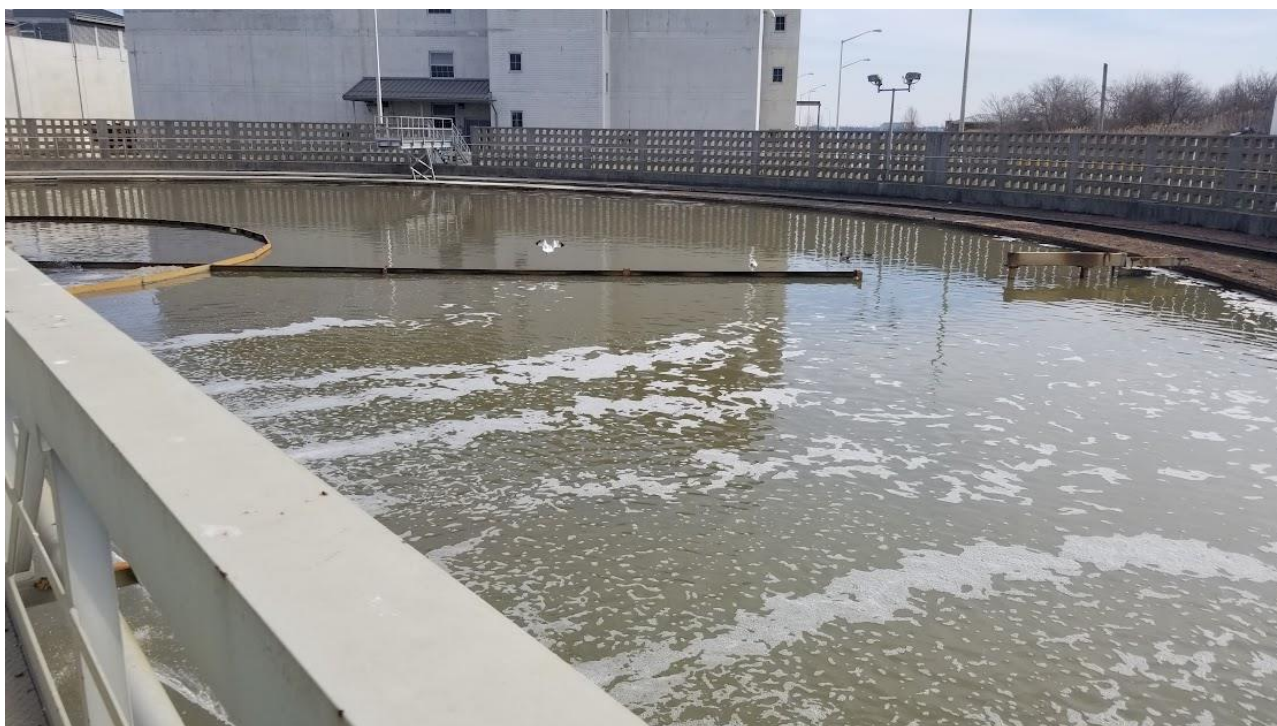
- 5) The secondary clarifiers are not operating per designed. Scrapper arms are missing in all operating clarifiers that were inspected during the time of this inspection. The purpose of the scrapper is to skim off any solids that accumulated on the water surface and into a trough. Mr. Neal Jackson stated that due to a supply chain issue, the plant is having trouble in getting parts. Pictures of Clarifier #4 are shown in Figures 5a and 5b. Picture of Clarifier #5a is shown in Figure 5c. Pictures of Clarifier #5b are shown in Figures 5d and 5e. The missing scrapper arms may contribute to the buildup of excessive amounts of solids on the surface of the clarifier.

Figure 5a: Scrapper arm in Clarifier #4 is missing.

Repair and maintain the clarifiers to ensure that they are functioning per design. Install scrapper arms to the clarifiers immediately, once the parts are available.

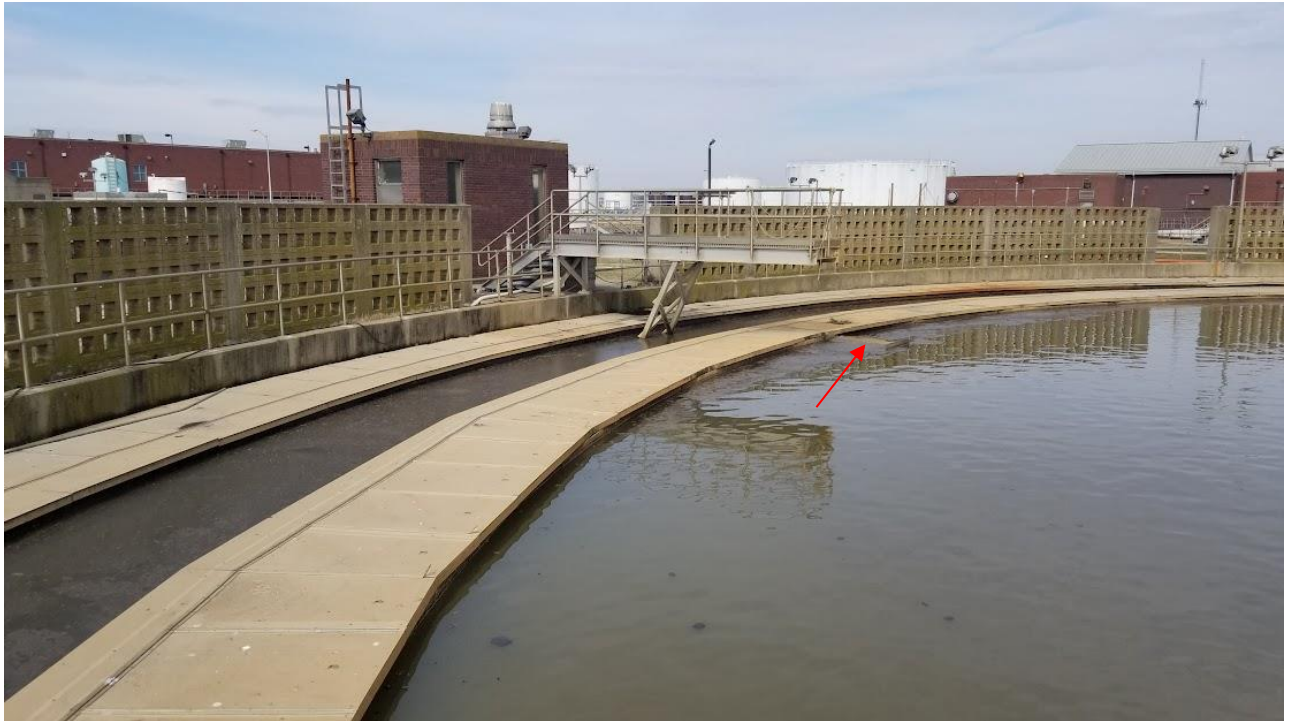
Figure 5b: Surface of the scum trough (pointed with a red arrow) at the same level as the water surface within Clarifier #4.

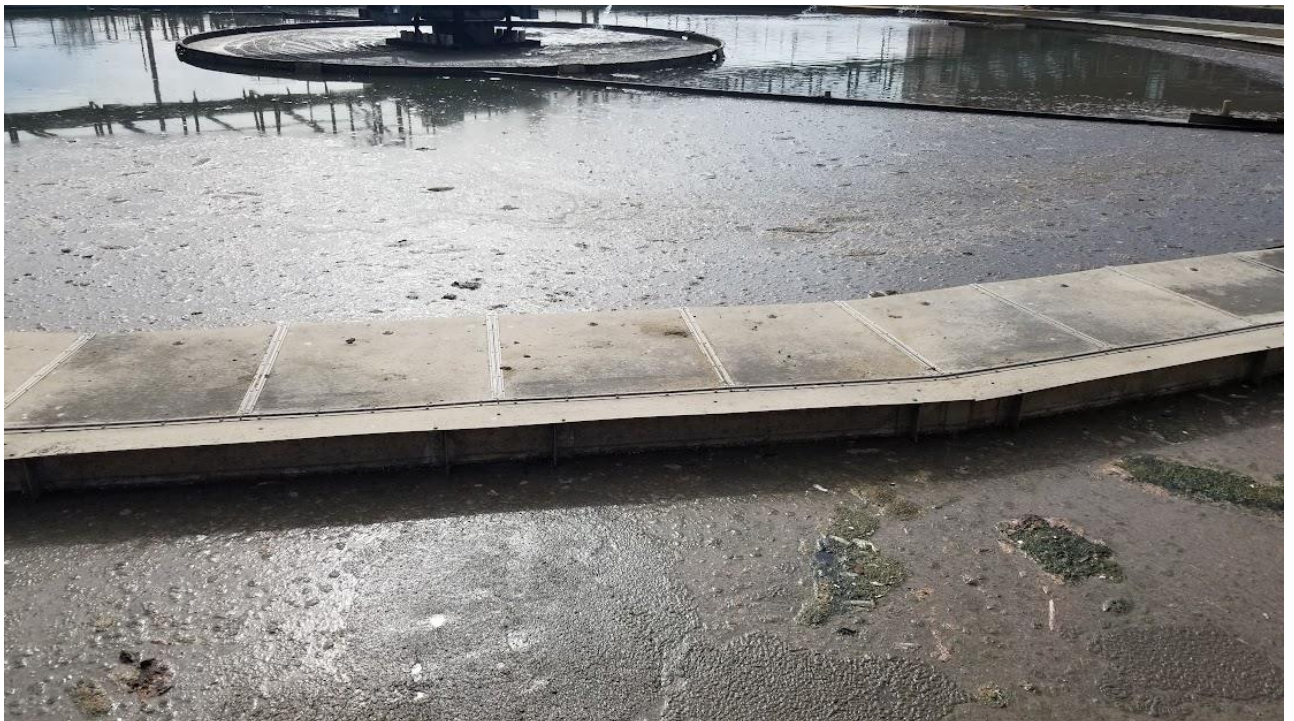
Figure 5c: Scum on the water surface at both sides of the launder cover within Clarifier # 5a.

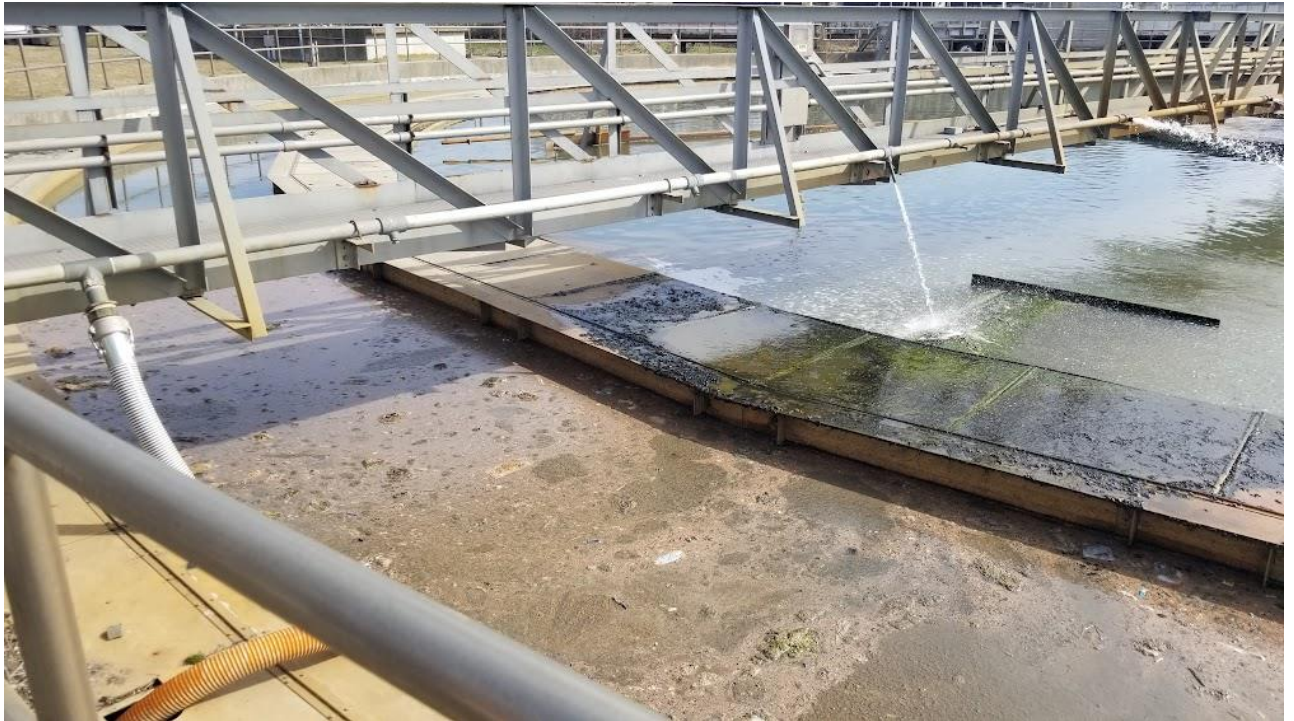
Figure 5d: Scum accumulation within Clarifier #5b.

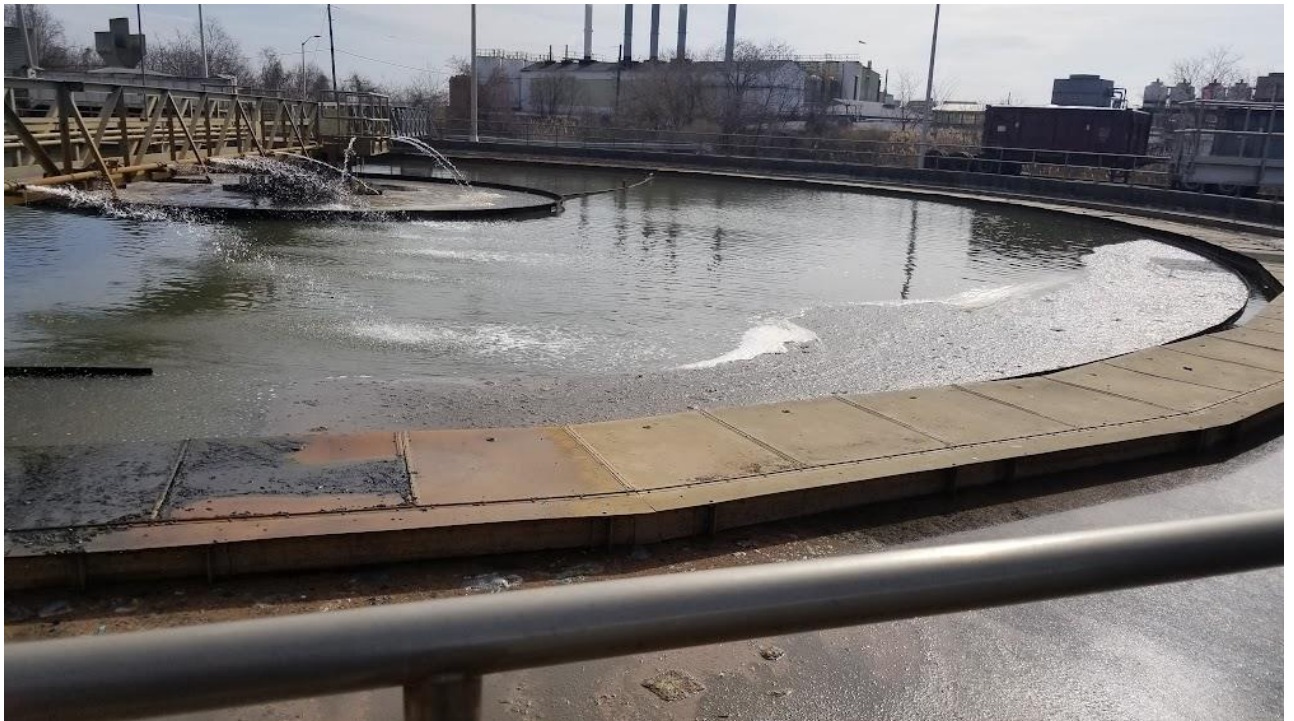
Figure 5e: Scum accumulation within Clarifier # 5b.
