**Subject: Water Supply Investigation Results
Jacksonville Veterinary Hospital
14240 Jarrettsville Pike
Phoenix, Maryland**

Veterinary Hospital Water Supply Investigation Data

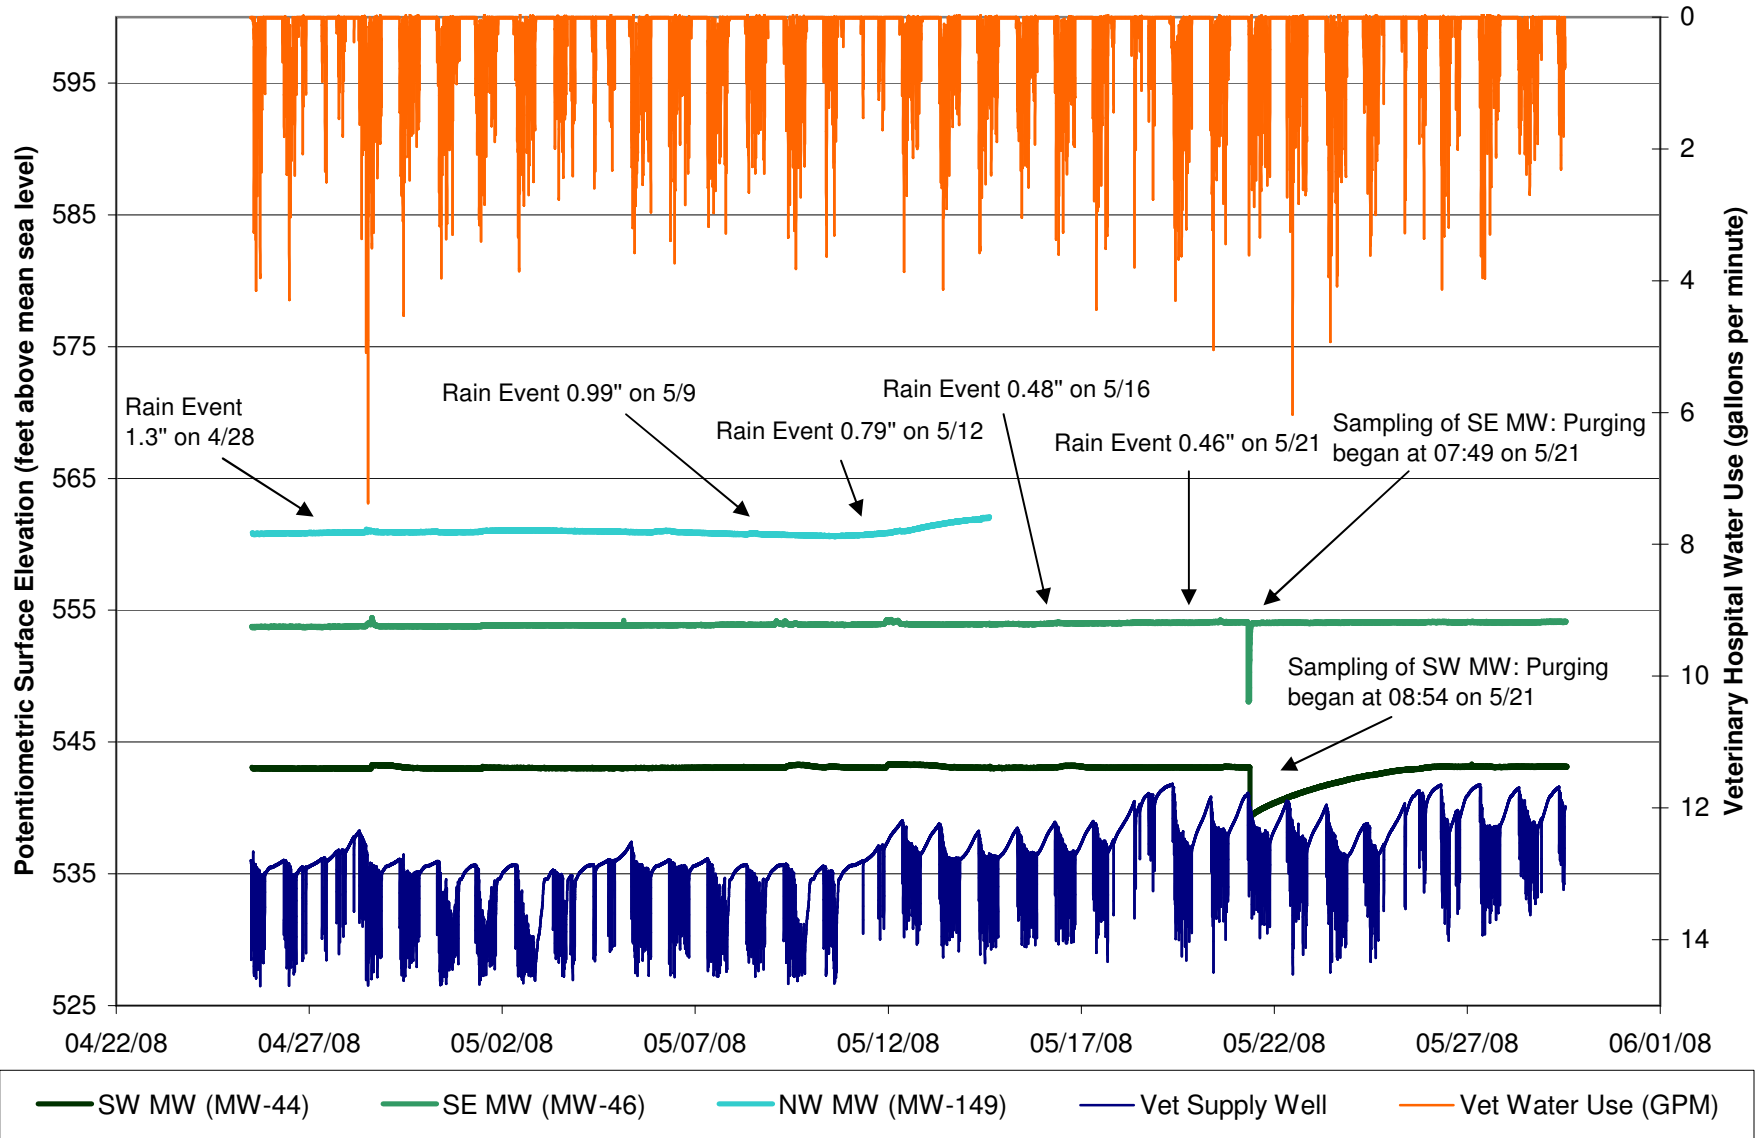
Attachment 1

The veterinary hospital supply well submersible pump is reportedly set at approximately 118 feet below grade (fbg), which corresponds to an elevation of approximately 456 feet above mean sea level, (ft-msl). As observed on the chart in **Attachment 1**, the potentiometric surface elevations measured in the veterinary hospital supply well during the investigation period ranged from 541.82 to 526.49 ft-msl. These data indicate that the water level inside the supply well did not fall to a level near the pump intake during the study period.

The potentiometric surface elevations in the monitoring wells measured (MW-149, MW-44, and MW-46) remained generally consistent during the study period, except during purging and sampling of MW-44 and MW-46 on May 21, 2008. The data indicate that pumping water from the veterinary hospital supply well between April 25 and May 29, 2008 did not affect potentiometric surface elevations in monitoring wells MW-149, MW-44, and MW-46.

- Kleinfelder received no reports of diminished yield from the veterinary hospital personnel during the period of April 25 through May 29, 2008.
- The data collected between April 25 and May 29, 2008 do not indicate a water supply issue associated with the supply well in the veterinary hospital since the water level in the pumping well was consistently greater than 70 feet above the pump intake.

It is recommended that the water storage capacity of the water supply system be increased to alleviate future water supply issues that may arise during peak demand periods. Replacing the existing pressure tank connected to the water supply system with larger capacity tanks will increase the storage capacity of the water supply system and reduce the amount of water extracted from the supply well during peak demand periods.
