## **Maryland Department of Environment**

Site Name: Patapsco WWTP

Media Type(s): NPDES Municipal Major Surface Water

Inspection Reason: Follow-up (Non-Compliance)

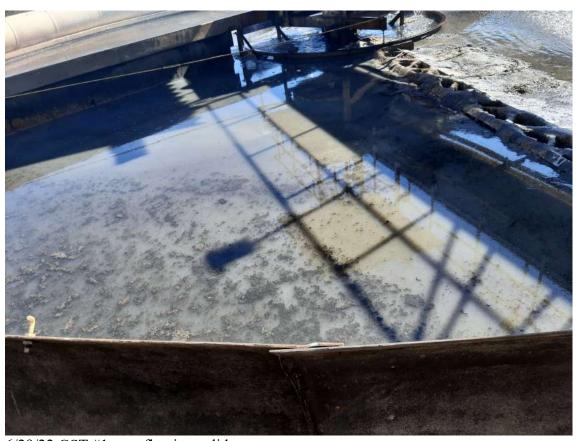
6/29/22 GST #1 note floating solids

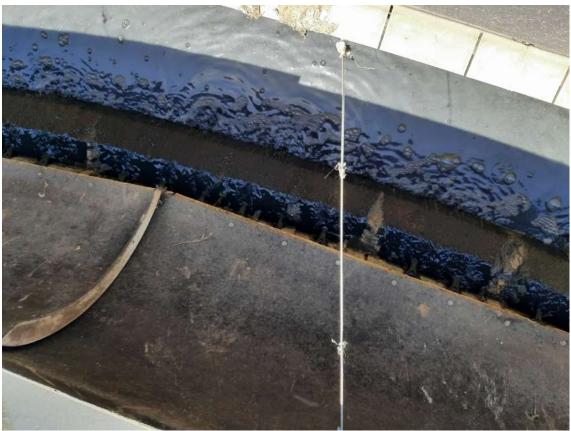
effluent weirs blocking the flow of the supernatant. As mentioned in the Department's previous inspection report, the #2 GST skimmer arm was not in complete alignment with the surface of the water and required reinforcement. The high sludge blanket is also causing the top layer of supernatant to be charcoal in color. These problems are increasing the amount of solids going through the system into the biological reactors and continues to cause high solids concentrations, leading to monthly effluent violations for BOD, ammonia as N, and cumulative total nitrogen.

6/29/22 Effluent from GST #1 the weirs are blocked and covered with the sludge

- 4. With respect to item D above, the Patapsco WWTP shall operate and process sludge in the GSTs in a manner that maintains a solids-free supernatant. Since the two operating GSTs are overburdened with solids, the #4 GST should be repaired so that the active GSTs can be taken offline one at a time and cleaned. This action will greatly improve the quality of supernatants from the GSTs. Within 30 days of the receipt of this report, the Patapsco WWTP shall submit to the Department a status report on the

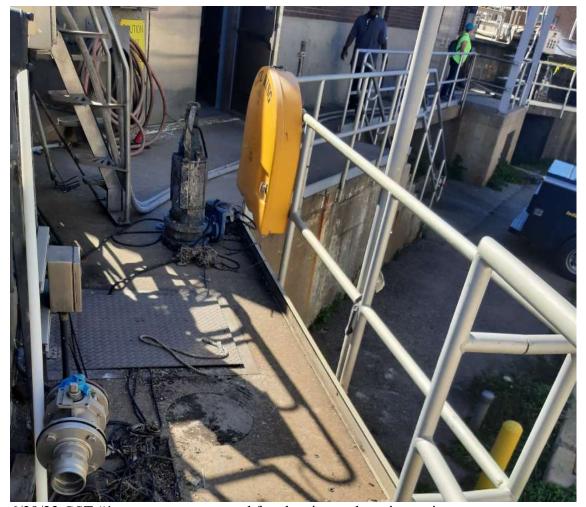
During an evaluation of the area, I observed that the #1 GST scum pump was on the deck. According to Jackson, they are cleaning and performing routine maintenance on the pump and pumping out the scum pits with a Vac truck.

6/29/22 GST #1 scum pump removed for cleaning and routine maintenance

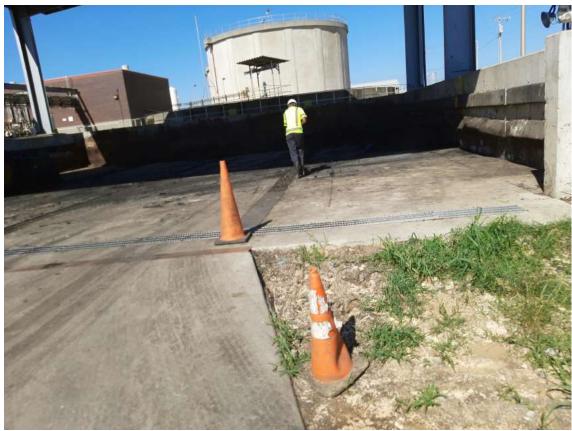
The next area of evaluation was the Tailings Transfer Station. Patapsco WWTP has been using the Tailings Transfer Station as a temporary sludge storage area to store unprocessed sludge. This area is now being cleared of sludge. According to Jackson, now that Synagro is using the railcars to transport the centrifuged sludge off-site, there is no need to store the sludge at the Tailings Transfer Station. The railcars offer a greater capacity than trucks and this change has significantly reduced Patapsco WWTP's biosolids inventory. Tailings Transfer Station will go back to being used as a storage area for the tailings from the fine screening area as designed. The area is in much better condition than before. See picture taken on June 29, 2022, and another picture taken on April 6, 2022. Note the improvement.

6/29/22 Tailings Transfer Station is being cleaned of sludge.

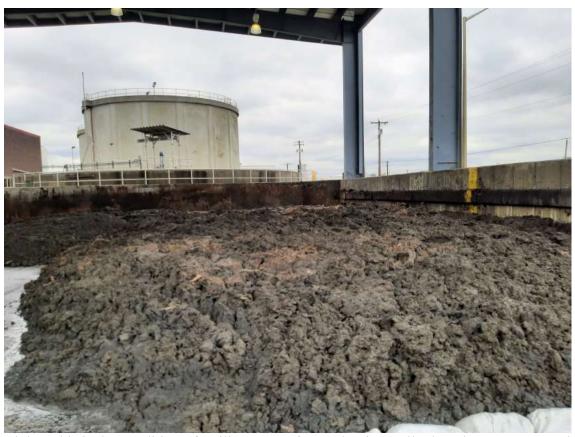
4/6/22 This is the condition of Tailings Transfer Station in April when the area was used for the storage of sludge. Picture above shows sludge inventory has diminished.

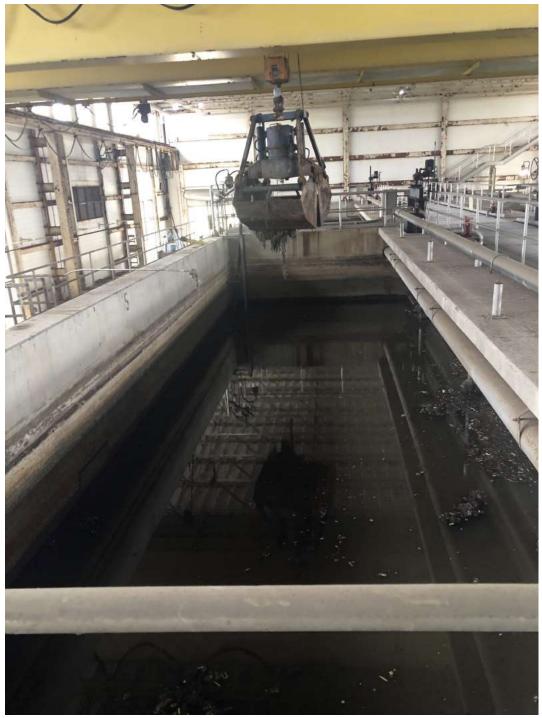
7/5/22 Grit tank and traveling crane with clamshell in Grit Building. Picture taken at my request by Hazen and Sawyer

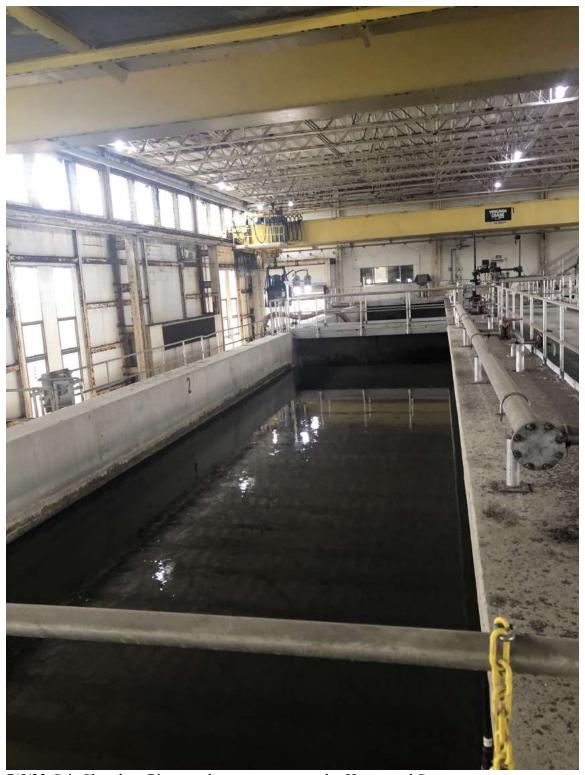
7/5/22 Grit Chamber. Picture taken at my request by Hazen and Sawyer

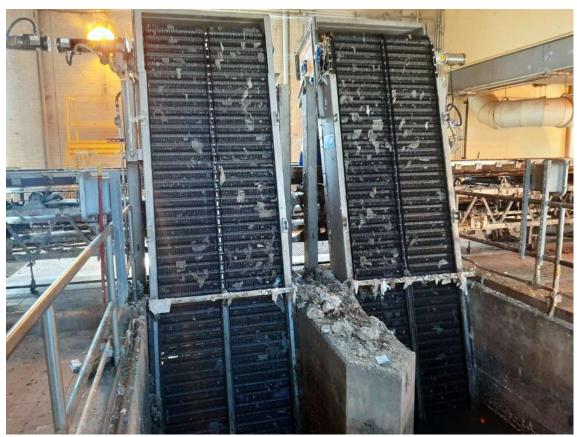
6/29/22 pile of trash from screening unit located in a position to get back into the system. The area should be checked and cleaned as appropriate.

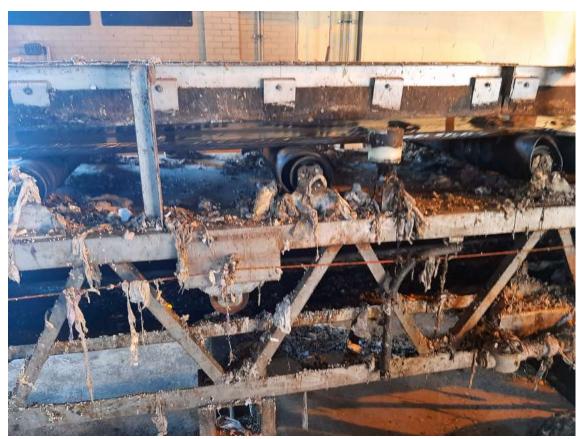
6/29/22 trash clogging conveyor belt. This area should be routinely cleaned of trash and maintained in a manner that promotes effective functioning of the system. The permittee must improve operating practices in this area.

- C. The fine screening system is not being maintained to the level necessary to keep the current equipment functioning satisfactorily. During previous inspections in 2021 and 2022, the belt conveyors were not operable due to the accumulation of debris such as rags, paper and plastic items. During this inspection, the belts were functioning; however, there was an accumulation of debris on and around the belts. The belts are old with missing and damaged skirting which allows the debris to fall from the belt and clog the mechanical parts. Due to this issue, the system requires constant maintenance to prevent blockage of the belt mechanisms.

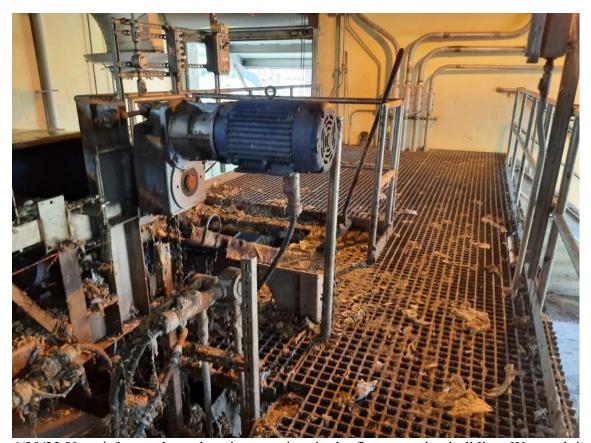
6/29/22 Unsatisfactory housekeeping practices in the fine screening building. Wet trash is a slip and trip hazard as well.

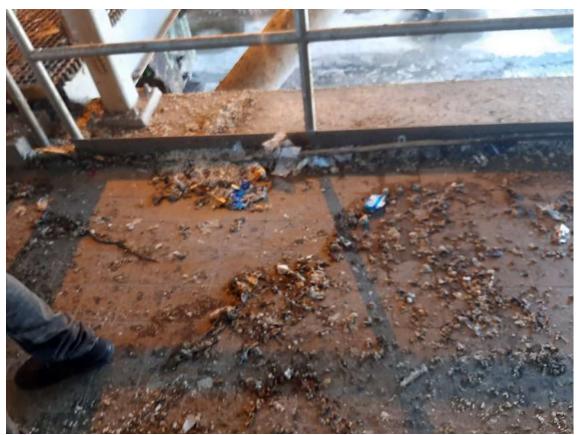
6/29/22 Unsatisfactory housekeeping practices as well as a safety issue.

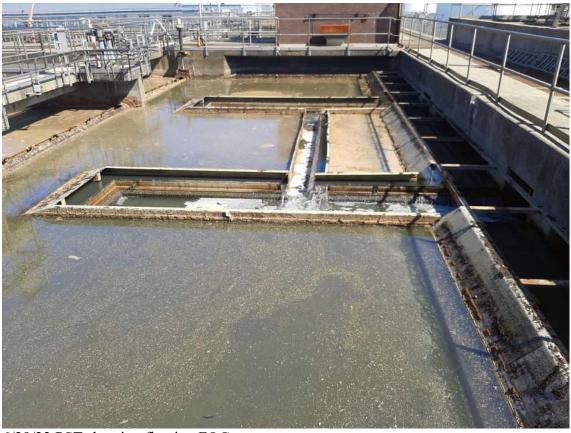
During the June, 29, 2022 inspection, five of the six PSTs were online. PST #3 was taken offline for cleaning and according to Jackson PST #3 would be back online by July 1, 2022. I observed floating scum along with fats, oils, and grease (FOG) floating on the surface of PSTs #1 and #2. However, the remaining three PSTs did not have the floating FOG and were in satisfactory condition. According to Jackson, the scum troughs are rotated twice a day to remove the scum and manual skimming with a net is being conducted as well to try to manage the floating scum and FOGs. There was no manual skimming or rotations being done during my time inspecting the PSTs. I inspected the final effluent from the PSTs and observed no floating scum going over the weir at this time. The facility shall ensure the operational integrity of the primary treatment system and shall take a proactive approach by removing the accumulation of FOGs that have accumulated in some of the PSTs.

6/29/22 PST showing floating FOG

- 5. With respect to item E above, the Patapsco WWTP shall immediately ensure the operational integrity of the PST and must take a proactive approach by removing the accumulation of FOG that has accumulated in some of the PSTs after the rain event. A root cause analysis should be performed to evaluate operations and maintenance including collection systems, inflow and infiltration problems, capacity issues during rainfall. The facility should also evaluate the effectiveness of the current contingency plan that is implemented during heavy rainfall and the success of implementation during these events.

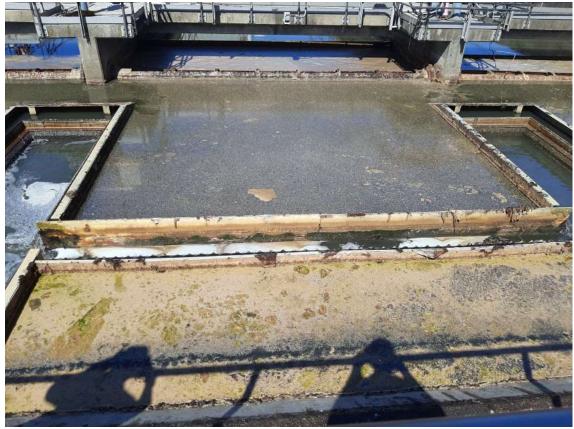
6/29/22 PST with floating FOG.

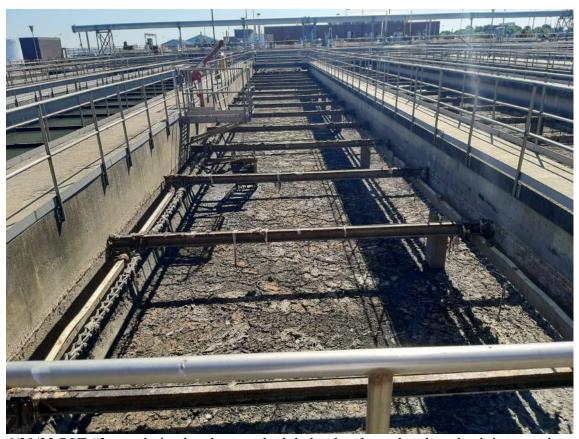
6/29/22 PST #3 was drained and now scheduled to be cleaned and put back into service on July 1.

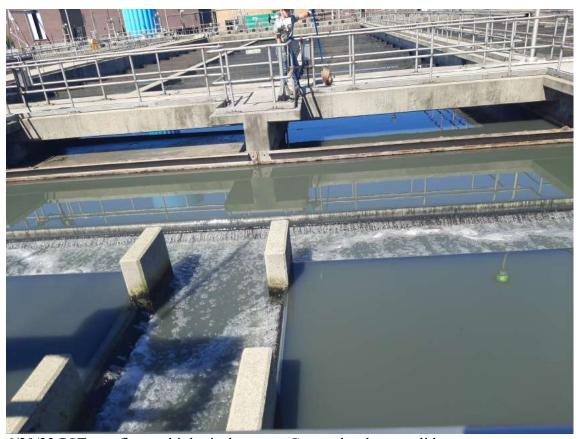
6/29/22 PST overflow to biological reactor. Gray color due to solids.

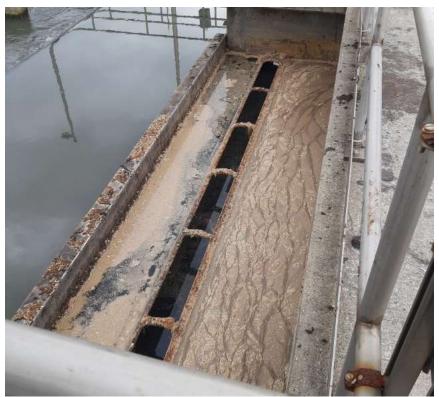
7/7/22 Scum trough for PST #4

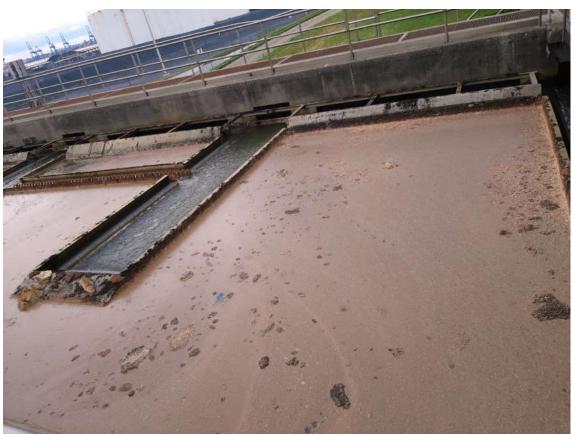
I observed a heavy layer of scum and FOG in PSTs #1 and #2, and a fine layer in PSTs #4, #5, and #6 during the July 7, 2022 inspection, which occurred the day after rainfall. The scum troughs were filled with FOG as well. PST #3 is still offline, and I observed that it had not been cleaned. The two pumps for the scum pit have been neglected and failed. They were removed and sent out for

7/7/22 Thick layer of scum on PST #2 after rain event the day before

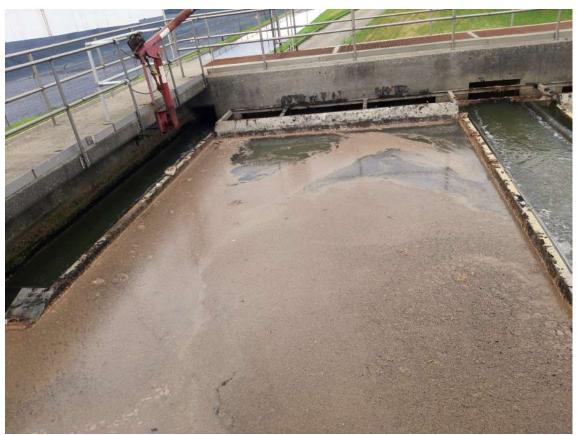
7/7/22 Thick layer of scum on PST #1 after rain event the day before

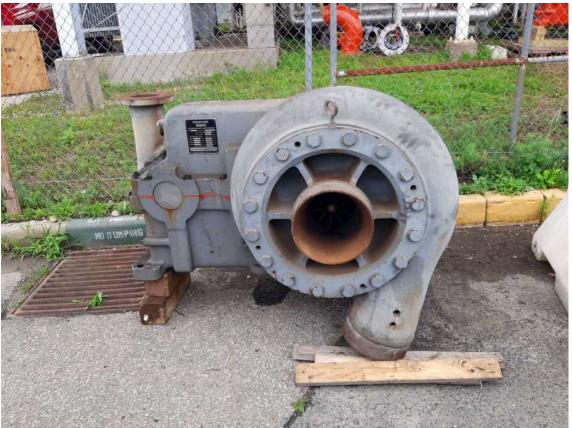
The liquid oxygen required for the reactors is produced in the liquid oxygen (LOX) plant. Originally, the Lox Plant had two compressors for the production of oxygen. Currently, only one of these compressors is functioning, but not to the level required for satisfactory oxygen production for the biological reactors. During the Department's April ,6, 2022 inspection, I was told that one of the compressors was repaired, back online, and the repairs to the second compressor have been made and was being shipped back to the plant. The Department received a letter dated June 10, 2022, stating that the compressor that was out for repairs was received on June 8, 2022, and would be installed on June 17, 2022. The compressors are critical to satisfactory nitrification and ammonia removal. Fully functional, as designed, compressors are necessary in order to meet the effluent limits of the permit.

7/7/22 Old LOX compressor that was overheating. This compressor will be refurbished in 2-3 months by Southern Designs.

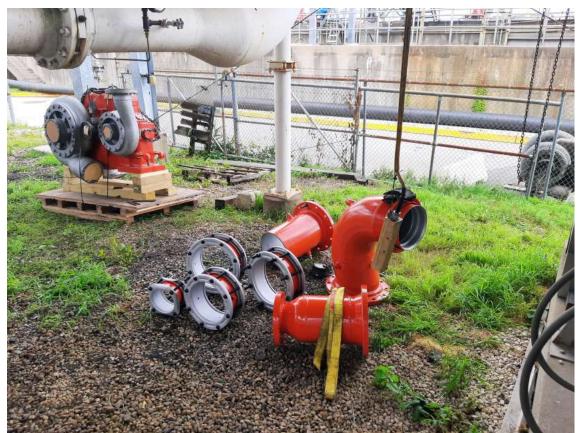
7/7/22 Refurbished compressor for the LOX plant.

On July 11, Thomas informed me by email that there was a setback in the installation of the refurbished compressor shown above and the scheduled installation date of July 9, 2022, is no longer achievable. The refurbished compressor did not line up with the discharge piping on train #1. The refurbished compressor was moved to train #2 and the installers were able to install the compressor to train #2. However, train #2 has electrical and mechanical issues that need to be corrected before the LOX plant can be put back online. According to Thomas, the Lox plant will be back online when the second compressor that is scheduled to be refurbished is back from the factory and installed on train #1 or the mechanical and electrical issues on train #2 are corrected whichever comes first. According to Michael Hallmen, Division Chief, Wastewater Facilities Division, they are purchasing oxygen from an outside contractor for the high-pressure pure oxygen reactors until the LOX plant is back in service.

- 10. With respect to item J above, the Patapsco WWTP shall immediately meet the effluent limitations of the permit.
- 11. With respect to item K above, within 15 days of the receipt of this report the Patapsco WWTP shall provide a status report on the progress of the repairs to the LOX plant with updates every 30 days until the repairs are completed and the LOX plant is producing oxygen for the biological reactors.

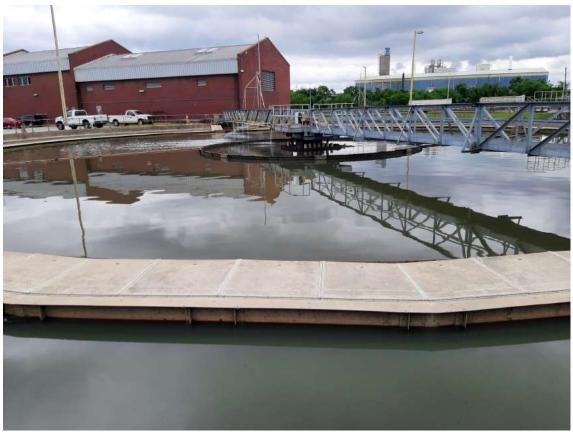
7/7/22 Secondary clarifier 6A RAS pump is functioning and the 6A clarifier is back in service

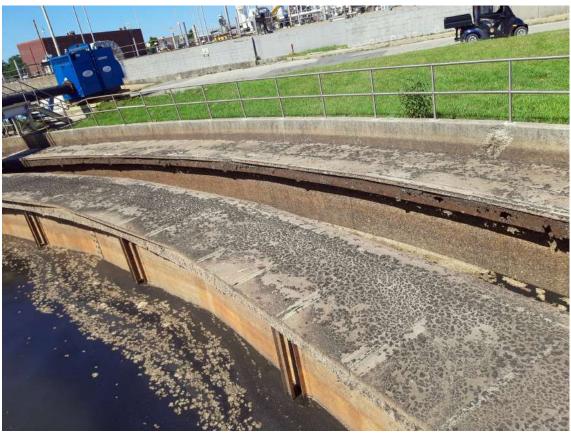
Secondary clarifier #3 is being used to collect the backwash from the BAF and the Denitrification Filter System (DNF). This appears to be isolating the BAF media that is being lost during backwash. The effluent from this clarifier goes back to the influent line of the PSTs. Currently, seven of the eight clarifiers are active and being used for wastewater treatment to settle solids. The water in the secondary clarifiers was gray due to the TSS concentration. There were also media pellets from the BAF system observed floating in the water of a few of the secondary clarifiers but not to the extent observed during previous inspections. The skimmer arm on clarifier #5A is slightly bent and the scum scraper is missing, therefore, there is no effective skimming being

6/29/22 Secondary clarifier #3 is being used to collect the filter backwash discharge

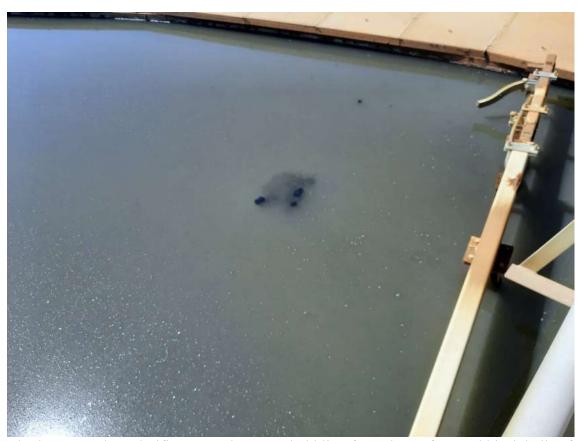
performed at this clarifier. I also observed bubbling of the water due to the release of methane gas in the secondary clarifiers along with floating balls of black solids. This condition is caused by anoxic conditions in the water due to over-aged sludge. This is a concern because it can lead to denitrification in the secondary clarifiers and the floating solids can cause solids to carry over to the next stage of treatment (BAF) causing further problems with solids. This was most evident at clarifier #4. The Patapsco WWTP should evaluate the following to prevent denitrification in the secondary clarifiers:

6/29/22 Secondary clarifier #4 methane gas bubbling from the surface and black balls of sludge floating on the surface

- Evaluate the sludge blanket, optimal is between -3 feet. According to Grace, the sludge blanket in clarifier #4 was approximately 3.5 feet.
- Evaluate hydraulic retention time in the clarifier. Optimal time is between 2-4 hours.
- Use a water spray to degas the floating solids. This will cause the bubbles to breakout and the sludge to sink

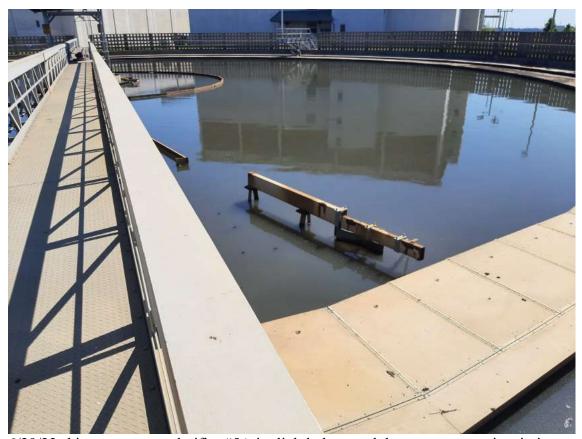
6/29/22 skimmer arm on clarifier #5A is slightly bent and the scum scraper is missing.

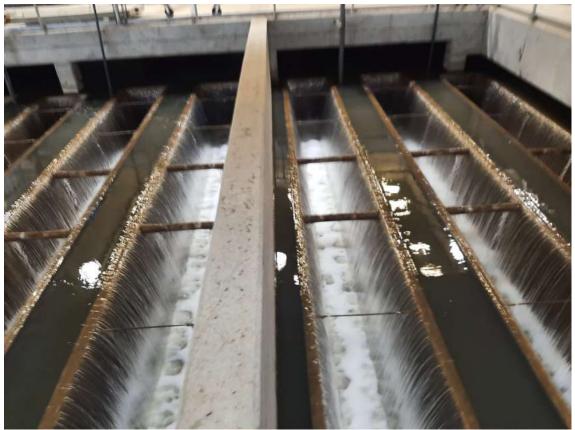
6/29/22 Effluent from BAF

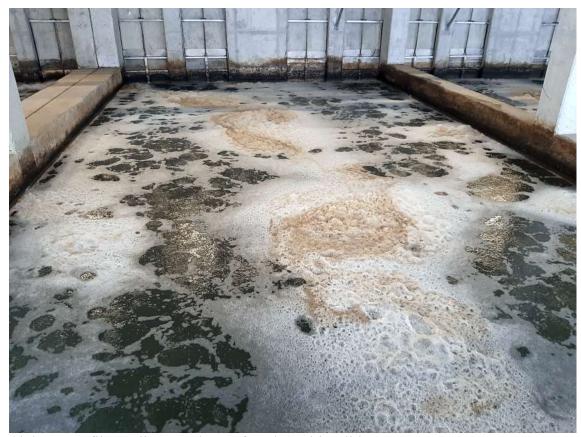
Next, I conducted an evaluation of the BAF system. Twenty-one of the 22 filters were online during this evaluation. I observed foaming in the filter cells caused by the high BOD due to the high concentration of solids. Solids were also observed floating in the foam. The solids load, now going into the BAF system, is above the capacity of the system. The effluent was moderately turbid due to solids. According to Grace, the ammonia as N concentration of the influent going to the BAF is 20 mg/L and the ammonia concentration of the effluent leaving the BAF is 14 mg/L, which is a 30% ammonia removal rate. The BAF should be capable of removing 75–90 % of Ammonia as N from the wastewater. Therefore, complete ammonia oxidation is not being performed by the BAF due to solid concentrations that are elevating the BOD and hindering nitrification. This data indicates that the BAF is not functioning to ENR standards as required by the permit. The facility shall make equipment and process corrections to achieve ENR standards for this treatment process.

7/7/22 BAF filter cell – Note heavy foaming with solids

of the treatment system. The Patapsco WWTP shall work with VWT to resolve this process problem to prevent the media loss.

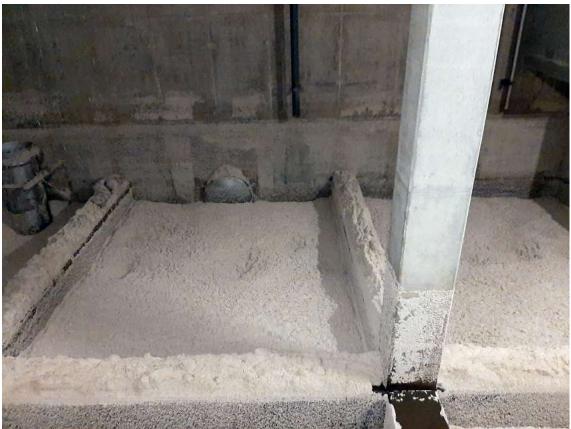
7/7/22 BAF mud well containing a heavy layer of media.

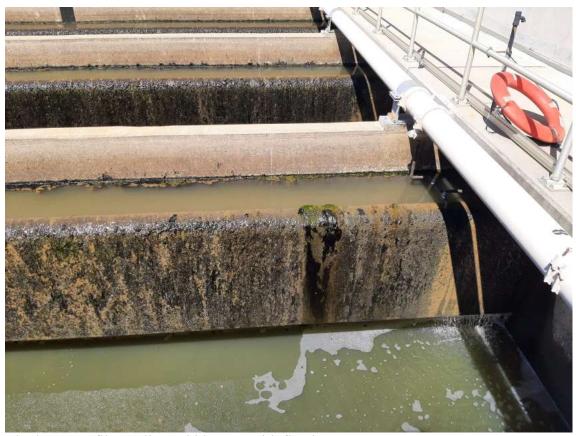
6/29/22 DNF filter cell – turbid water with floating scum

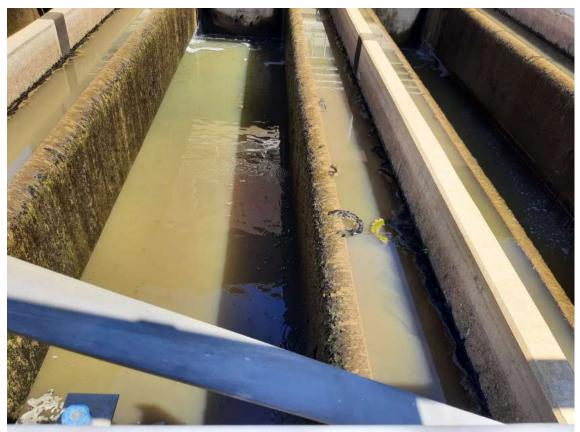
6/29/22 DNF – turbid water with floating solids

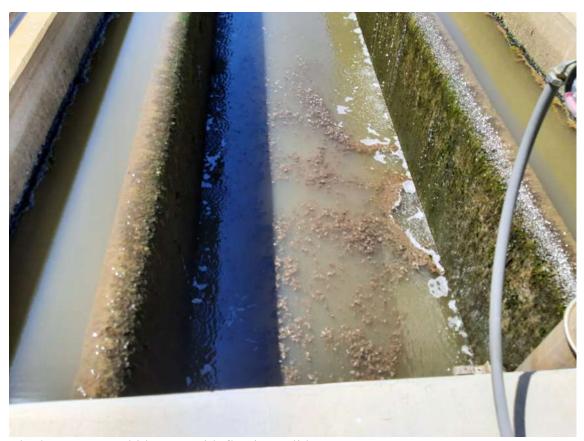
6/29/22 DNF – turbid water with floating solids

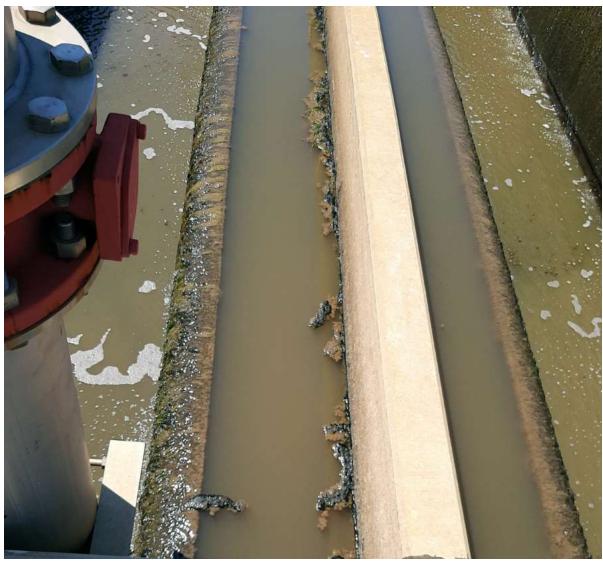
6/29/22 DNF – Algae, solids and scum

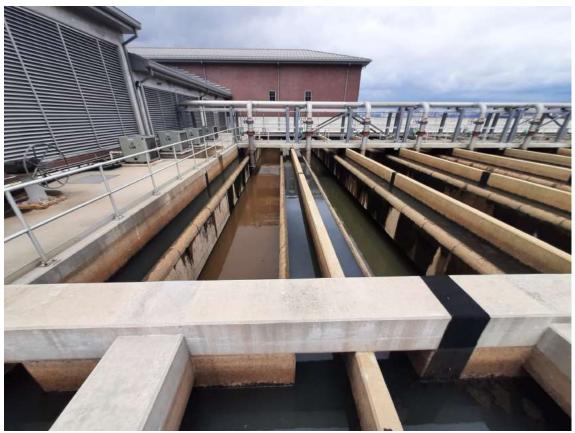
When I returned on July 2, 2022, 17 of the 34 DNFs were offline, and the exposed areas were being dried in order to remove the algae and scum on the filter walls.

7/7/22 DNF taken offline and allowed to dry in an attempt to remove the algae on the overflow weirs

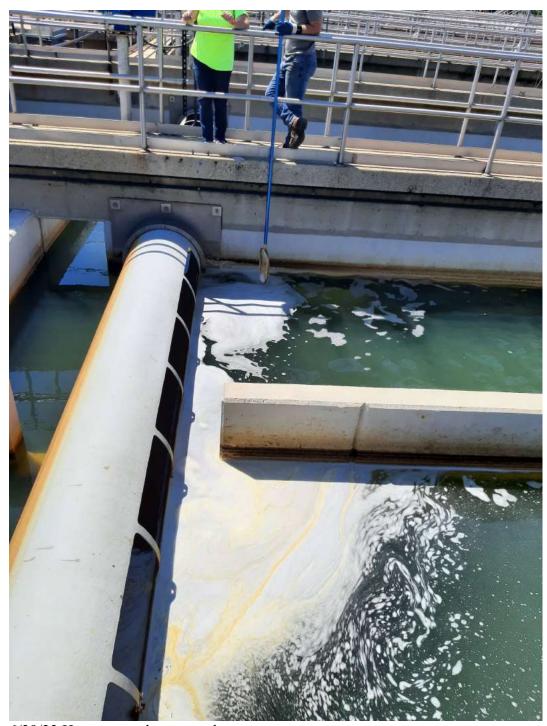
Next, I inspected the chlorine contact basins prior to the final discharge. There are four contact chambers and three are currently online. Each contact chamber has three scum logs or troughs to remove floating scum. Contact chamber #3 is offline, and the #2 scum trough is down and requires repairs. According to Johnson, a service contractor inspected the unit on June 27, 2022, and they are expecting a quote to be submitted today. However, Johnson was not able to give me a date for the completion of the repairs to the scum log. I observed floating scum and FOG at the chlorine contact chambers. Currently, there was staff skimming at the chlorine contact basins.

6/29/22 Heavy scum layer noted.

- 7. With respect to item G above, within 15 days of the receipt of this report the Patapsco WWTP shall provide a status report on the progress of the repairs to the scum log for CCC #2 with updates every 30 days until the repairs are completed and the scum log is back online. The Patapsco WWTP shall determine if additional manual skimming is required and implement as necessary.

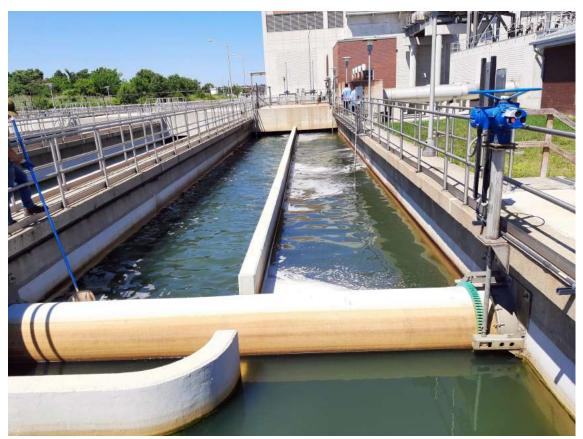
6/29/22 Another view of chlorine contact chamber

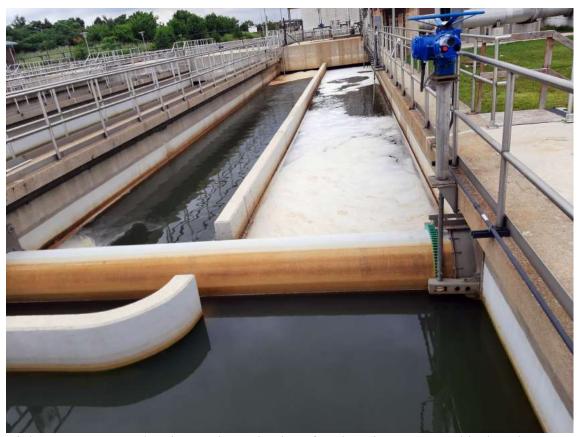
7/7/22 Same area as the picture above the day after the rain event. On this date there was no skimming being done.

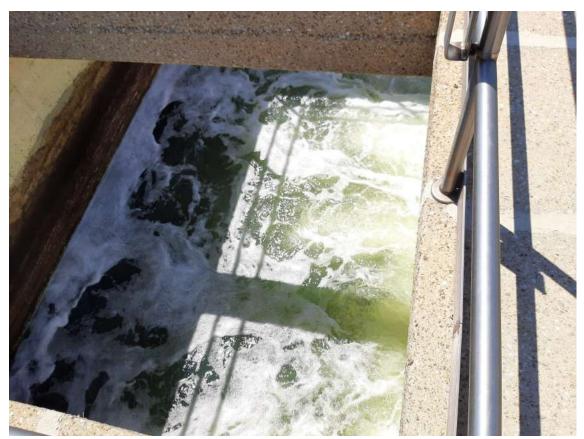
6/29/22 Final effluent

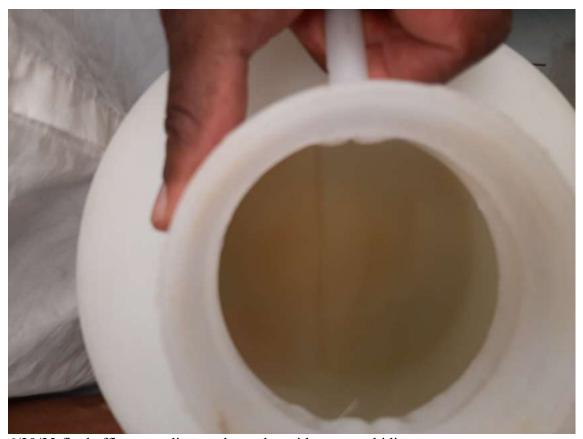
The facility is collecting 24-hour, flow-proportioned composite samples at Outfall 001 in accordance with the requirements of the permit. The primary refrigerated, automatic composite sampler was inspected, and I found that the temperature of the compartment was satisfactory, and the sampling container was also clean. The temperature of the refrigerated compartment was 5 degrees C, which meets 40 CFR Part 136 requirements. I inspected the final effluent in the sampling container and observed that the composite sample was a medium amber color with visible particulates (see picture).

6/29/22 final effluent medium amber color with some turbidity.
