**WELLHEAD AREA SURVEY
BELLE GROVE GROCERY
ACHD SITE NO. 61
Belle Grove, Allegany County, Maryland**

ALWI Project No. AL7N001

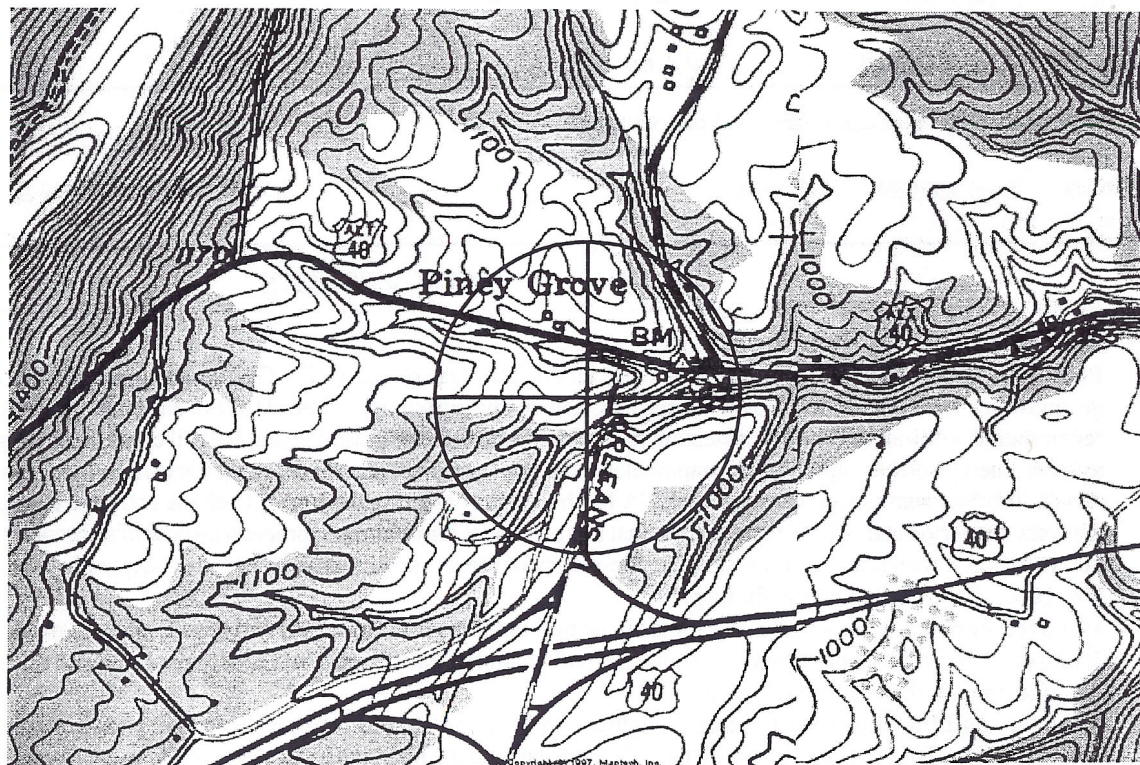
24. Well Location Diagram (1 in. = 1250 ft.) with Approximate Distances from Potential Contaminant Sources (i.e. septic, sewer lines, structures, petroleum storage, surface water bodies, etc.):

Based on observation and interview information, on December 14, 1998, ALWI assessed several potential contamination sources in the delineated area. ALWI identified the following potential sources of contamination within the surveyed area: surficial and subsurface fuel spills from USTs², possible stormwater infiltration along the well's casing³, salt from road deicing, vehicle drippings from both functional and junked vehicles onto the gravel parking lot, and a continuing risk of well casing damage based on its location in the middle of the gravel parking lot.
