**WELLHEAD AREA SURVEY
DAN'S MOUNTAIN STATE PARK
ACHD SITE NO. 3
Lonaconing, Allegany County, Maryland**

ALWI Project No. AL7N001

NONCOMMUNITY WATER SUPPLY SANITARY SURVEY

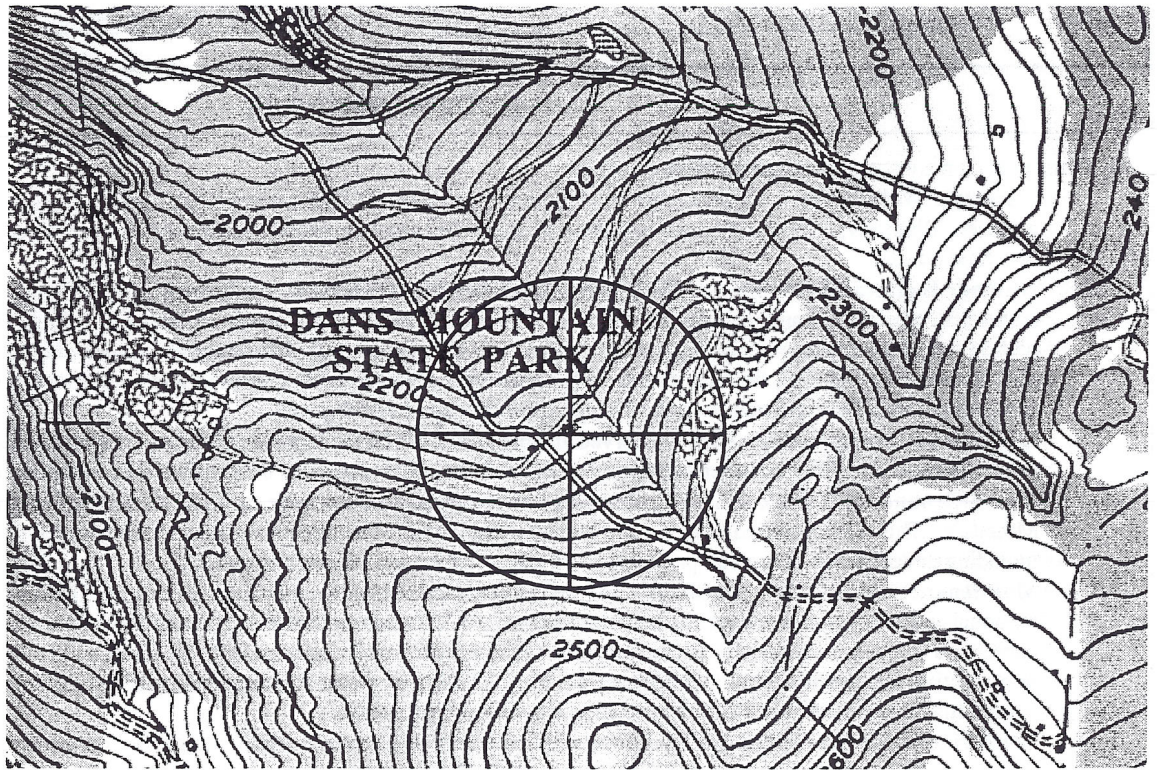
24. Well Location Diagram (1 in. = 1250 ft.) with Approximate Distances from Potential Contaminant Sources (i.e. septic, sewer lines, structures, petroleum storage, surface water bodies, etc.):

- 1. Uncertain Well Location** – The on-site well could not be located. Common potability hazards such as casing and cap integrity could not be assessed. Similarly, ALWI could not verify the well's proximity or topographic setting with respect to the other potential contamination hazards observed on site.
