**WELLHEAD AREA SURVEY
DIPLOMAT MOTEL
ACHD SITE NO. 50
Rawlings, Allegany County, Maryland**

ALWI Project No. AL7N001

NONCOMMUNITY WATER SUPPLY SANITARY SURVEY

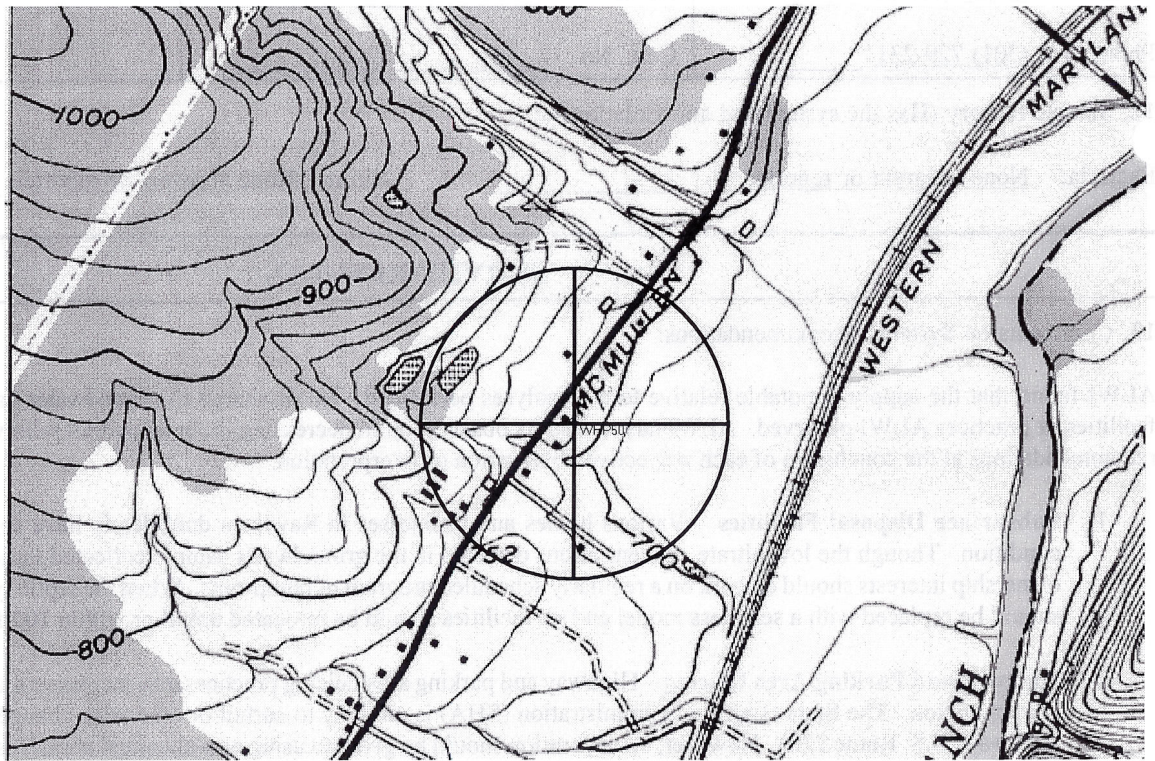
24. Well Location Diagram (1 in. = 1250 ft.) with Approximate Distances from Potential Contaminant Sources (i.e. septic, sewer lines, structures, petroleum storage, surface water bodies, etc.):

ALWI identified the following potential sources of contamination: the proximity of US Route 220 and the associated vehicle droppings and deicing practices.

1. **Subsurface Disposal Facilities** – Various homes and businesses in Rawlings doubtlessly have septic systems varying in age and condition. Though the low nitrate concentrations detected in the groundwater sample collected indicate no present release, property ownership interests should embark on a regularly scheduled program of pump-outs. When the septic system needs replacement, the tank should be replaced with a seamless model and no facilities should be relocated uphill or within 100 feet of the well.
