**WELLHEAD AREA SURVEY
HOUSE OF ICE
ACHD SITE NO. 24
Dawson, Allegany County, Maryland**

ALWI Project No. AL7N001

NONCOMMUNITY WATER SUPPLY SANITARY SURVEY

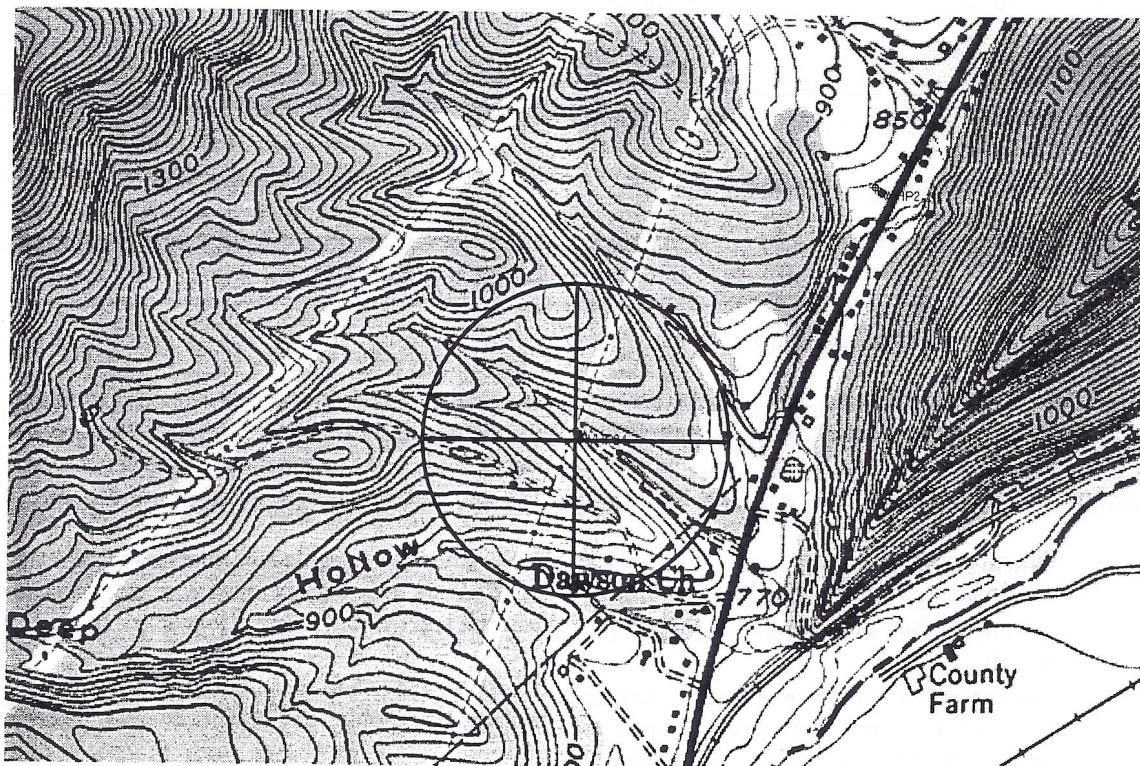
24. Well Location Diagram (1 in. = 1250 ft.) with Approximate Distances from Potential Contaminant Sources (i.e. septic, sewer lines, structures, petroleum storage, surface water bodies, etc.):

The resultant delineation is shown on the "Water Plant Information" survey form (Appendix B) and encompasses approximately 80% of the circle (originally 72 acres in size) or 58 acres. Within an assumed 600 gallons per day per acre (gpd/ac) of annualized groundwater recharge (Slaughter and Darling, 1962, Table 37), slightly less than 35,000 gallons per day exists within the aquifer beneath this surveyed area. In actuality, the modest demand of this well (500 – 600 gpd on average) is more than one full order of magnitude smaller than the total available in the surveyed area, lending a high degree of conservatism to this analysis.
