Compliance Program
1800 Washington Blvd, Suite 420
Baltimore, MD 21230-1719
410-537-3510, 1-800-633-6101

Back River WWTP

NPDES Municipal Major Surface Water

NPDES Numbers: MD0021555 Inspection Reason: Complaint

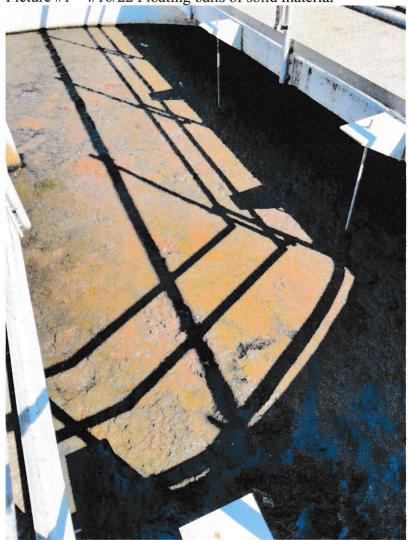
- I followed the process back to the treated water coming from the sand filters. I inspected the
  treated water from the sand filters and found that there was a heavy layer of floating solids and
  scum on the surface of the water in the distribution chamber that feeds the chlorine contact
  chambers. This condition may have been caused by a wash out of the secondary clarifiers that
  entered into the influent line of the denitrification filters (DNF).

- Because of an operational problem at the DNF system, the sludge from the DNF flowed to the sand filters and then to the chlorine contact chambers. See picture #2 below

Picture # 2 - 4/16/22 Treated water from the sand filters that flows to the chlorine contact chambers

The sand filters are not designed to treat this sludge and the wastewater flowed to the chlorine contact chambers as seen in Picture #2. According to Mr. Slattery, he has only been at the DNF building for two days and the mud well overflow occurred before ProStart took over management of the DNF system.

- A. With respect to item 1 above, the Back River WWTP must ensure that floating materials and partially treated solids are not allowed to discharge to waters of the State.
- B. With respect to item 2 above, the Back River WWTP must ensure that all process equipment is functioning as designed and evaluate and confirm that there is adequate staff at all times to monitor all process equipment and ensure satisfactory performance.
- C. With respect to item 3 above, the Back River should determine the cause for the problems with the out of service denitrification filters and make the necessary repairs.

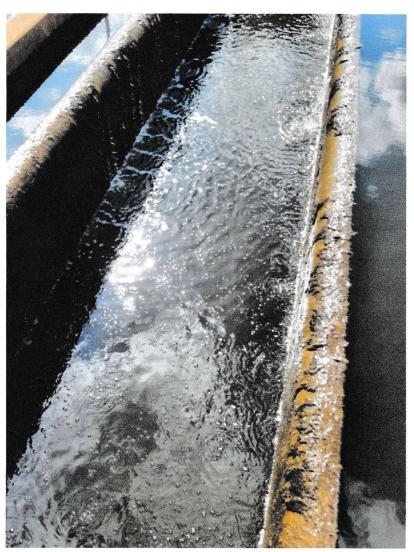
I observed that some of the operating filters were not functioning as designed. There were solid materials and sludge on the overflow weirs, and floating scum layer on the surface of the water in some of the filters. See Pictures # 3-5. In addition, some of the filters designated as in service were not functioning as designed.

Picture #3 - 4/16/22 DNF Note dark scum on the ledge of the overflow weir

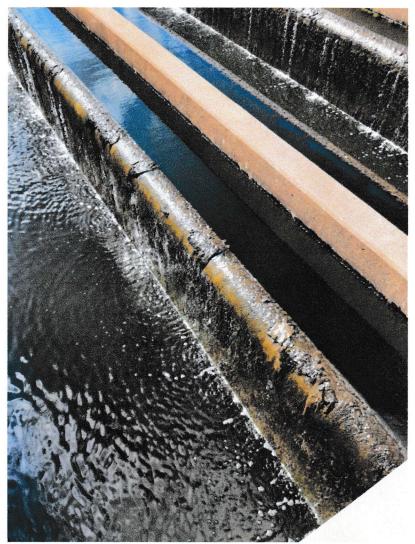
Picture #4 - 4/16/22 Sludge on weirs and dark water

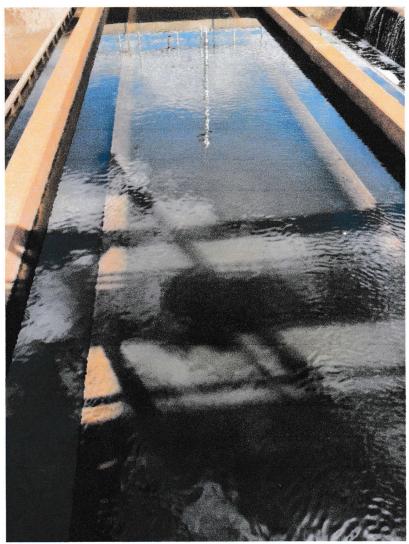
Picture #5 - 4/16/22 submerged filter not functioning as designed.

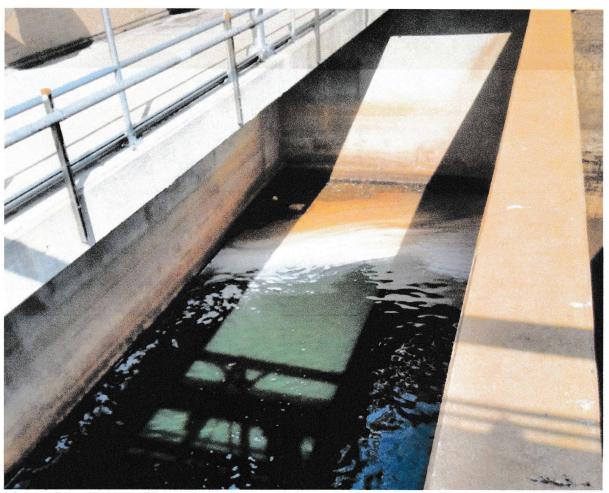
I observed a scum layer of floating solids and FOG on the water in the clear well. The DNF effluent flows to the clear well and then to the sand filters.

The solids and scum collected in the filters are removed during the filter back wash cycle and sent to the mud well which is next to the clear well. The filter back wash water that is collected in the mud well under normal operations flows to the tertiary clarifier. However, the mud well that collects the filter backwash from the Tetra filters was at some point allowed to overflow into the final effluent channel from the Tetra filters sending the floating scum and solids mixture from the back wash to the sand filters. During an inspection of the clear well, I observed a floating layer of scum, foam and FOG. See Picture #6.

Picture #6 - 4/16/22 effluent from DNF at Clear well. Note floating remnants of scum, FOG and solids
