Maryland Department of Environment
Water and Science Administration
Compliance Program
1800 Washington Blvd, Suite 420
Baltimore, MD 21230-1719
410- 537-3510, 1-800-633-6101

Site Name: Back River WWTP
Facility Address: 8201 Eastern Ave, Baltimore, MD 21224
County: Baltimore County

Start Date/Time: June 14, 2023 08:30 AM
End Date /Time: June 14, 2023 02:30 PM

Inspection Reason: Follow-up (Non-Compliance)

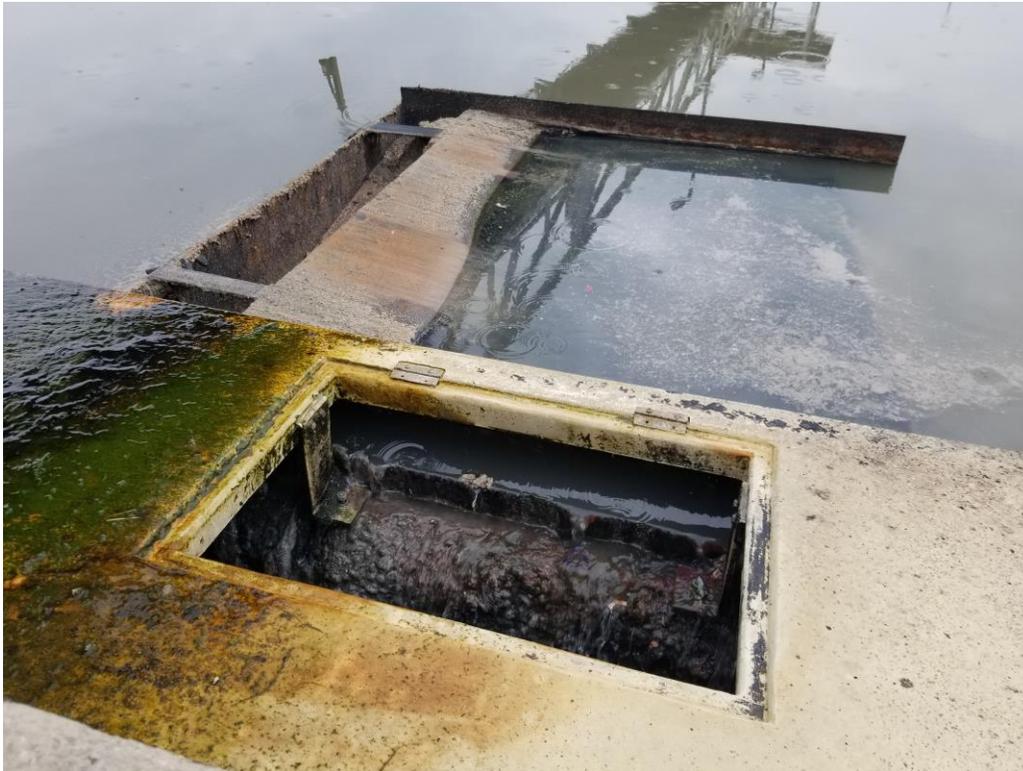
The next area of evaluation was at the PSTs. The PST #8 skimming arm was observed to be intact with no issues. Vegetation/other debris was observed along/past the weir of PST#8 at the visible opening near the scum trough and requires routine maintenance. The PST #11 skimming arm was observed to be functioning, but should be adjusted as needed to function as designed. The scum trough at PST #1 was observed to be clogged with scum and requires routine maintenance. The PST #1 skimming arm was observed to be intact with no issues. The PST #7 skimming arm was observed to be functioning, but should be adjusted as needed to function as designed. According to Timothy Simmons, PST #7 requires re-balancing adjustments due to issues resulting from previous contractor work done.

Picture 1: 6/14/23 – Vegetation/other debris was observed along/past the weir of PST#8 at the visible opening near the scum trough.

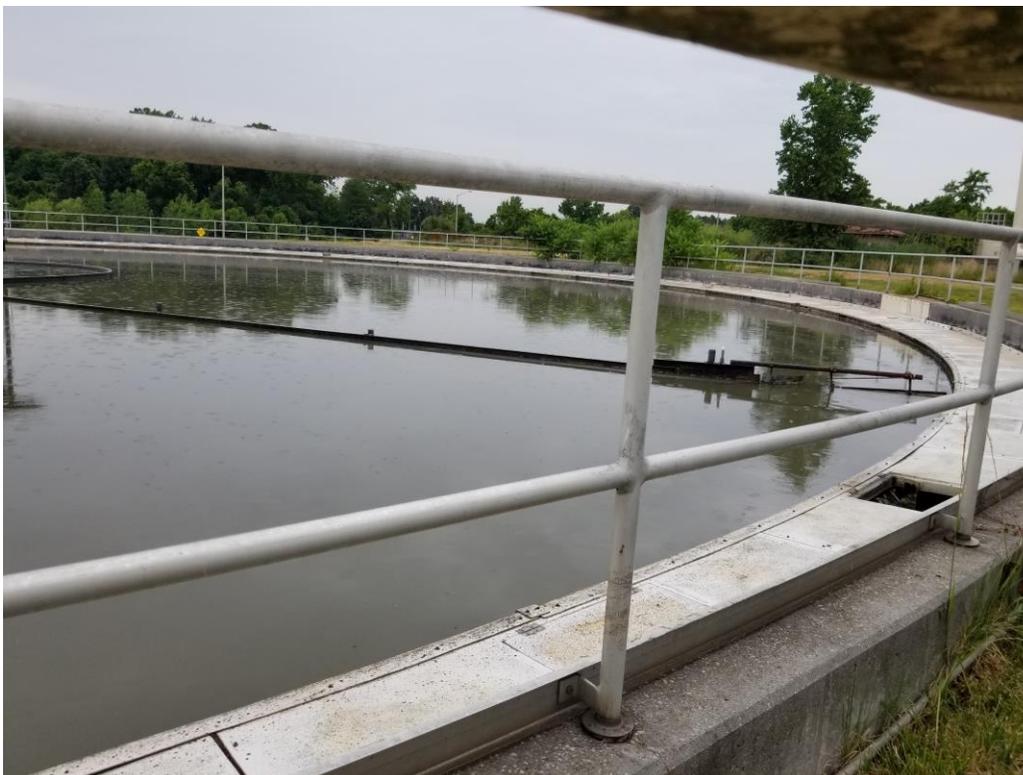
Picture 2: 6/14/23 – The PST #11 skimming arm was observed to be functioning, but should be adjusted as needed to function as designed.

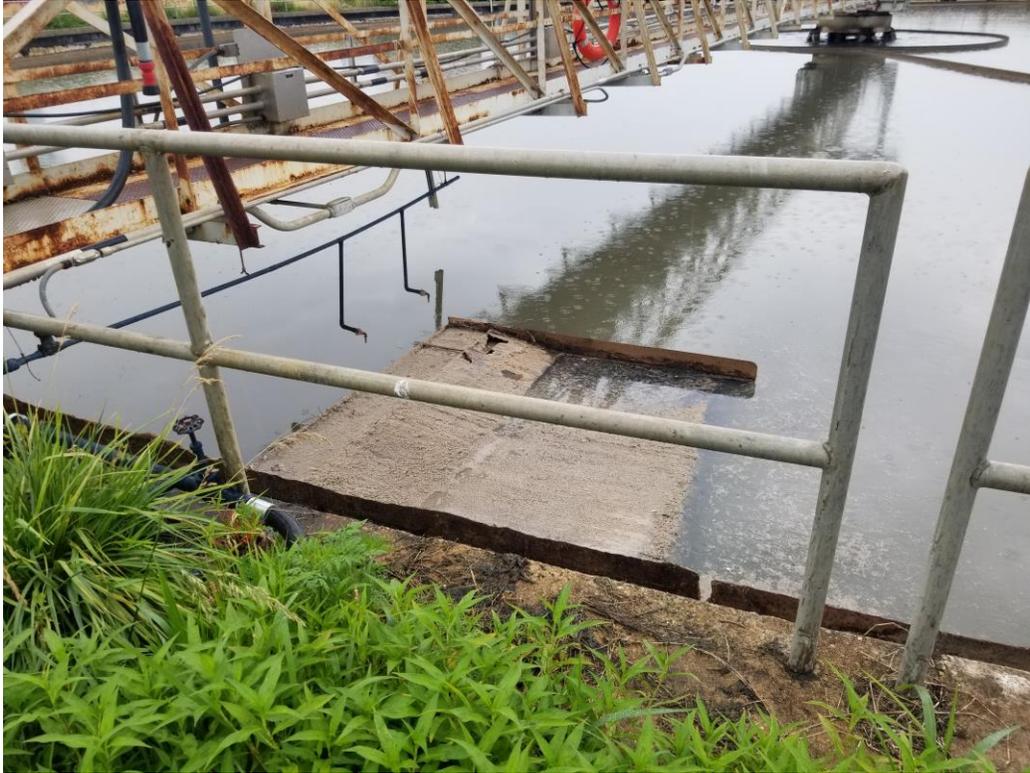
Picture 3: 6/14/23 – The scum trough at PST #1 was observed to be clogged with scum.

4. The scum trough on PST #1 is clogged with scum and requires routine maintenance. This is a violation of General Condition B3 of the NPDES permit.
5. At ASP #2, there is vegetation around one of the mixers at the reactor labeled 8A PASS. This is a violation of General Condition B3 of the NPDES permit.

- D. With respect to item #4 above, the Back River WWTP should maintain the PSTs as required to keep them functioning properly to comply with the requirements under General Condition B3 of the NPDES permit. The scum pit should be pumped out as necessary and the scum trough should be cleaned. Going forward, the scum troughs on the PSTs should be routinely inspected and the scum pits pumped out as necessary to keep the scum trough openings clear.

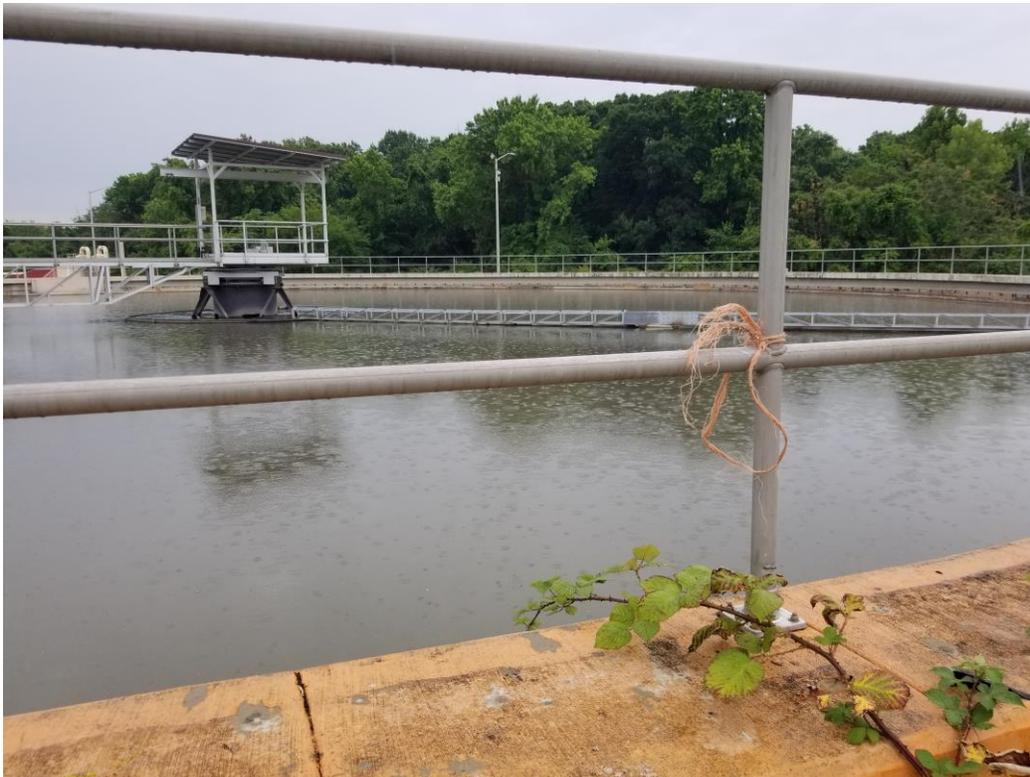
Picture 4: 6/14/23 – The PST #7 skimming arm was observed to be functioning, but should be adjusted as needed to function as designed.

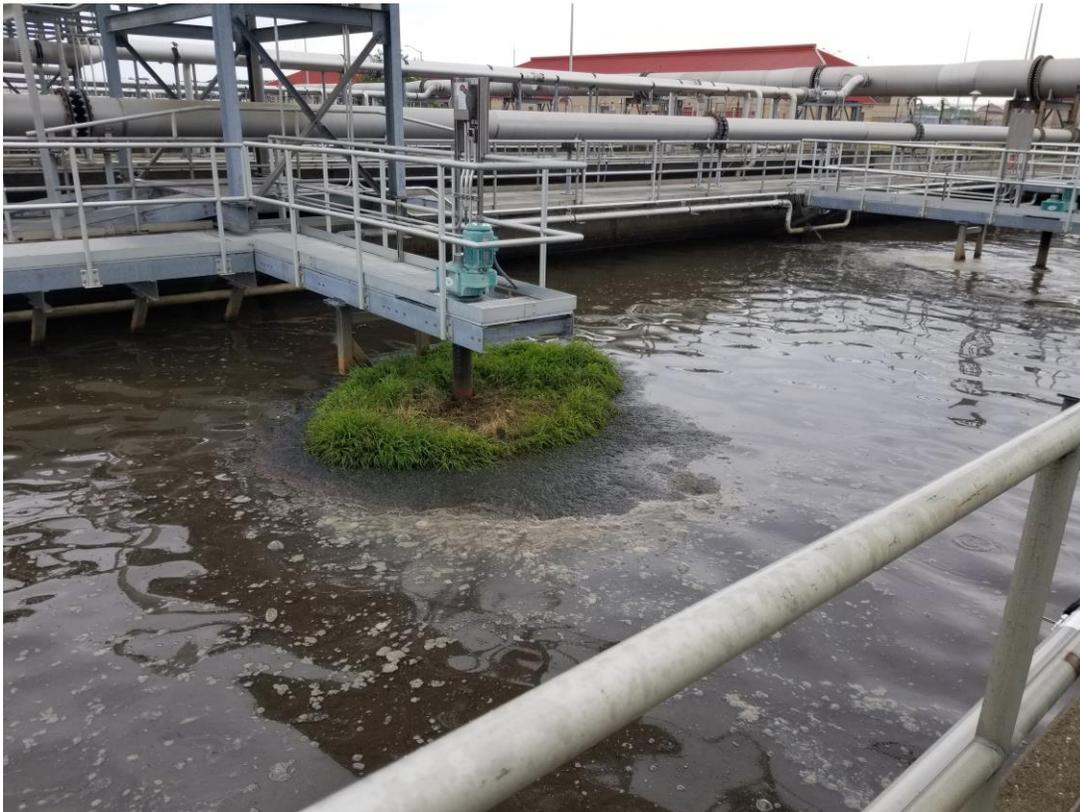
During the next phase of this evaluation, Activated Sludge Plant #2 was observed. At ASP #2, vegetation was observed around one of the mixers at the reactor labeled 8A PASS. According to Timothy Simmons, the contractor Badger is having difficulties getting to the area with vegetation and they are working on another contingency plan to remove the vegetation.

Picture 5: 6/14/23 – At ASP #2, vegetation was observed around one of the mixers at the reactor labeled 8A PASS.

- E. With respect to item #5 above, the vegetation should be removed from the reactor and routine maintenance should be performed to prevent the recurrence of the problem to minimize upsets and discharges of excessive pollutants as required under General Condition B3 a and b of the permit.

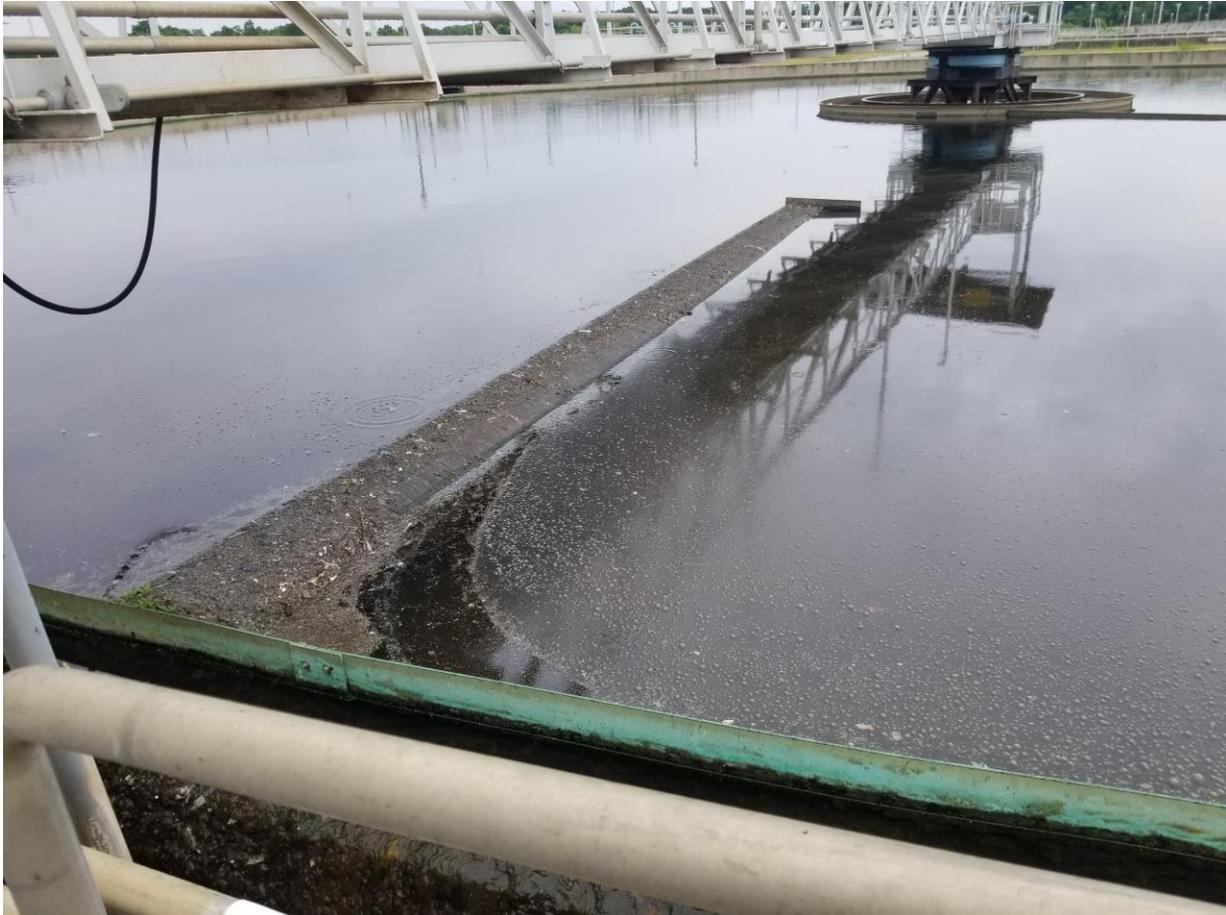
Picture 6: 6/14/23 – The scum trough at secondary clarifier 5A was observed to be clogged with scum.

6. The scum troughs on secondary clarifiers 5A, 7A, 7B, 5B, 6A, and 13B are clogged with scum and require routine maintenance. Secondary clarifier 5B was observed to have solids/trash debris leaving past the weir. The sludge blanket depth in secondary clarifiers 7B and 13B is too high. The skimming arm on secondary clarifier 14B is missing a skimming flap. This is a violation of General Condition B3 of the NPDES permit.

- F. With respect to item #6 above, the Back River WWTP should maintain the secondary clarifiers as required to keep them functioning properly to comply with the requirements under General Condition B3 of the NPDES permit. The scum pits should be pumped out as necessary and the scum troughs should be cleaned. The sludge blanket depth of the secondary clarifiers should be managed to 2 to 4 feet and sludge should be wasted as necessary. The skimming flap for the skimming arm on secondary clarifier 14B should be installed. Going forward, the scum troughs on the secondary clarifiers should be routinely inspected and the scum pits pumped out as necessary to keep the scum trough openings clear.

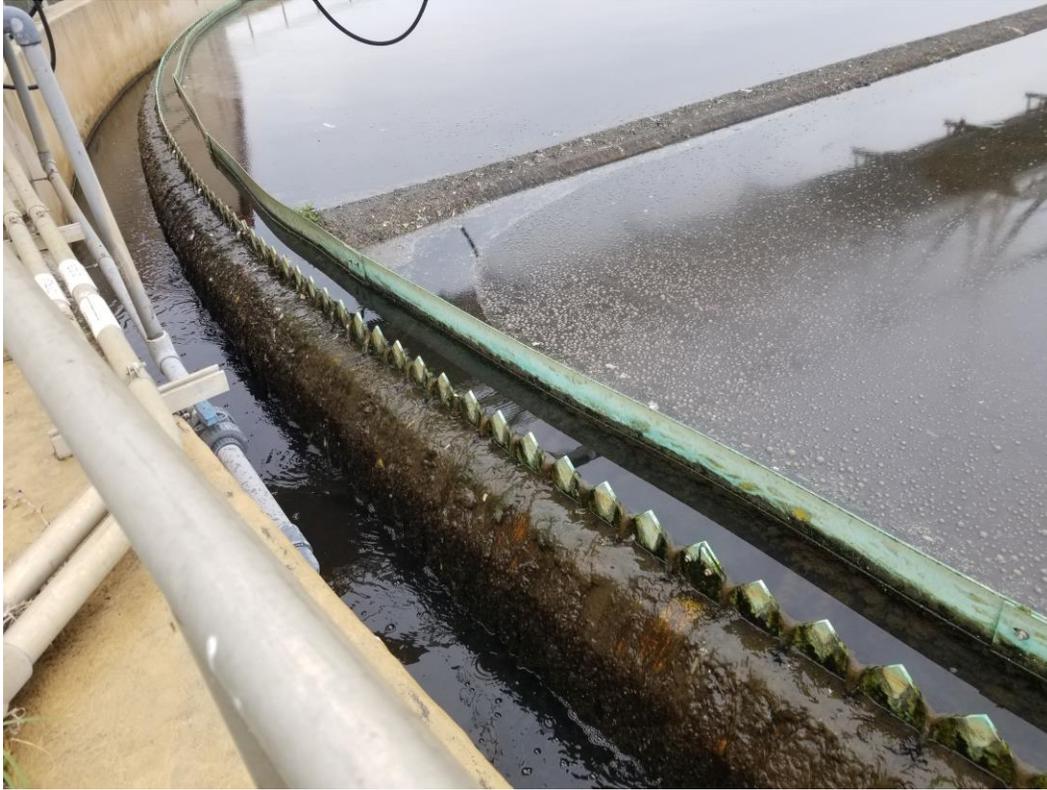
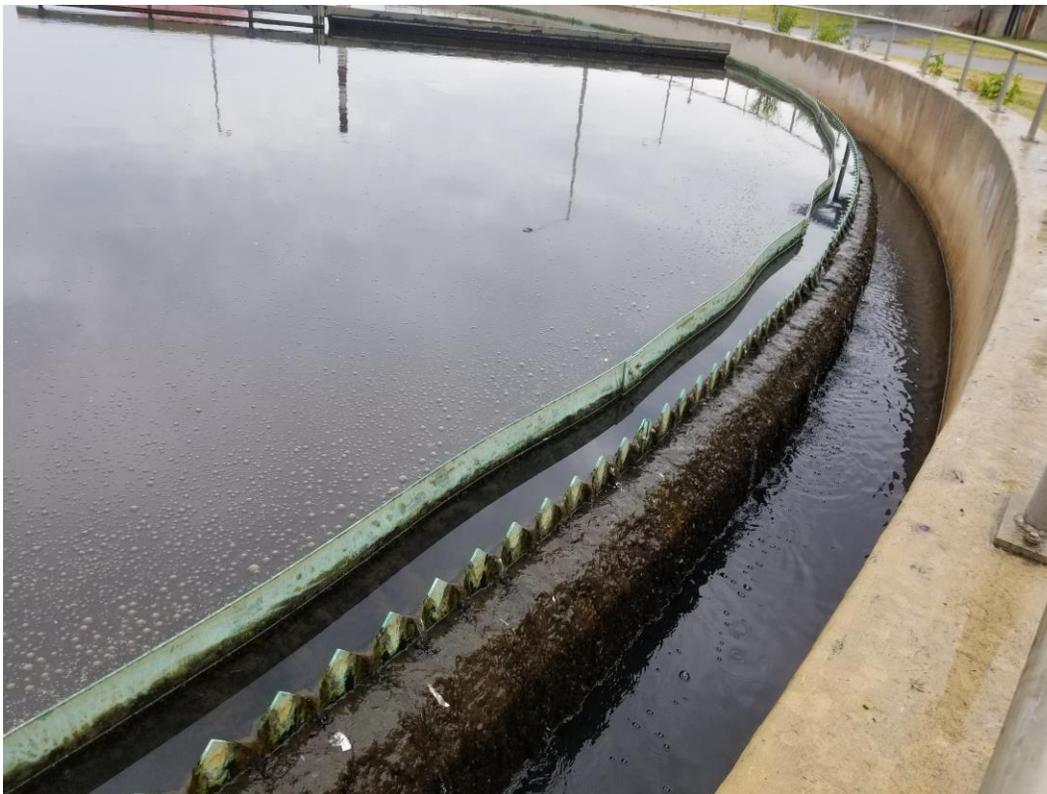
Picture 7: 6/14/23 – Secondary clarifier 5A was observed to have algae/vegetation growth along/past the weir.

Picture 8: 6/14/23 – Secondary clarifier 5A was observed to have algae/vegetation growth along/past the weir.

- a. Of the 7 secondary clarifiers observed today 6/14/23, 4 were observed to have algae/vegetation growth along/past the weir and the other 3 were observed to have varying grass or other vegetation growth. Secondary clarifiers 5A, 7A, 7B, and 5B were observed to have algae/vegetation growth along/past the weir. Secondary clarifier 6A was observed to have grass/vegetation growth along the weir. Secondary clarifier 13B was observed to have grass/vegetation growth near the center of the clarifier and along the weir. Secondary clarifier 14B was observed to have grass/vegetation

- G. With respect to item #7 above, all vegetation should be removed from the secondary clarifiers and routine maintenance should be performed to prevent the recurrence of the problem to minimize upsets and discharges of excessive pollutants as required under General Condition B3 a and b of the permit. The Back River WWTP should continue to provide 30-day updates on the progress in achieving the goal of removing all vegetation from the secondary clarifiers and reactors.

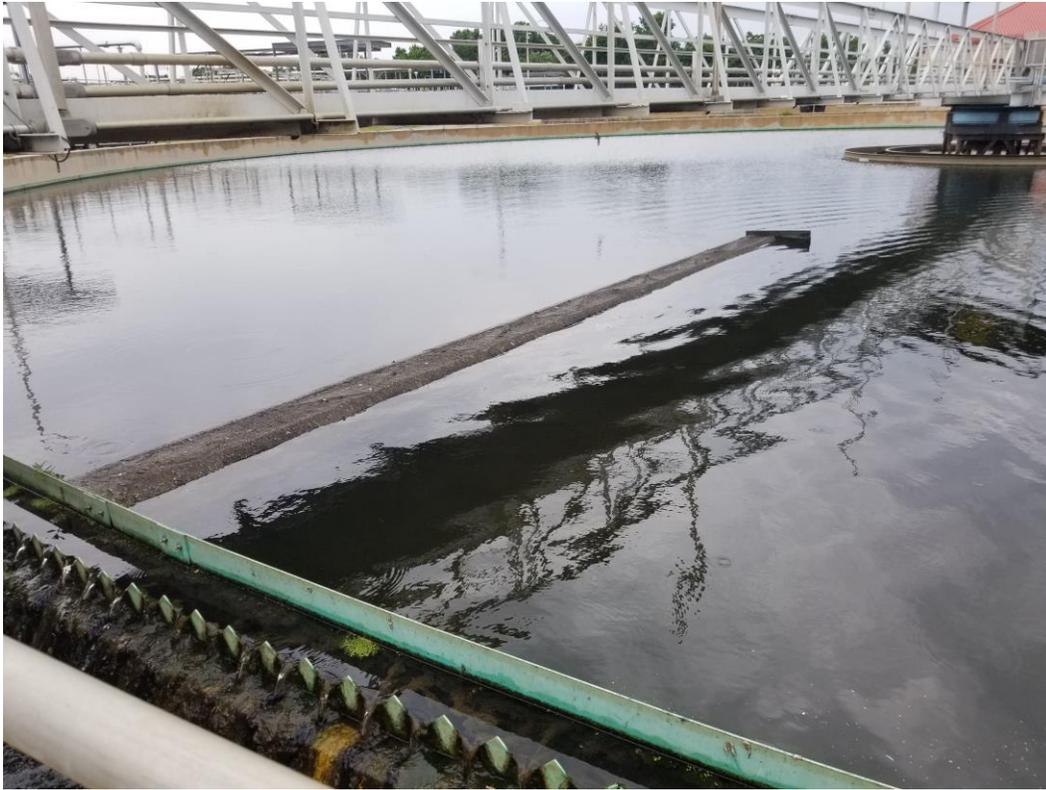
Picture 9: 6/14/23 – The scum trough at secondary clarifier 7A was observed to be clogged with scum.

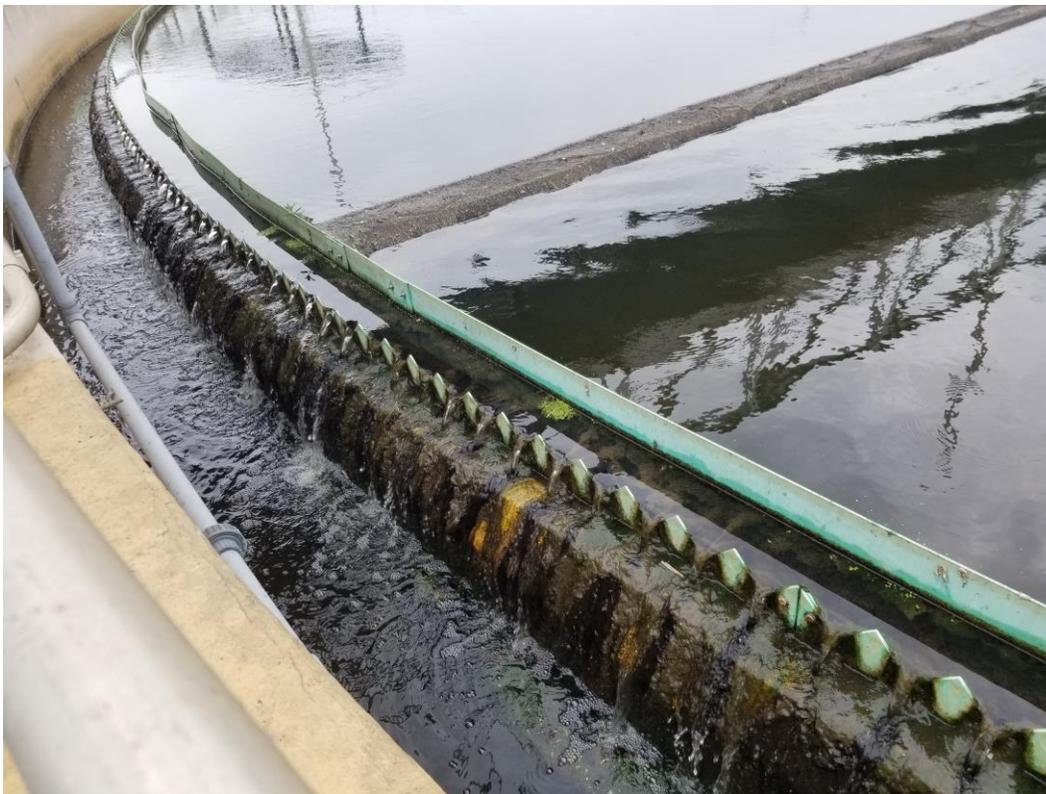
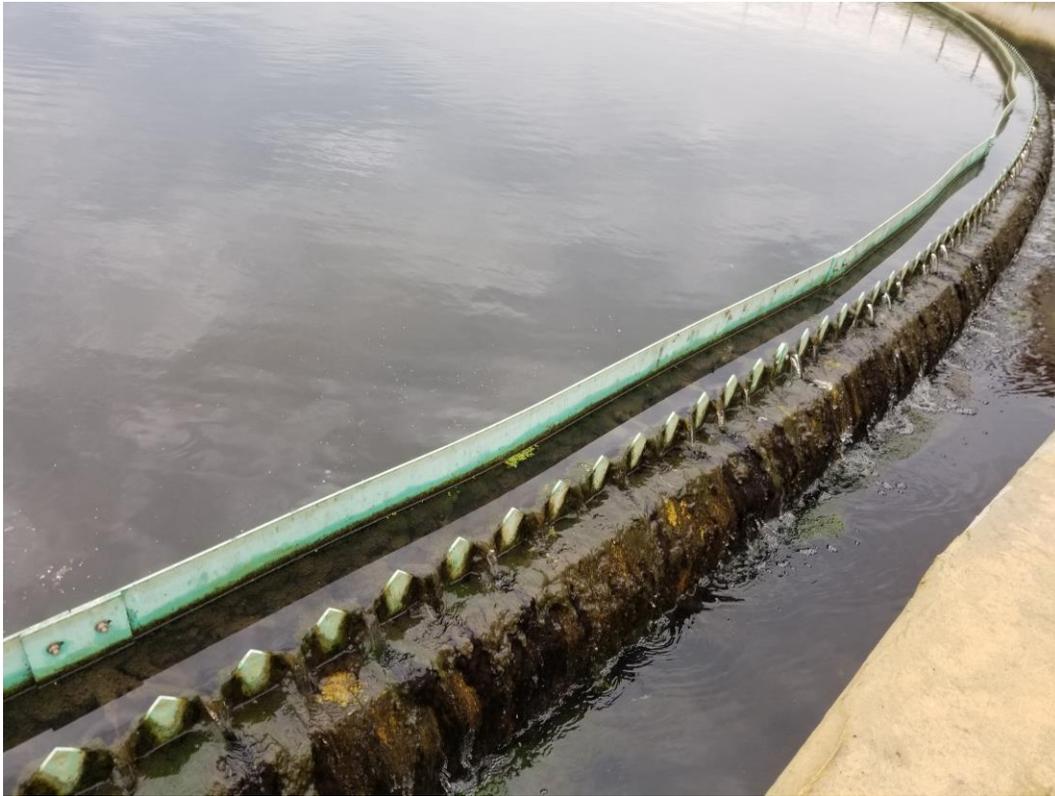
Picture 10: 6/14/23 – Secondary clarifier 7A was observed to have algae/vegetation growth along/past the weir.

Picture 11: 6/14/23 – Secondary clarifier 7A was observed to have algae/vegetation growth along/past the weir.

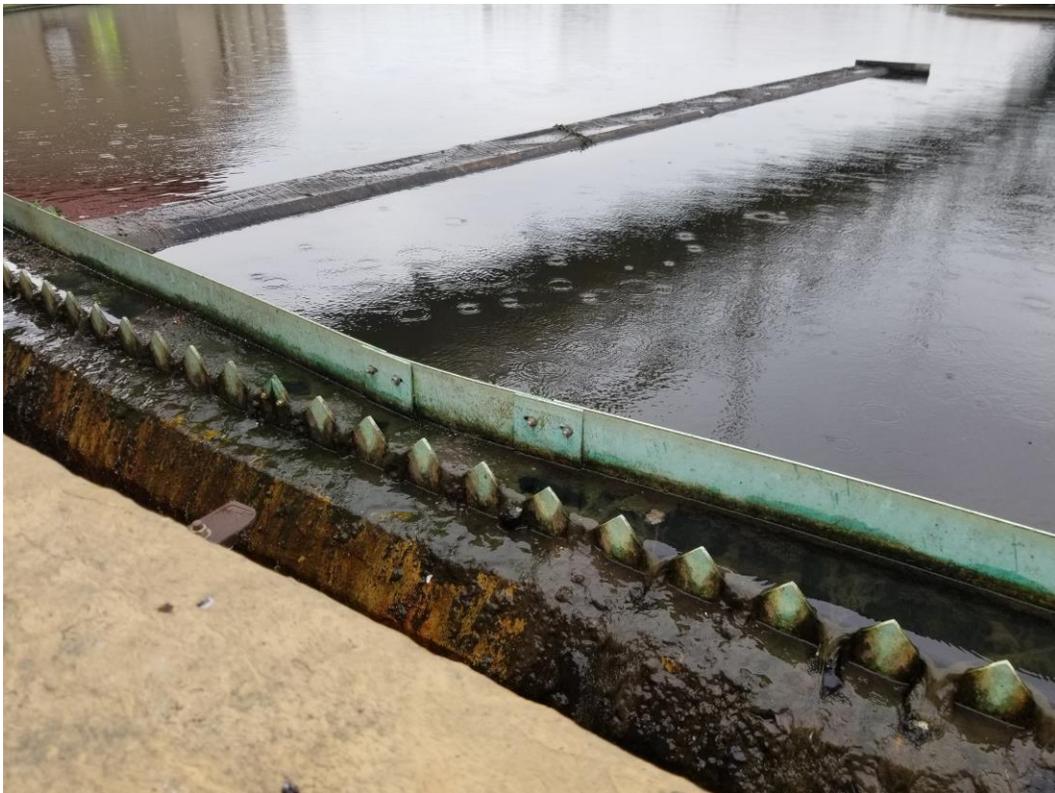
Picture 12: 6/14/23 – The scum trough at secondary clarifier 7B was observed to be clogged with scum.

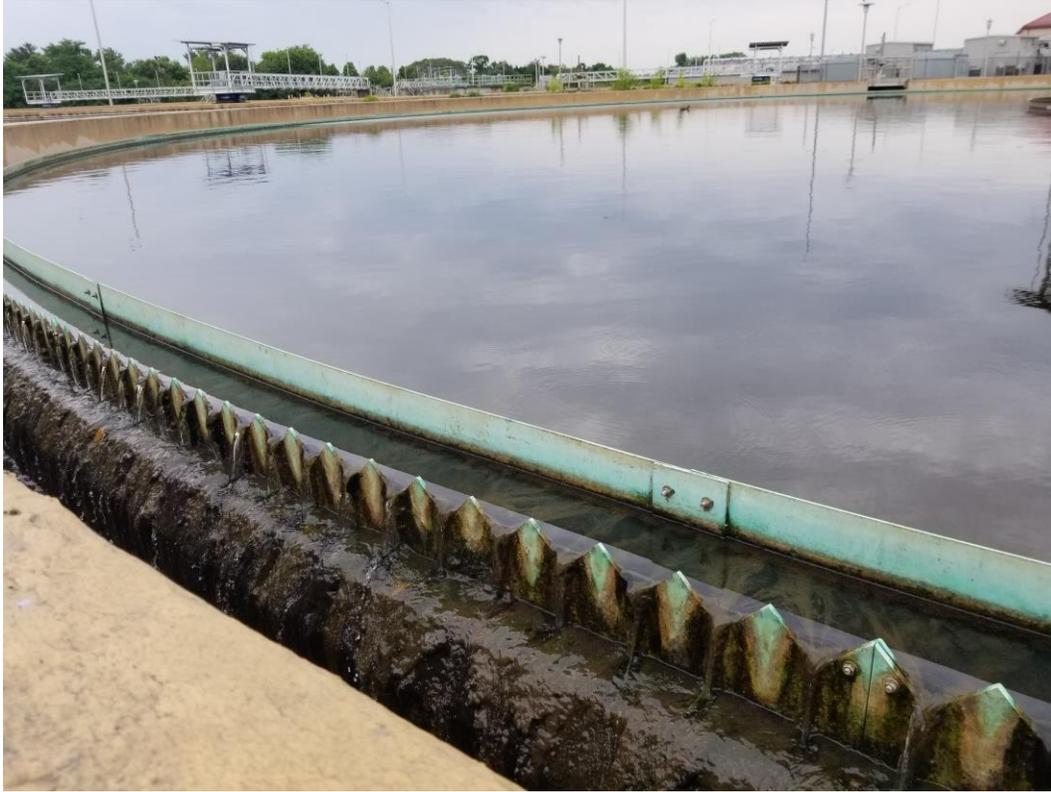
Picture 13: 6/14/23 – Secondary clarifier 7B was observed to have algae/vegetation growth along/past the weir.

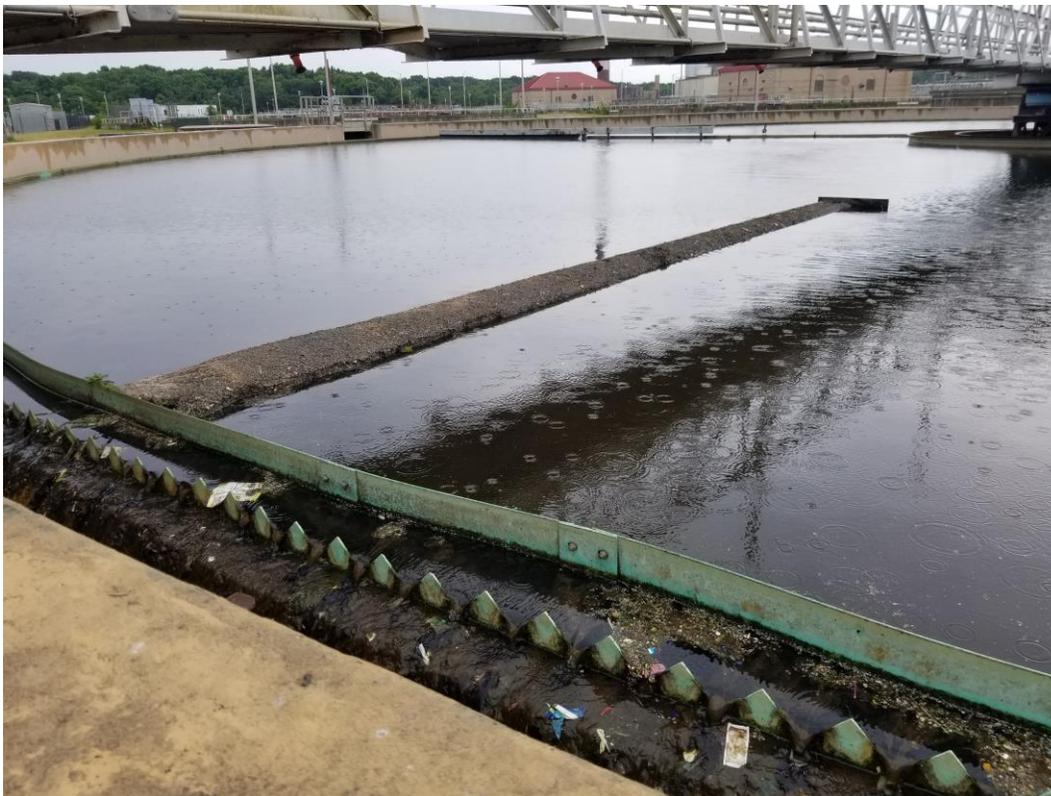
Picture 14: 6/14/23 – The scum trough at secondary clarifier 5B was observed to be clogged with scum.

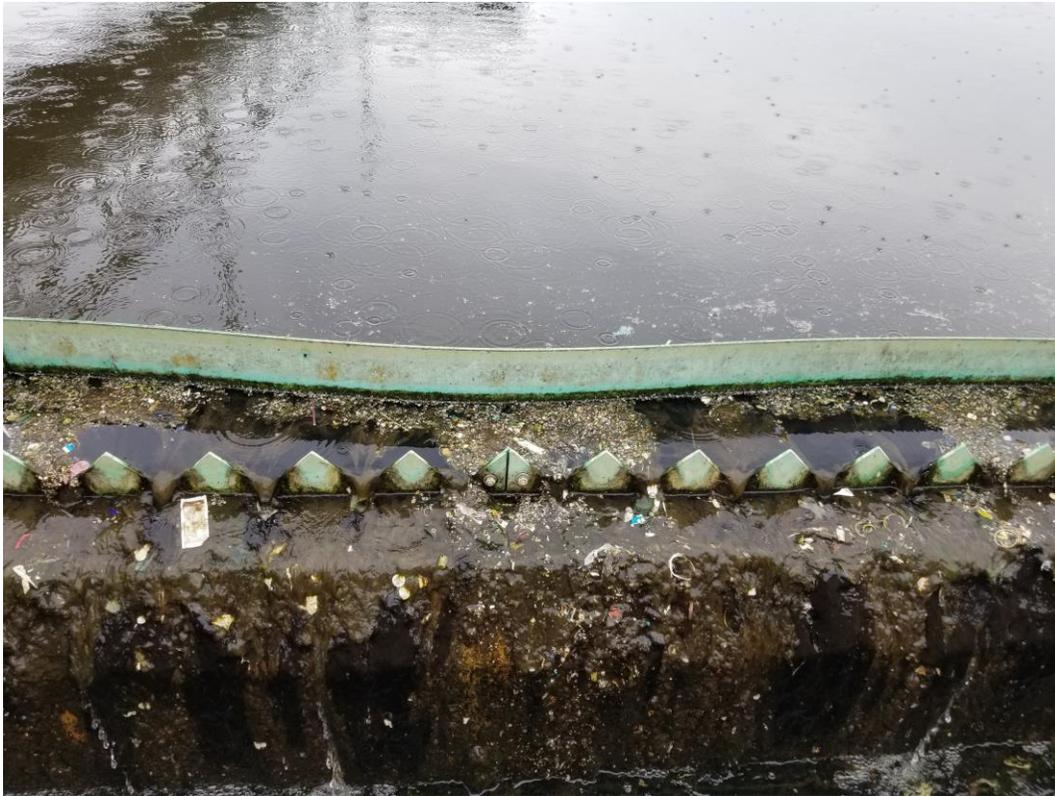
Picture 15: 6/14/23 – Secondary clarifier 5B was observed to have solids/trash debris leaving past the weir.

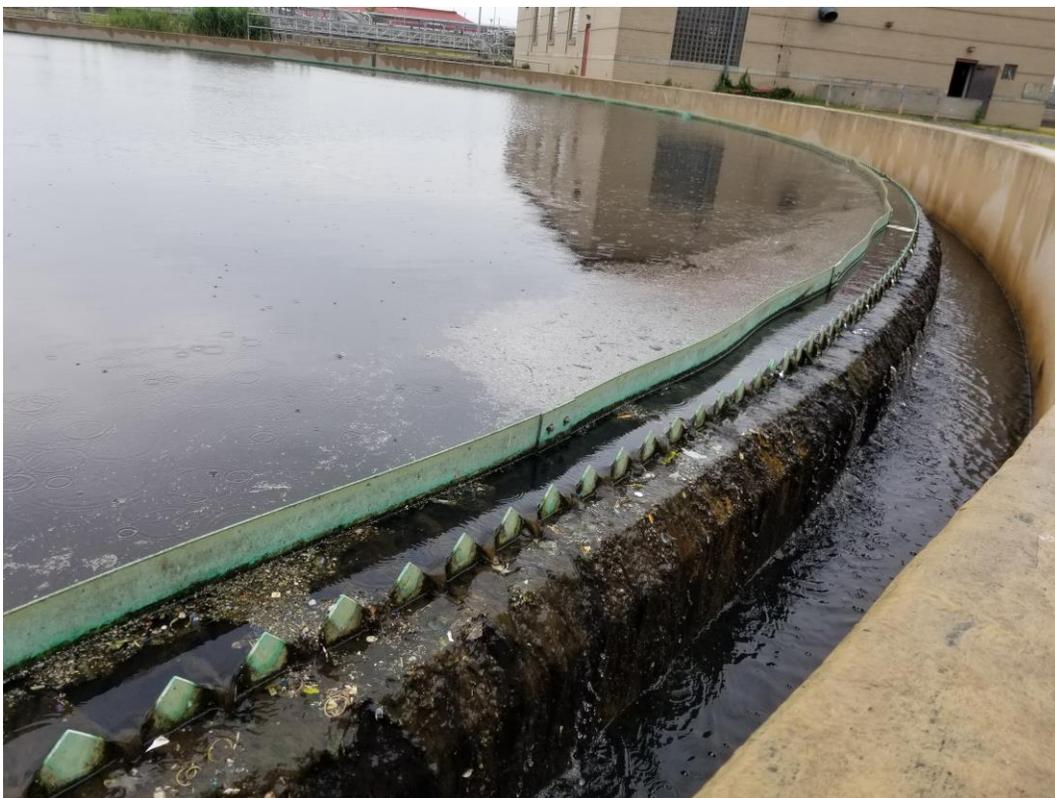
Picture 16: 6/14/23 – Secondary clarifier 5B was observed to have algae/vegetation growth along/past the weir.

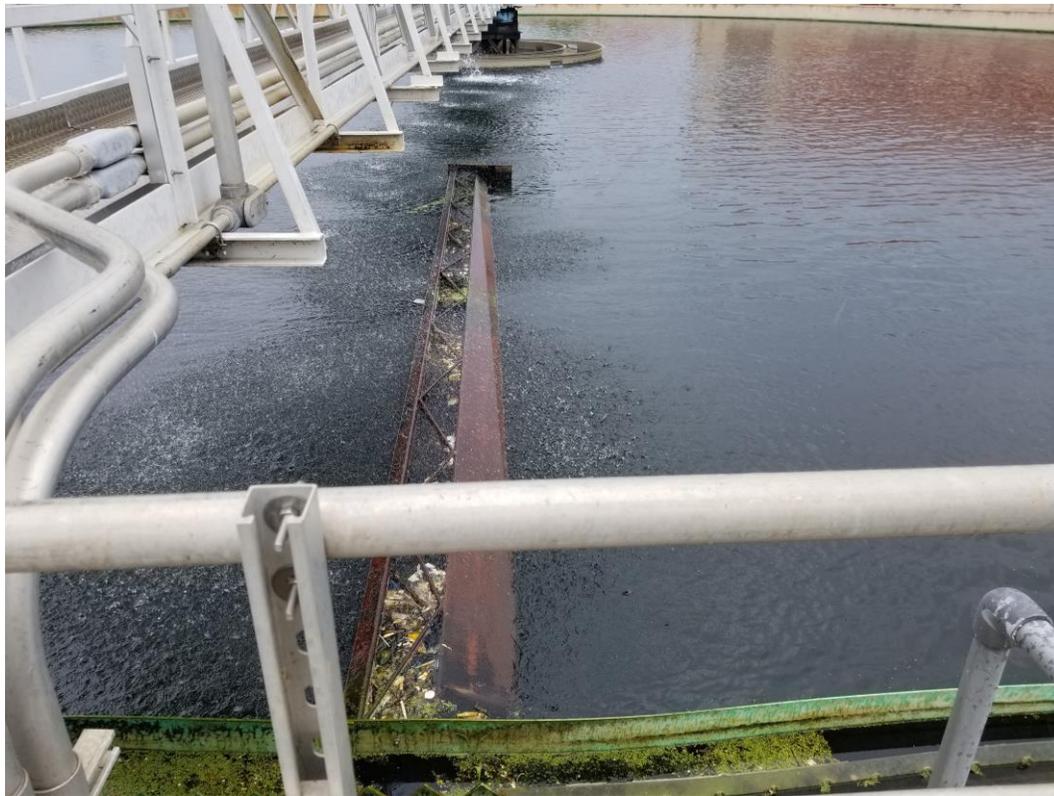
Picture 17: 6/14/23 – The scum trough at secondary clarifier 6A was observed to be clogged with scum.

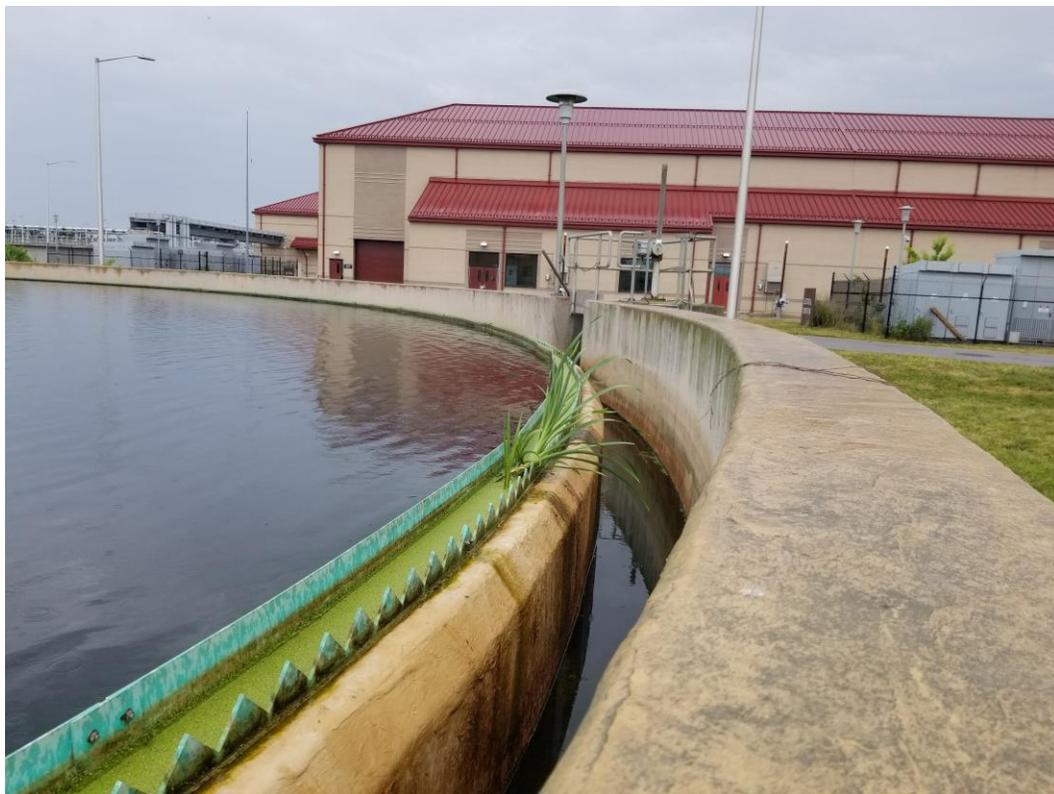
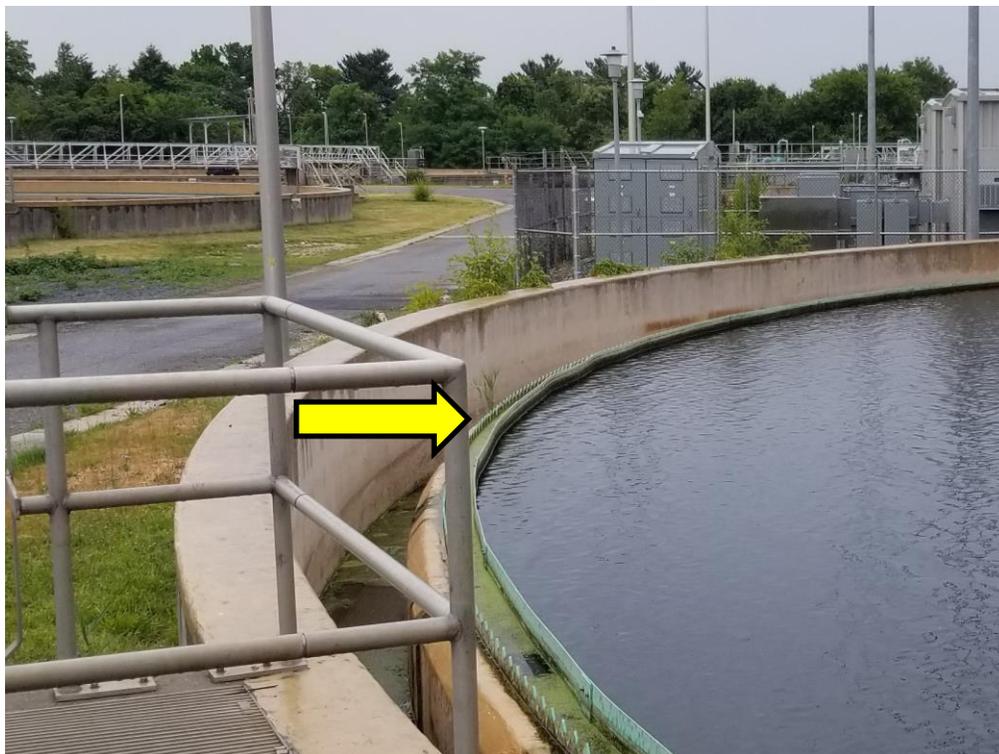
Picture 18: 6/14/23 – Secondary clarifier 6A was observed to have grass/vegetation growth along the weir.

Picture 19: 6/14/23 – Secondary clarifier 6A was observed to have grass/vegetation growth along the weir (yellow arrow pointing to this).

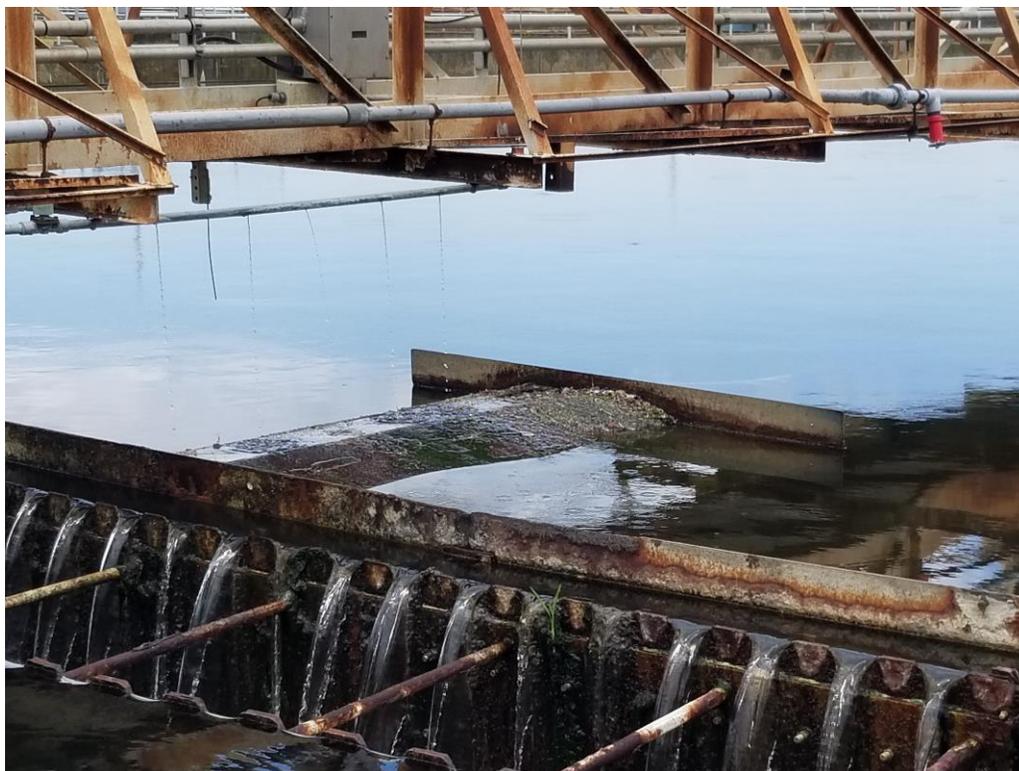
Picture 20: 6/14/23 – The scum trough at secondary clarifier 13B was observed to be clogged with scum.

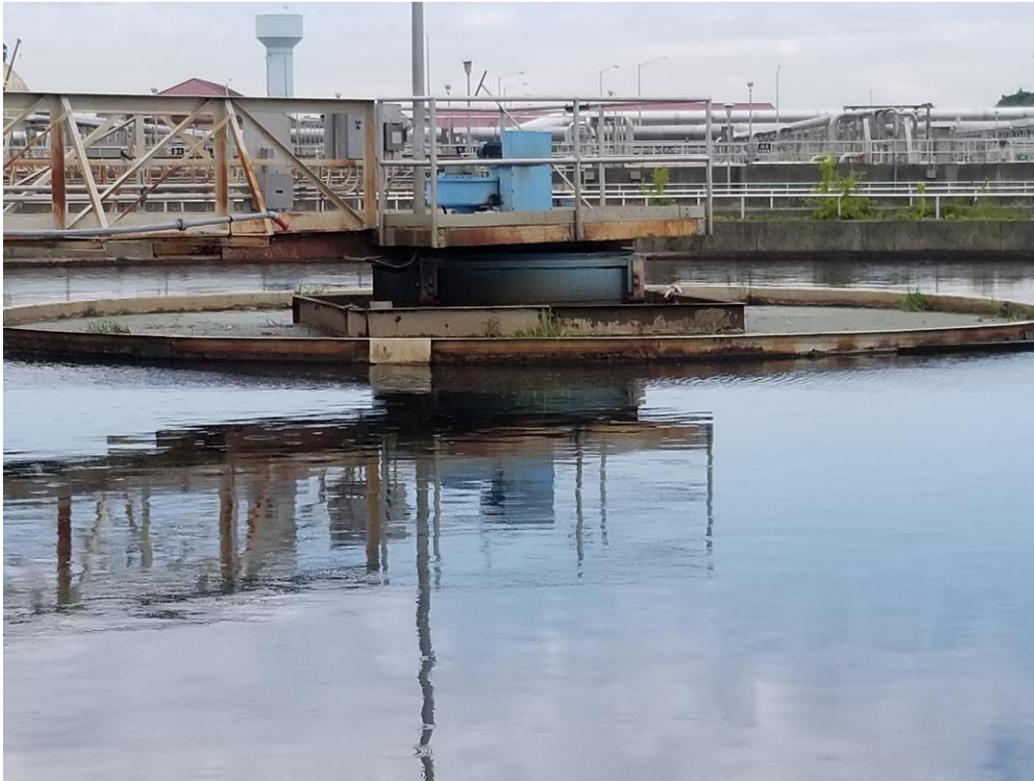
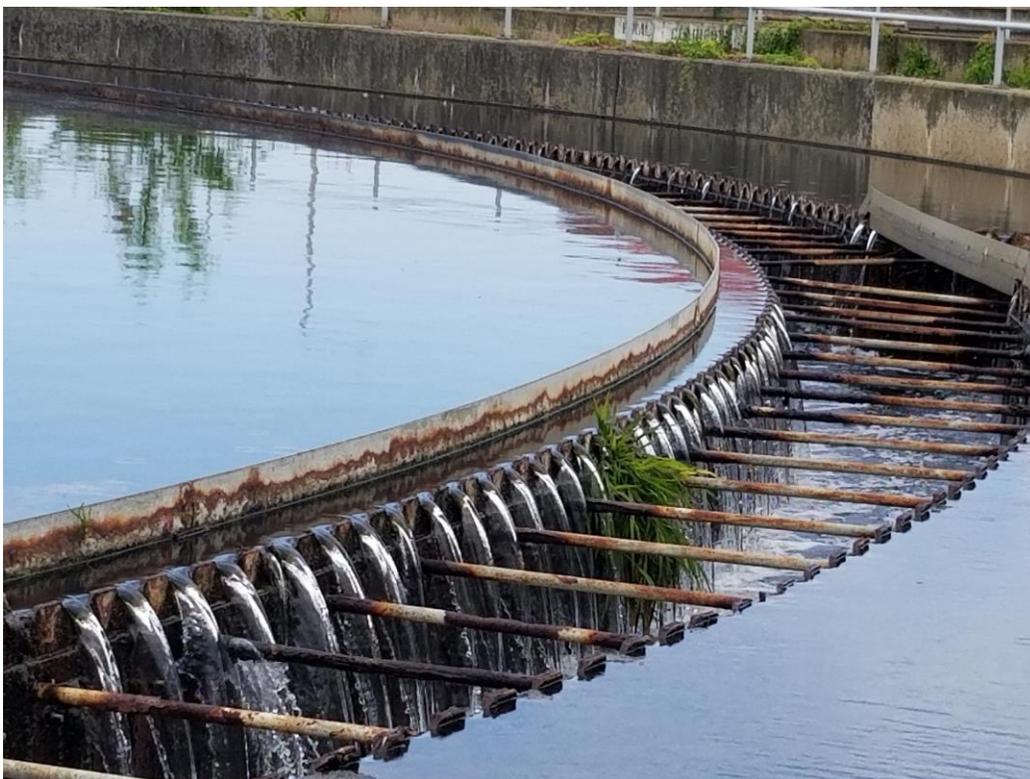
Picture 21: 6/14/23 – Secondary clarifier 13B was observed to have grass/vegetation growth near the center of the clarifier.

Picture 22: 6/14/23 – Secondary clarifier 13B was observed to have grass/vegetation growth along the weir.

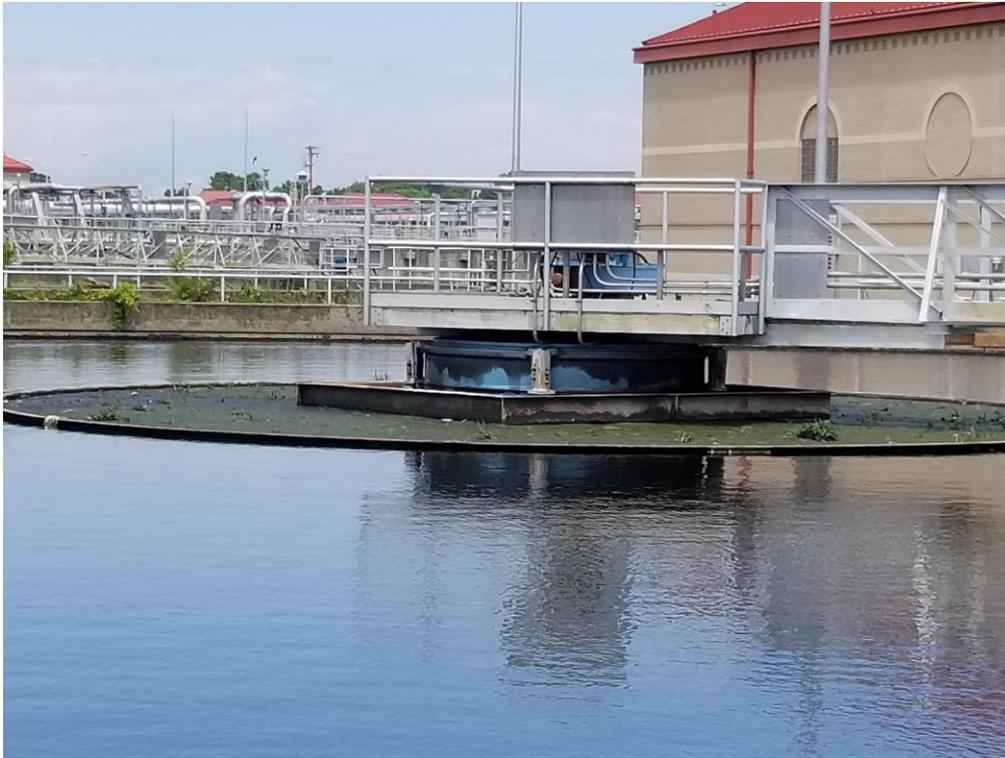
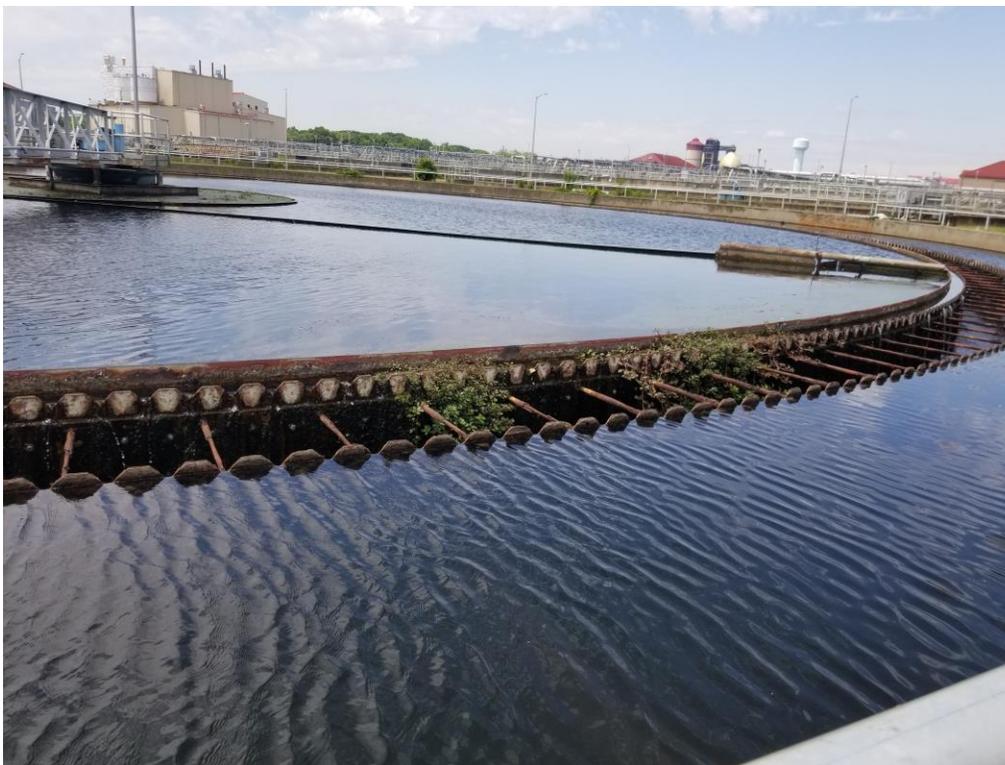
Picture 23: 6/14/23 – Secondary clarifier 14B was observed to have grass/vegetation growth near the center of the clarifier.

Picture 24: 6/14/23 – Secondary clarifier 14B was observed to have grass/vegetation growth along the weir.
