Maryland Department of Environment
Water and Science Administration
Compliance Program
1800 Washington Blvd, Suite 420
Baltimore, MD 21230-1719
410- 537-3510, 1-800-633-6101

Site Name: Back River WWTP
Facility Address: 8201 Eastern Ave, Baltimore, MD 21224
County: Baltimore County

Start Date/Time: June 14, 2023 08:30 AM
End Date /Time: June 14, 2023 02:30 PM

Inspection Reason: Follow-up (Non-Compliance)

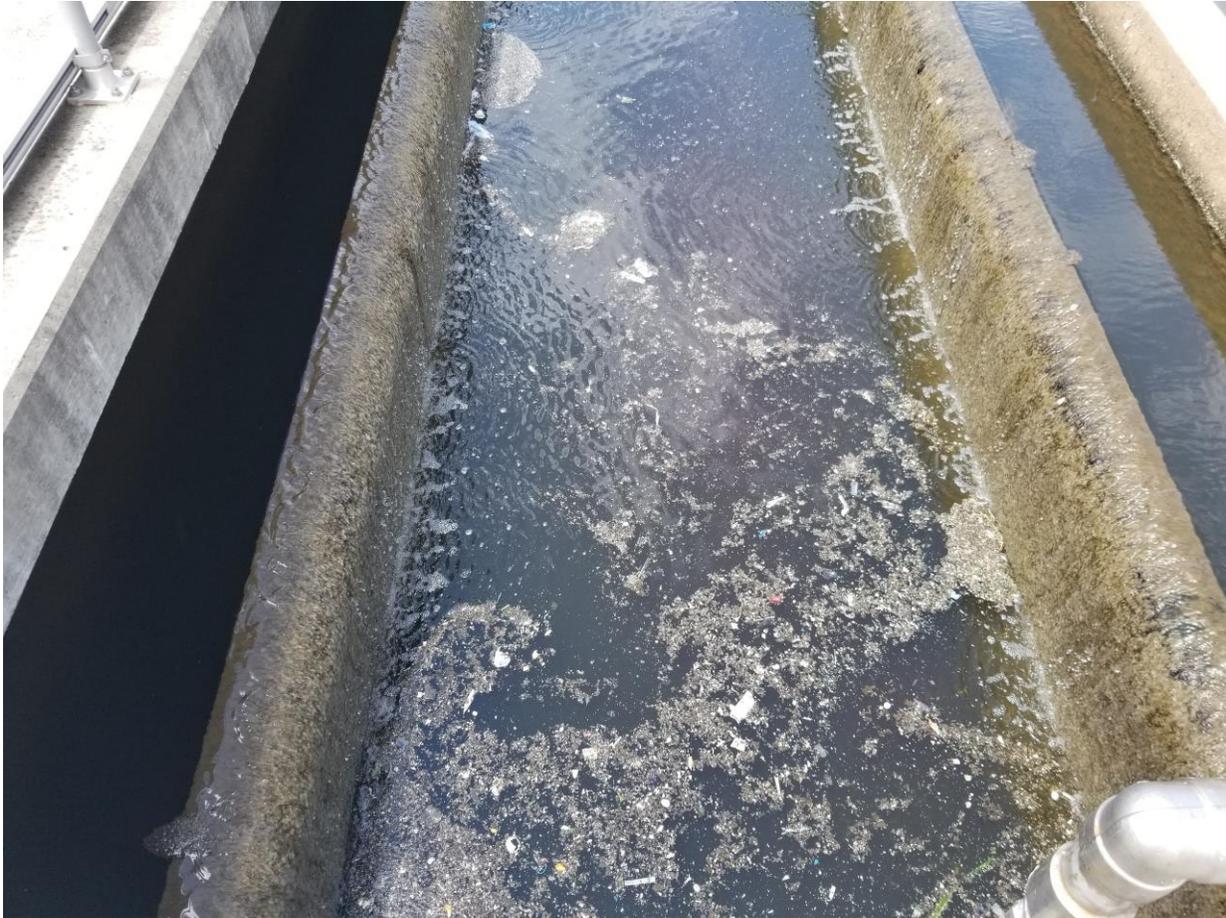
During an inspection of the filters in quads #1 and #2, there were still floating solids observed in the filter at the end of the quad (also observed during inspection on 1/26/23, 2/24/23, and 4/26/23). On 6/14/23, Michael Hallmen provided (via email) to MDE the TSS data for the DNF influent and effluent from 4/1/23 to 6/12/23. The DNF effluent data showed TSS greater than 10 mg/L on 4/28/23, 4/29/23, 5/3/23, and 5/19/23.

Picture 25: 6/14/23 – Solids and trash observed to be floating on water surface in the DNFs.

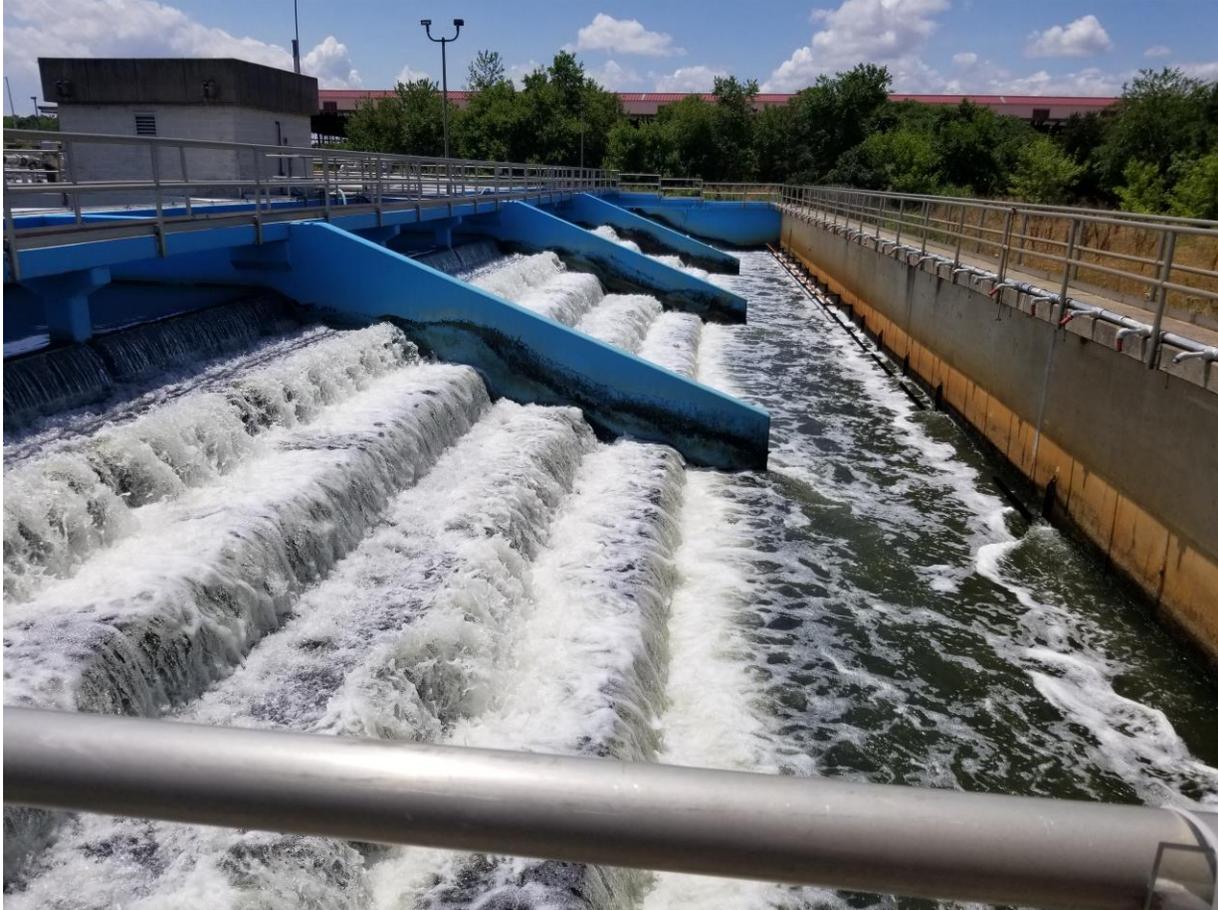
Next, I inspected the final effluent at the step aeration system. During an evaluation of the final effluent, I observed that the effluent was clear with no visible particulates.

Picture 26: 6/14/23 – Final Effluent at the step aeration system.

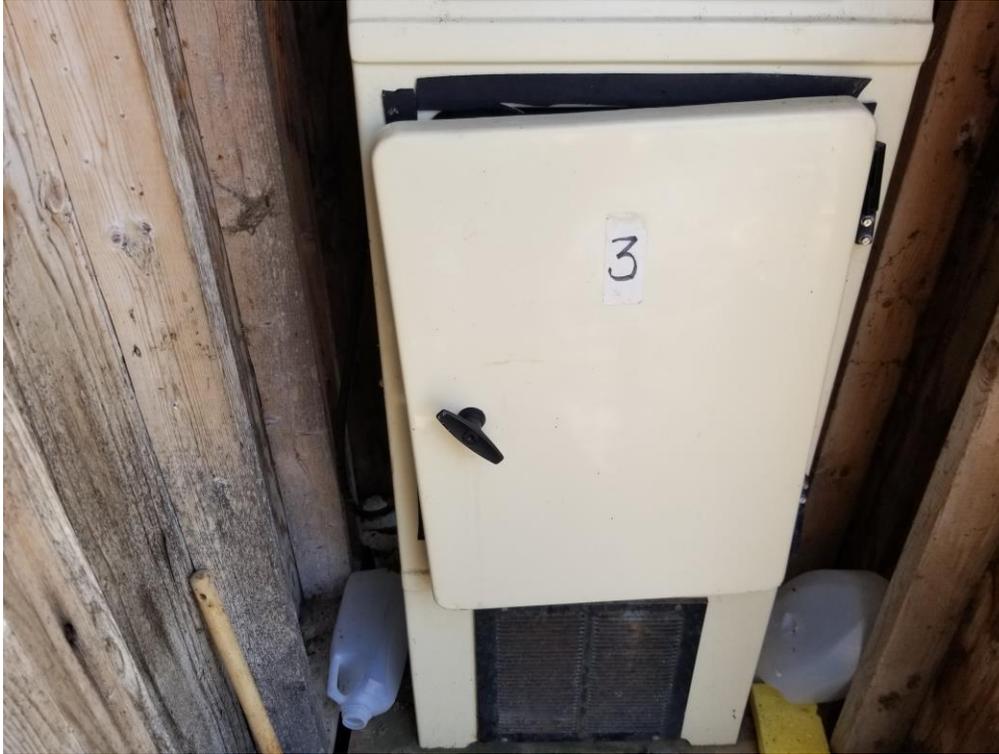
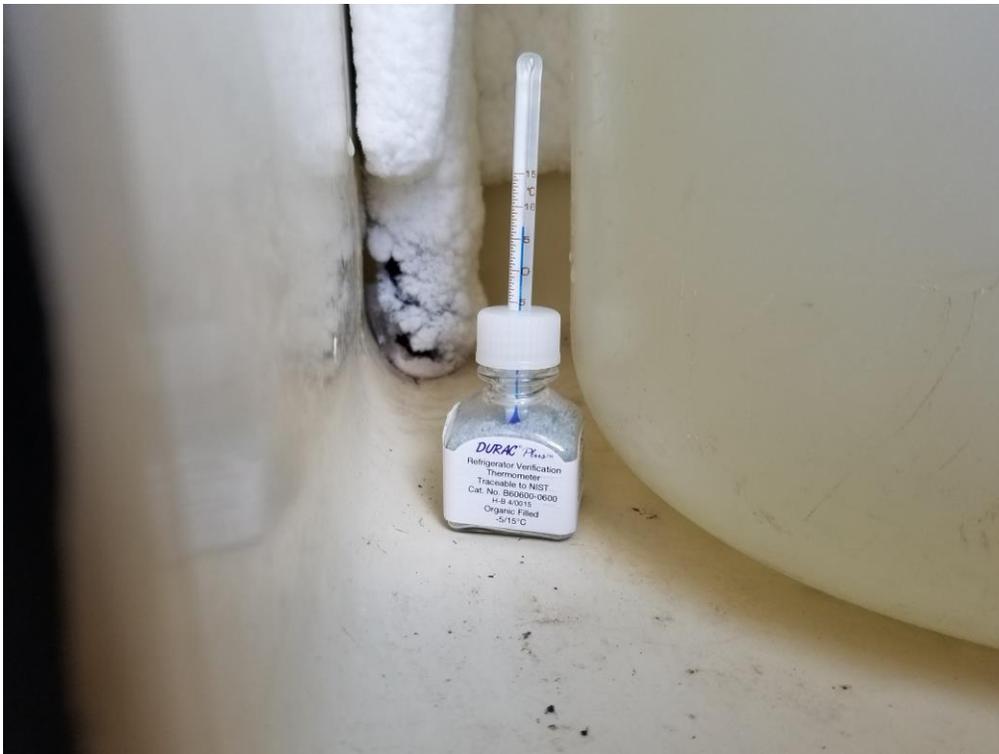
Picture 27: 6/14/23 – The refrigerator door of the automatic sampler (at monitoring point for Outfall 002) was observed to be broken and not properly sealed when shut.

Picture 28: 6/14/23 – At the automatic sampler refrigerator (at monitoring point for Outfall 002), the refrigerator verification thermometer was observed to have a temperature reading of 7 degrees Celsius.

8. At the automatic sampler refrigerator (at the monitoring point for Outfall 002), the refrigerator door of the automatic sampler was observed to be broken and not properly sealed when shut. At the time of inspection today 6/14/23, the refrigerator verification thermometer was observed to have a temperature reading of 7 degrees Celsius, which exceeds the maximum 6 degrees Celsius holding temperature for samples. This is a violation of General Condition A3 of the NPDES permit.

- H. With respect to item #8 above, the Back River WWTP should ensure that analytical and sampling methods conform to test procedures for the analysis of pollutants as identified in 40 CFR Part 136 - "Guidelines Establishing Test Procedures for the Analysis of Pollutants." The automatic sampler refrigerator should be repaired as needed to ensure the holding temperature for samples complies with the requirements under General Condition A3 of the NPDES Permit.
