**WELLHEAD AREA SURVEY
BALTIMORE PIKE VOLUNTEER FIRE COMPANY
ACHD SITE NO. 44
Cumberland, Allegany County, Maryland**

ALWI Project No. AL7N001

NONCOMMUNITY WATER SUPPLY SANITARY SURVEY

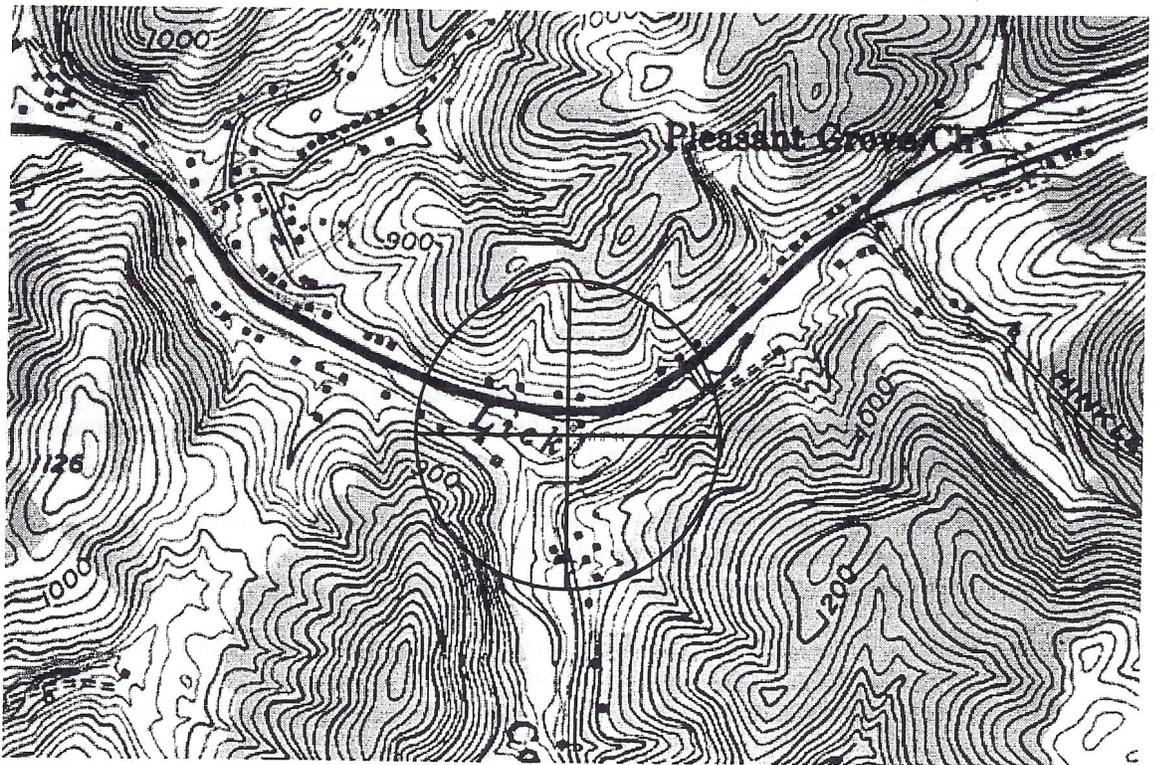
24. Well Location Diagram (1 in. = 1250 ft.) with Approximate Distances from Potential Contaminant Sources (i.e. septic, sewer lines, structures, petroleum storage, surface water bodies, etc.):

ALWI delineated an area of potential concern surrounding this site's well using generalized criteria developed by MDE for non-community supplies, as modified by ALWI (with ACHD consent) based on the specific topographic setting of the site. The resultant delineation is shown on the "Water Plant Information" survey form (Appendix B). ALWI used a fixed radius of 1,000 feet around the well, which creates an area of approximately 72 acres. Within an assumed 600 gallons per day per acre (gpd/ac) of annualized groundwater recharge (Slaughter and Darling, 1962, Table 37), slightly more than 43,000 gallons per day exists within the aquifer beneath this surveyed area. In actuality, the modest demand of this well is much smaller than the total available in the surveyed area, lending a high degree of conservatism to this analysis.

The proximity of the well to Elk Lick Run places it at "high risk" for surface water influence as defined in the MDE guidance document. This risk would be better quantified with better information on subsurface borehole conditions (e.g., depth of casing) and the potential for variance in surface water indicator parameters (raw water bacteria; temperature and turbidity) with differing precipitation regimes. Ultimate decisions regarding possible filtration retrofits or bottled water conversion are appropriately driven by economic considerations (the capital and operational costs of domestic-scale filtration vs. the daily consumption of water).
