**WELLHEAD SURVEY AREA  
MAPLESHADE SPORTSMEN'S CLUB  
ACHD SITE NO. 11  
Dawson, Allegany County, Maryland**

**ALWI Project No. AL7N001**

# NONCOMMUNITY WATER SUPPLY SANITARY SURVEY

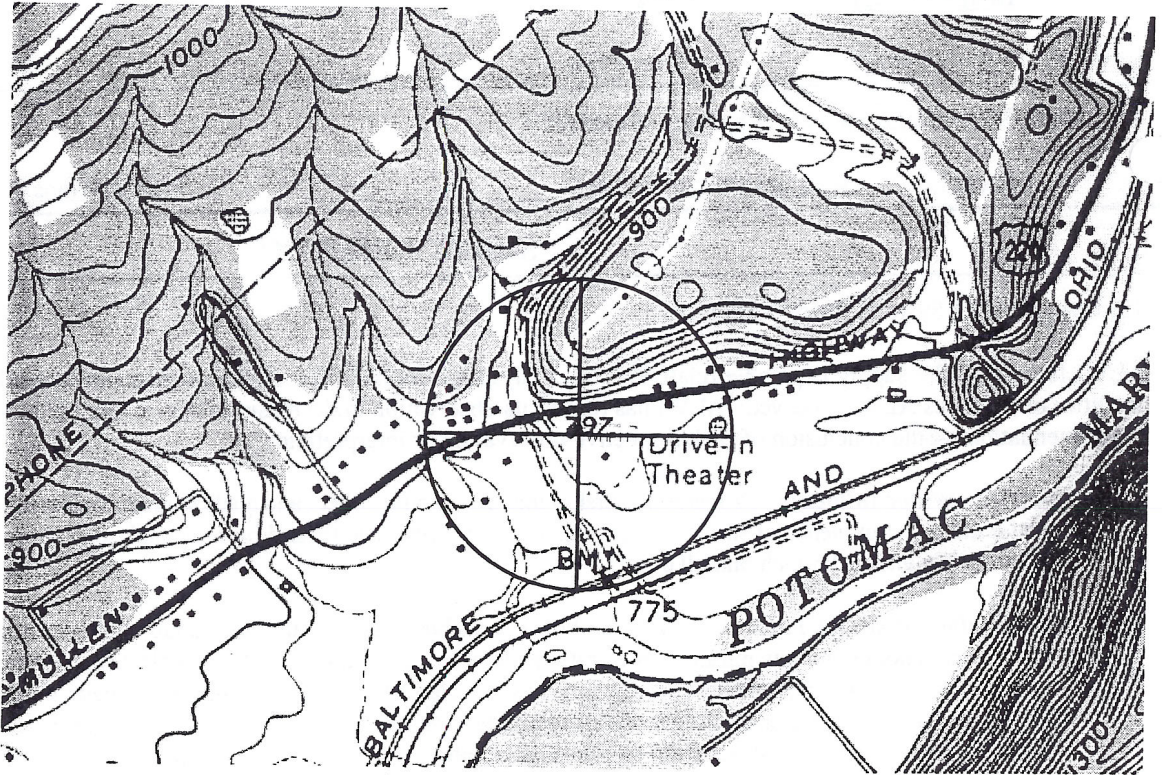
24. Well Location Diagram (1 in. = 1250 ft.) with Approximate Distances from Potential Contaminant Sources (i.e. septic, sewer lines, structures, petroleum storage, surface water bodies, etc.):

ALWI observed several potential contamination sources in the delineated area. ALWI identified the following potential sources of contamination within the surveyed area: the proximity of the septic system, parking and highway de-icing practices, and the location of the well in a floodplain. ALWI performed a site reconnaissance and conducted limited personal interviews to identify and describe these potential contaminant hazards.

The proximity of the well to the nearby stream and the Potomac River places it at "high risk" for surface water influence as defined in the MDE guidance document. This risk would be better quantified with better information on subsurface borehole conditions (e.g., depth of casing) and the potential for variance in surface water indicator parameters (raw water bacteria; temperature and turbidity) with differing precipitation regimes. Ultimate decisions regarding possible filtration retrofits are appropriately driven by economic considerations (the capital and operational costs of domestic-scale filtration vs. the daily consumption of water).
