**MARYLAND DEPARTMENT OF THE ENVIRONMENT
WATER and SCIENCE ADMINISTRATION**

Bermed Infiltration Pond Study

November 2022

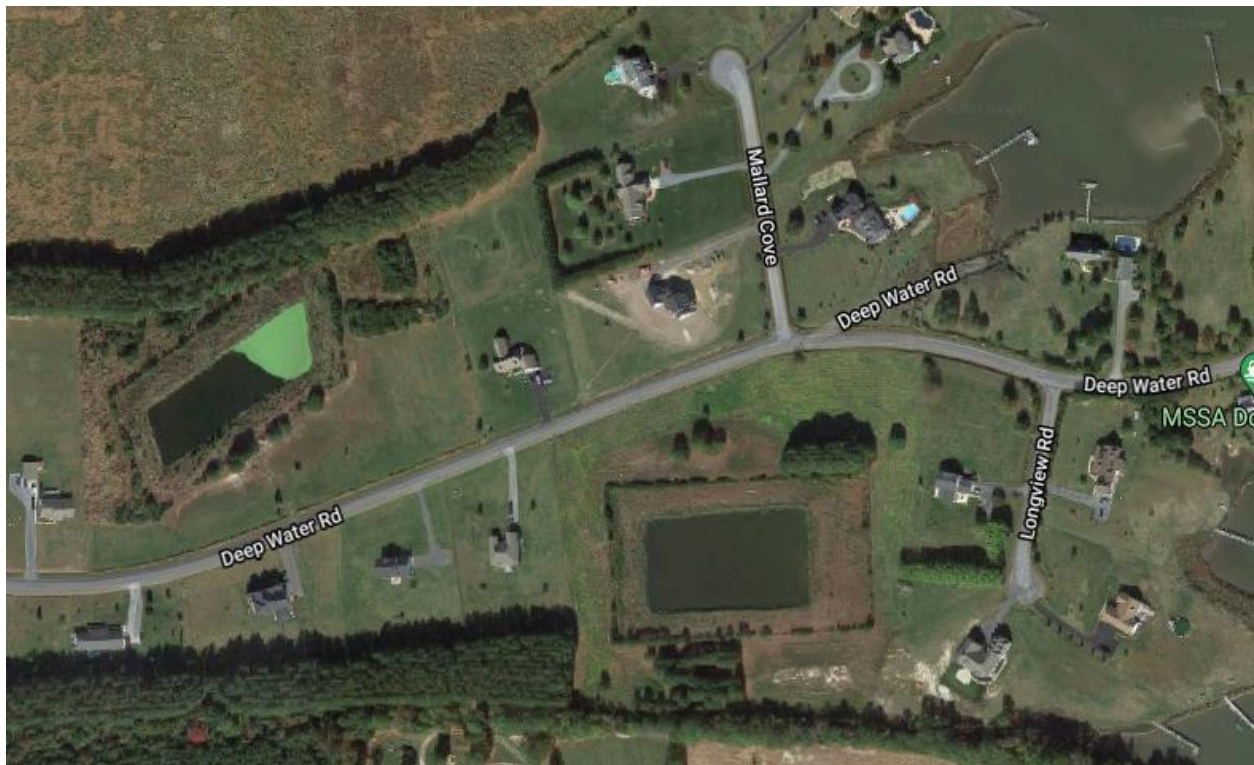
Aerial view of Deep Water 1 and 2 BIPs (left and bottom) near Little Choptank River (upper and lower right). Note proximity to tidal wetland transitions and surface water.

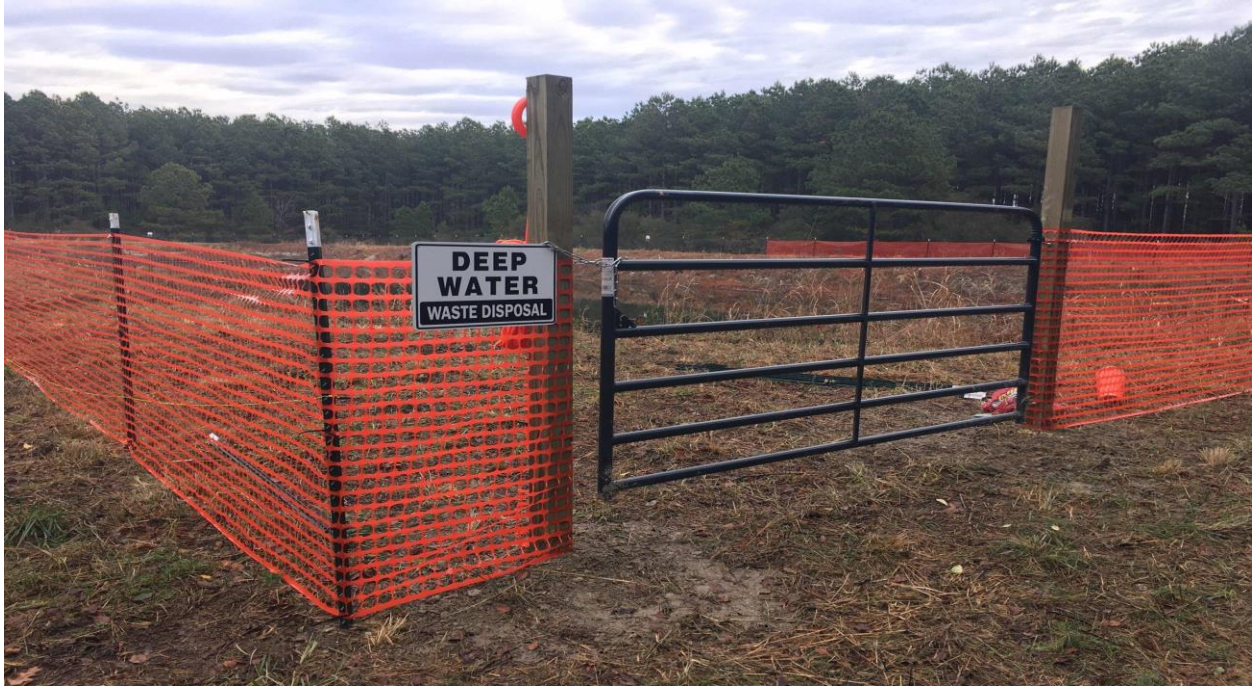
BIP with temporary fencing and adequate gate, signage, and life ring.

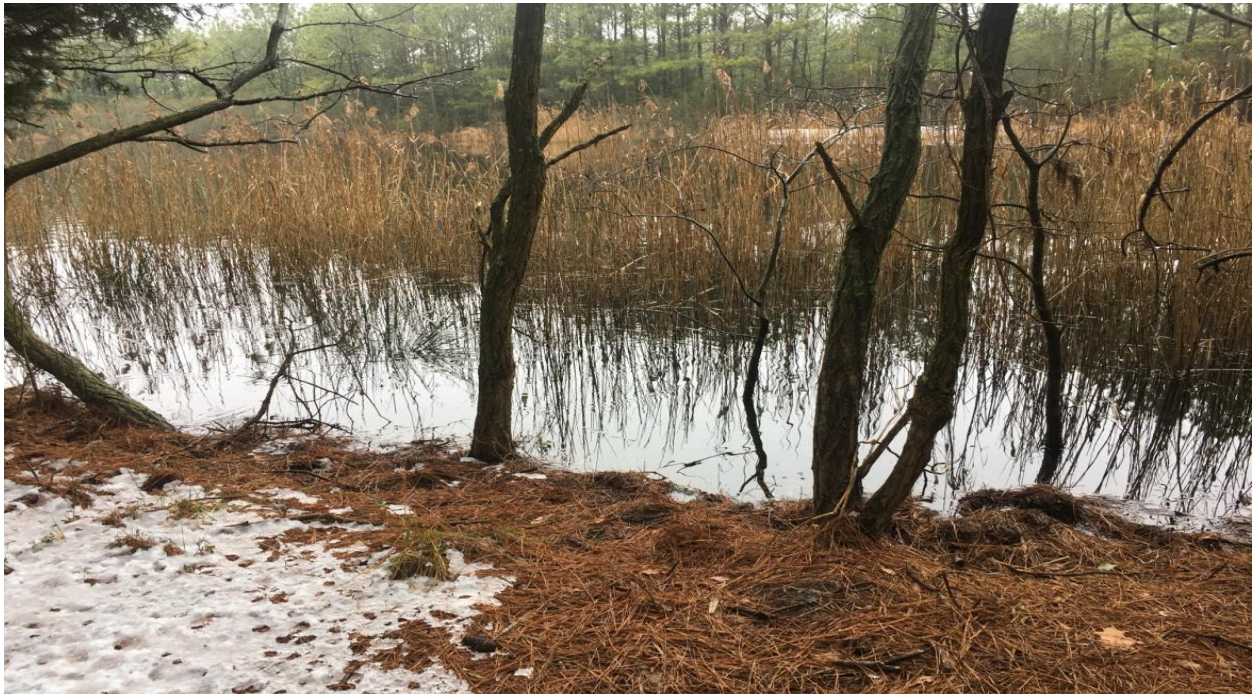
BIP with poor vegetation maintenance, lacking adequate fencing, and less than 2 feet of freeboard.

Recommendation A.2: During the interim period prior to connection to municipal sewers, all BIPs should maintain a 2-foot freeboard within the BIP to prevent surface discharges.

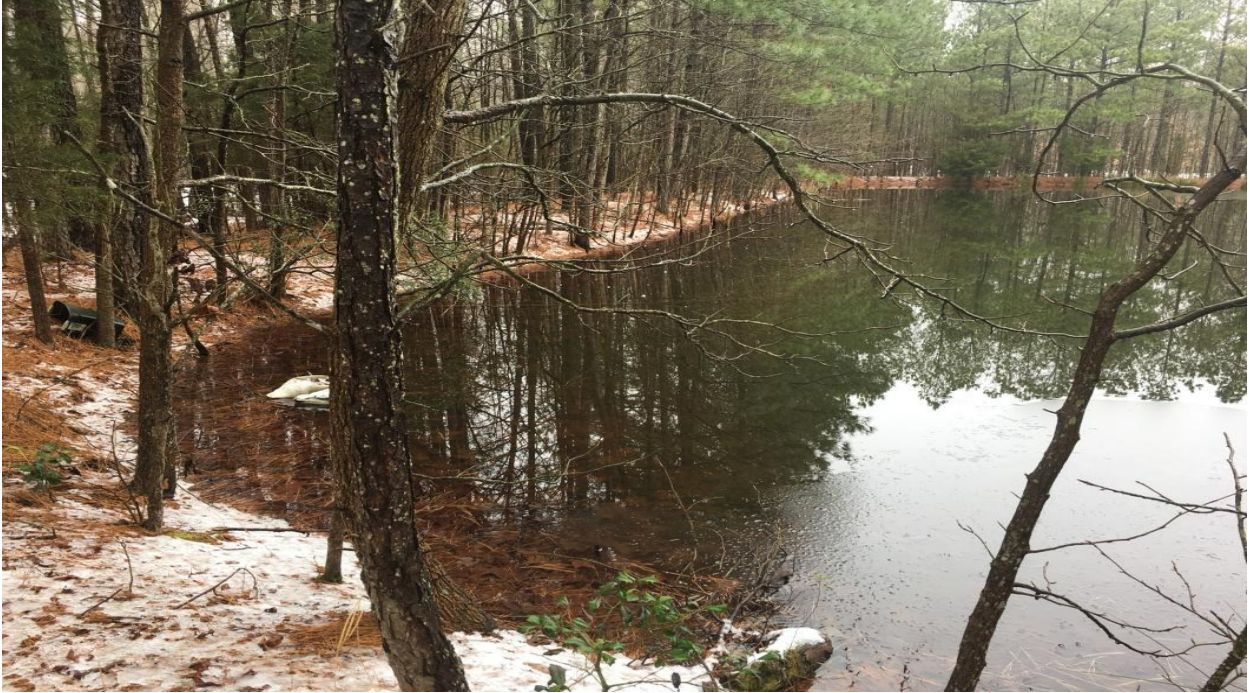
BIP with poor vegetation maintenance and less than 2 feet of freeboard.

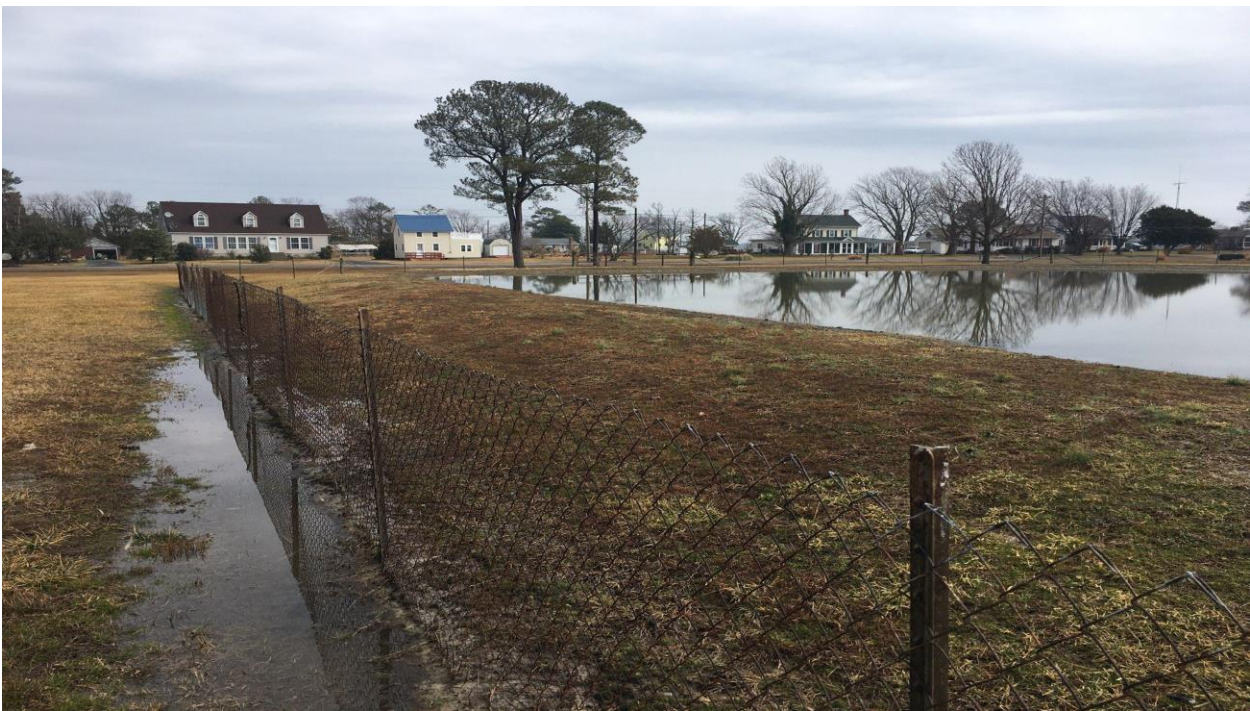
BIP with adequate fencing and vegetation maintenance but has inadequate freeboard (less than 2') and at potential risk of discharge in the event of a storm event.
