**Screening Study of Surface Soil  
in Selected Baltimore City Parks**

**December 2007**

**Prepared by: Maryland Department of the Environment  
Waste Management Administration  
Land Restoration Program  
1800 Washington Blvd.  
Baltimore, MD 21230**

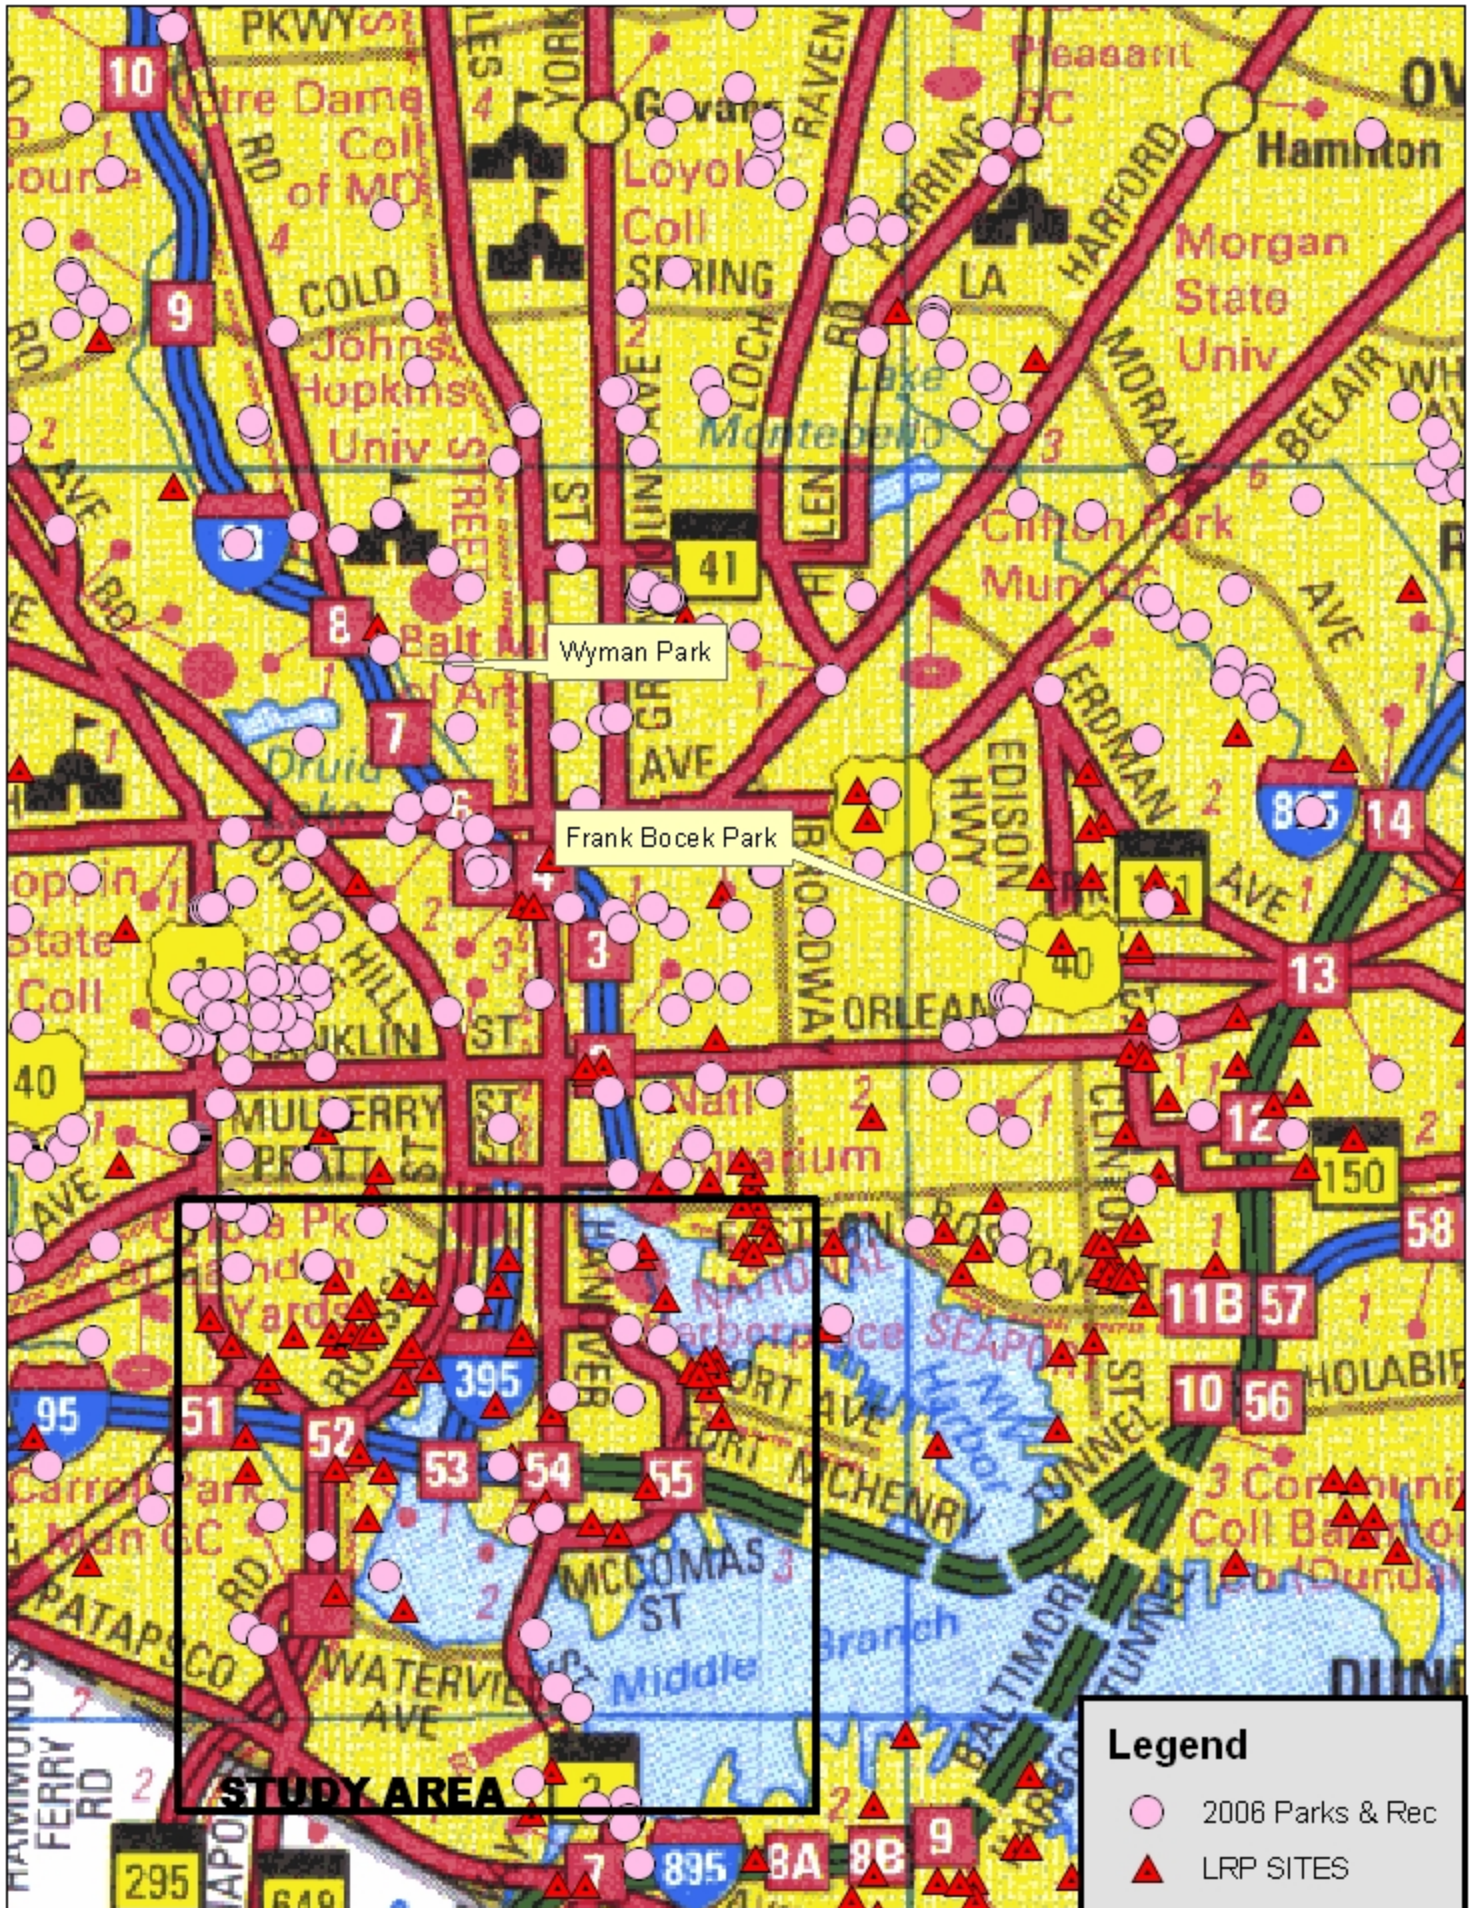
Figure 1 - Study Area and Outlying Parks

Therefore, all parks within approximately a 1.5-mile radius of Allied Chemical were selected, as shown on Figure 1, and listed below:

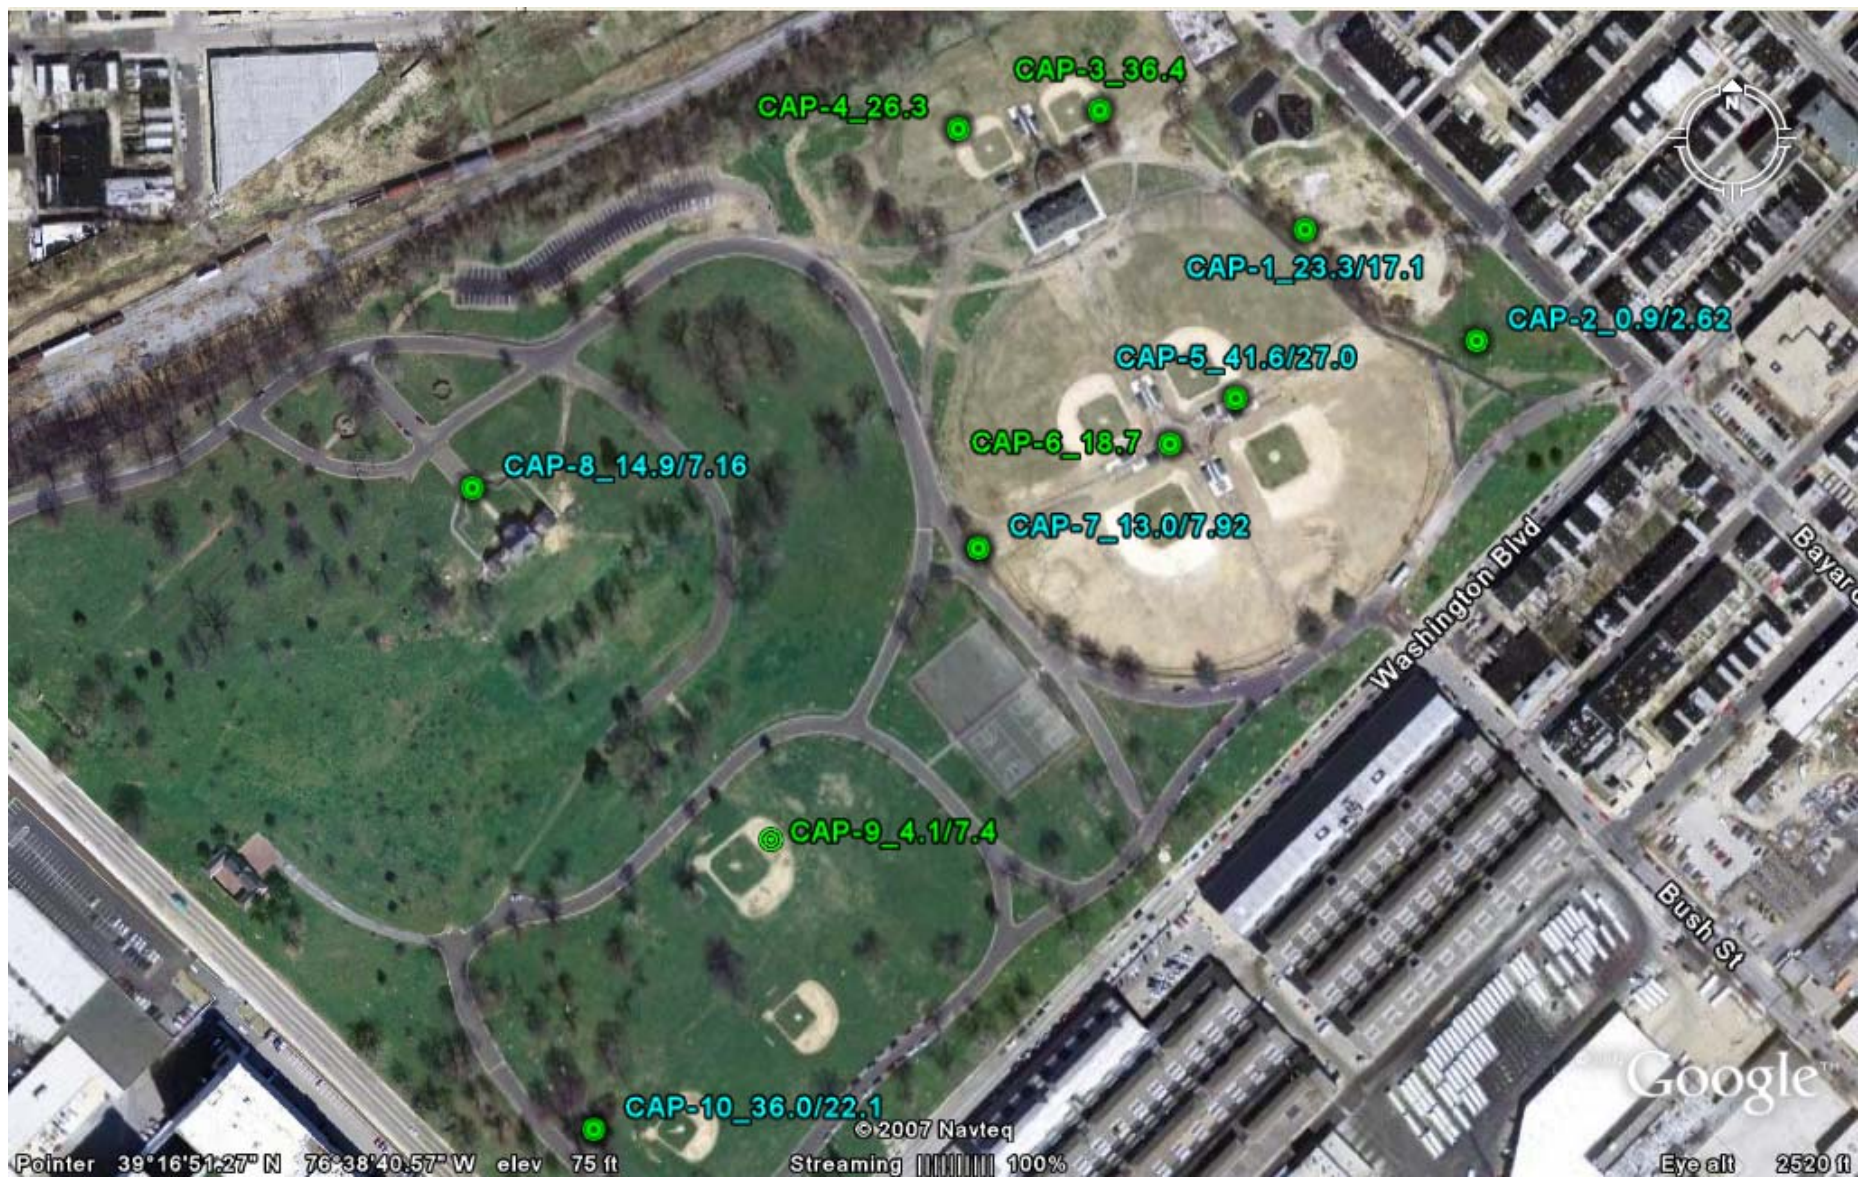
Carroll Park, Arsenic Concentrations in mg/kg

Green text – XRF data. Blue text - both MDE XRF and DHMH analysis run (XRF/DHMH).

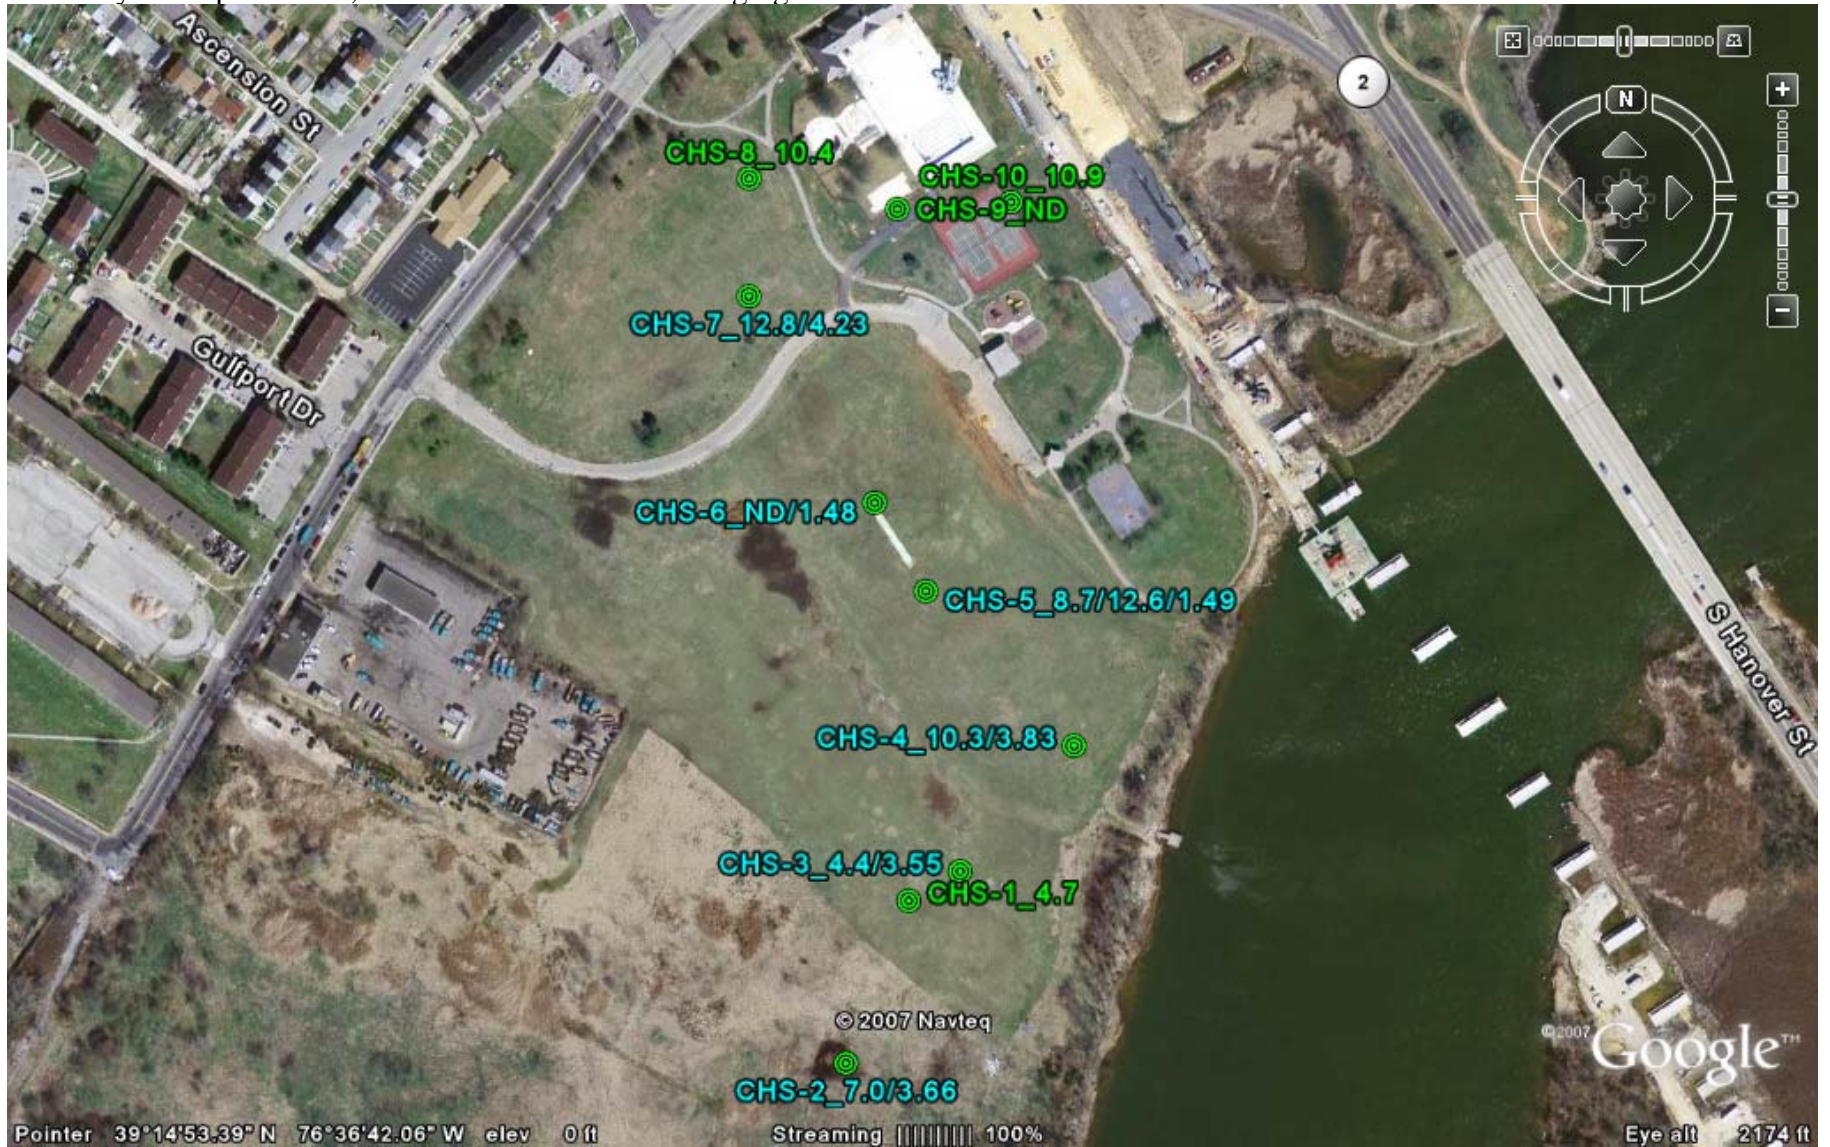
Cherry Hill Splash Park, Arsenic Concentrations in mg/kg

Green text – XRF data. Blue text - both MDE XRF and DHMH analysis run (XRF/DHMH). Note for sample CHS-5, results are as follows: XRF / XRF DUP / DHMH.

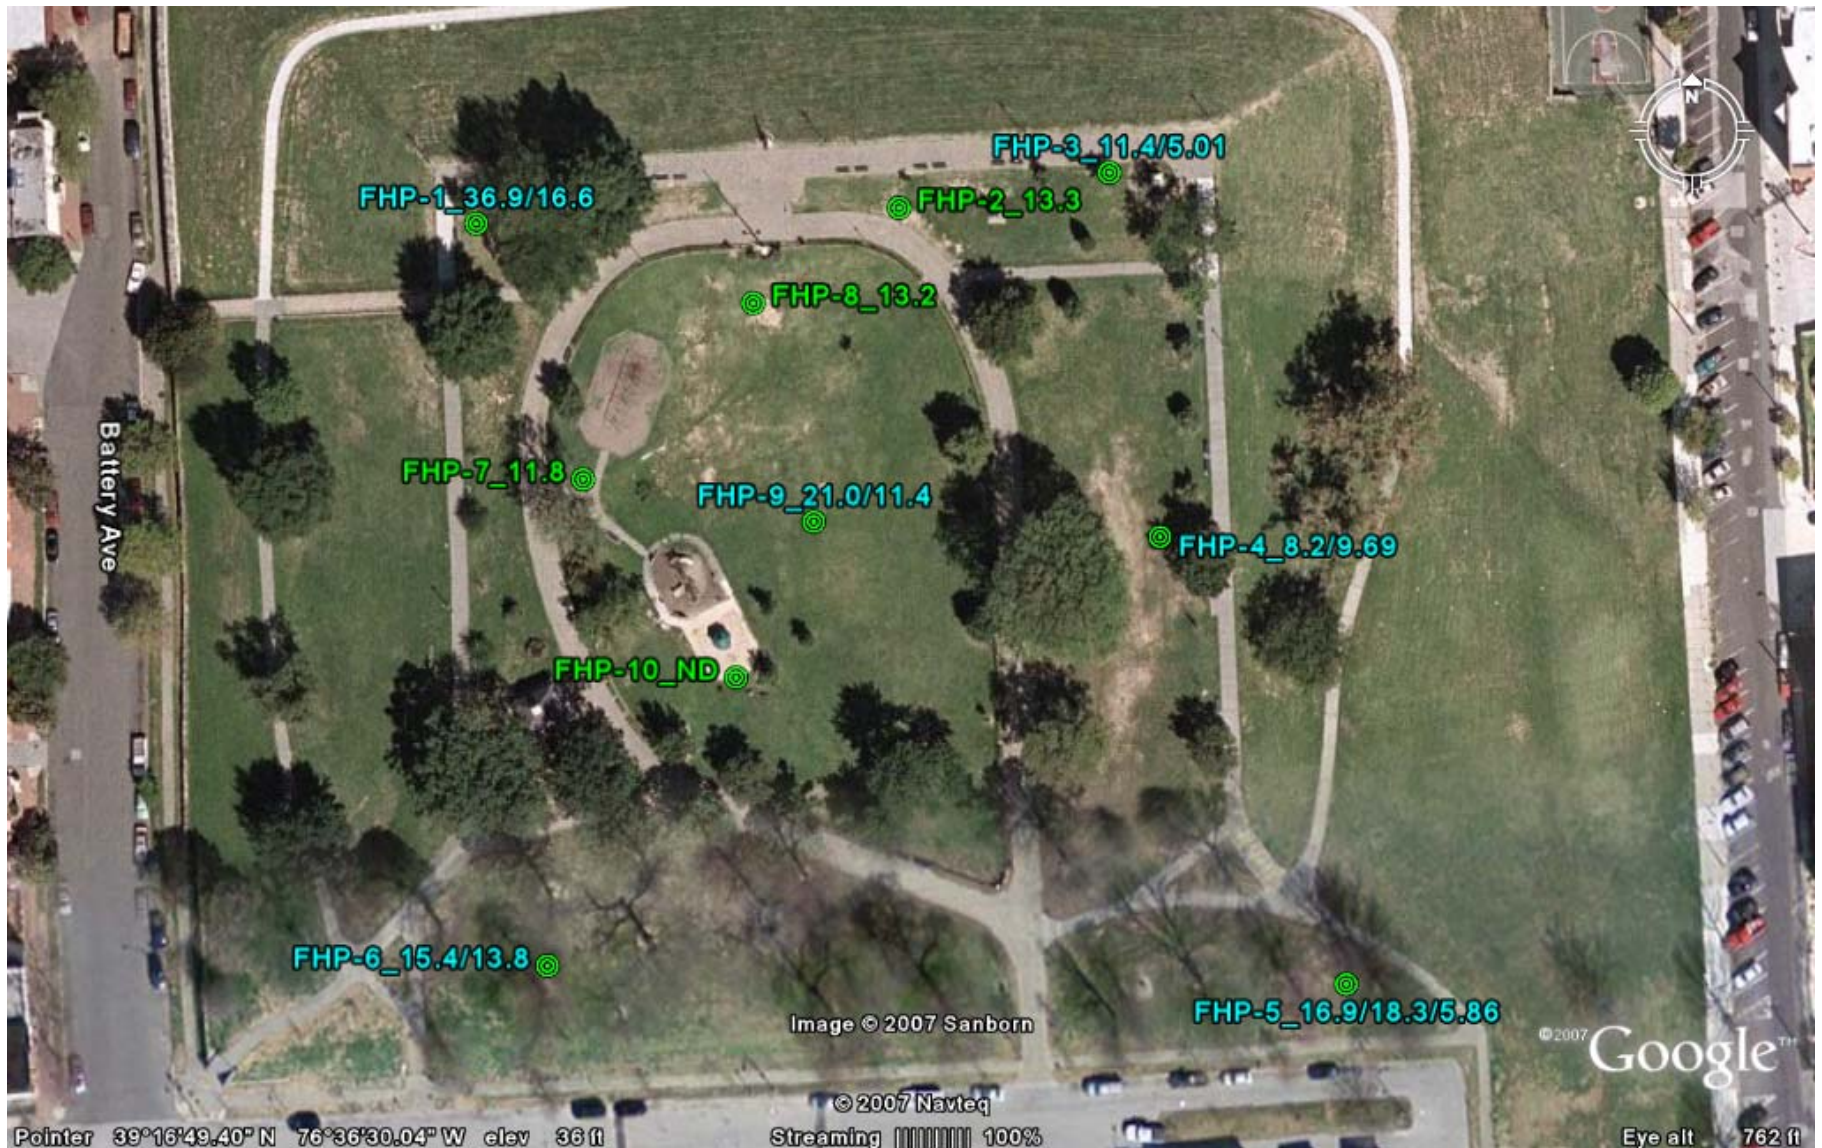
Federal Hill Park, Arsenic Concentrations in mg/kg

Green text – XRF data. Blue text - both MDE XRF and DHMH analysis run (XRF/DHMH). Note for sample FHP-5, results are as follows: XRF / XRF DUP / DHMH.

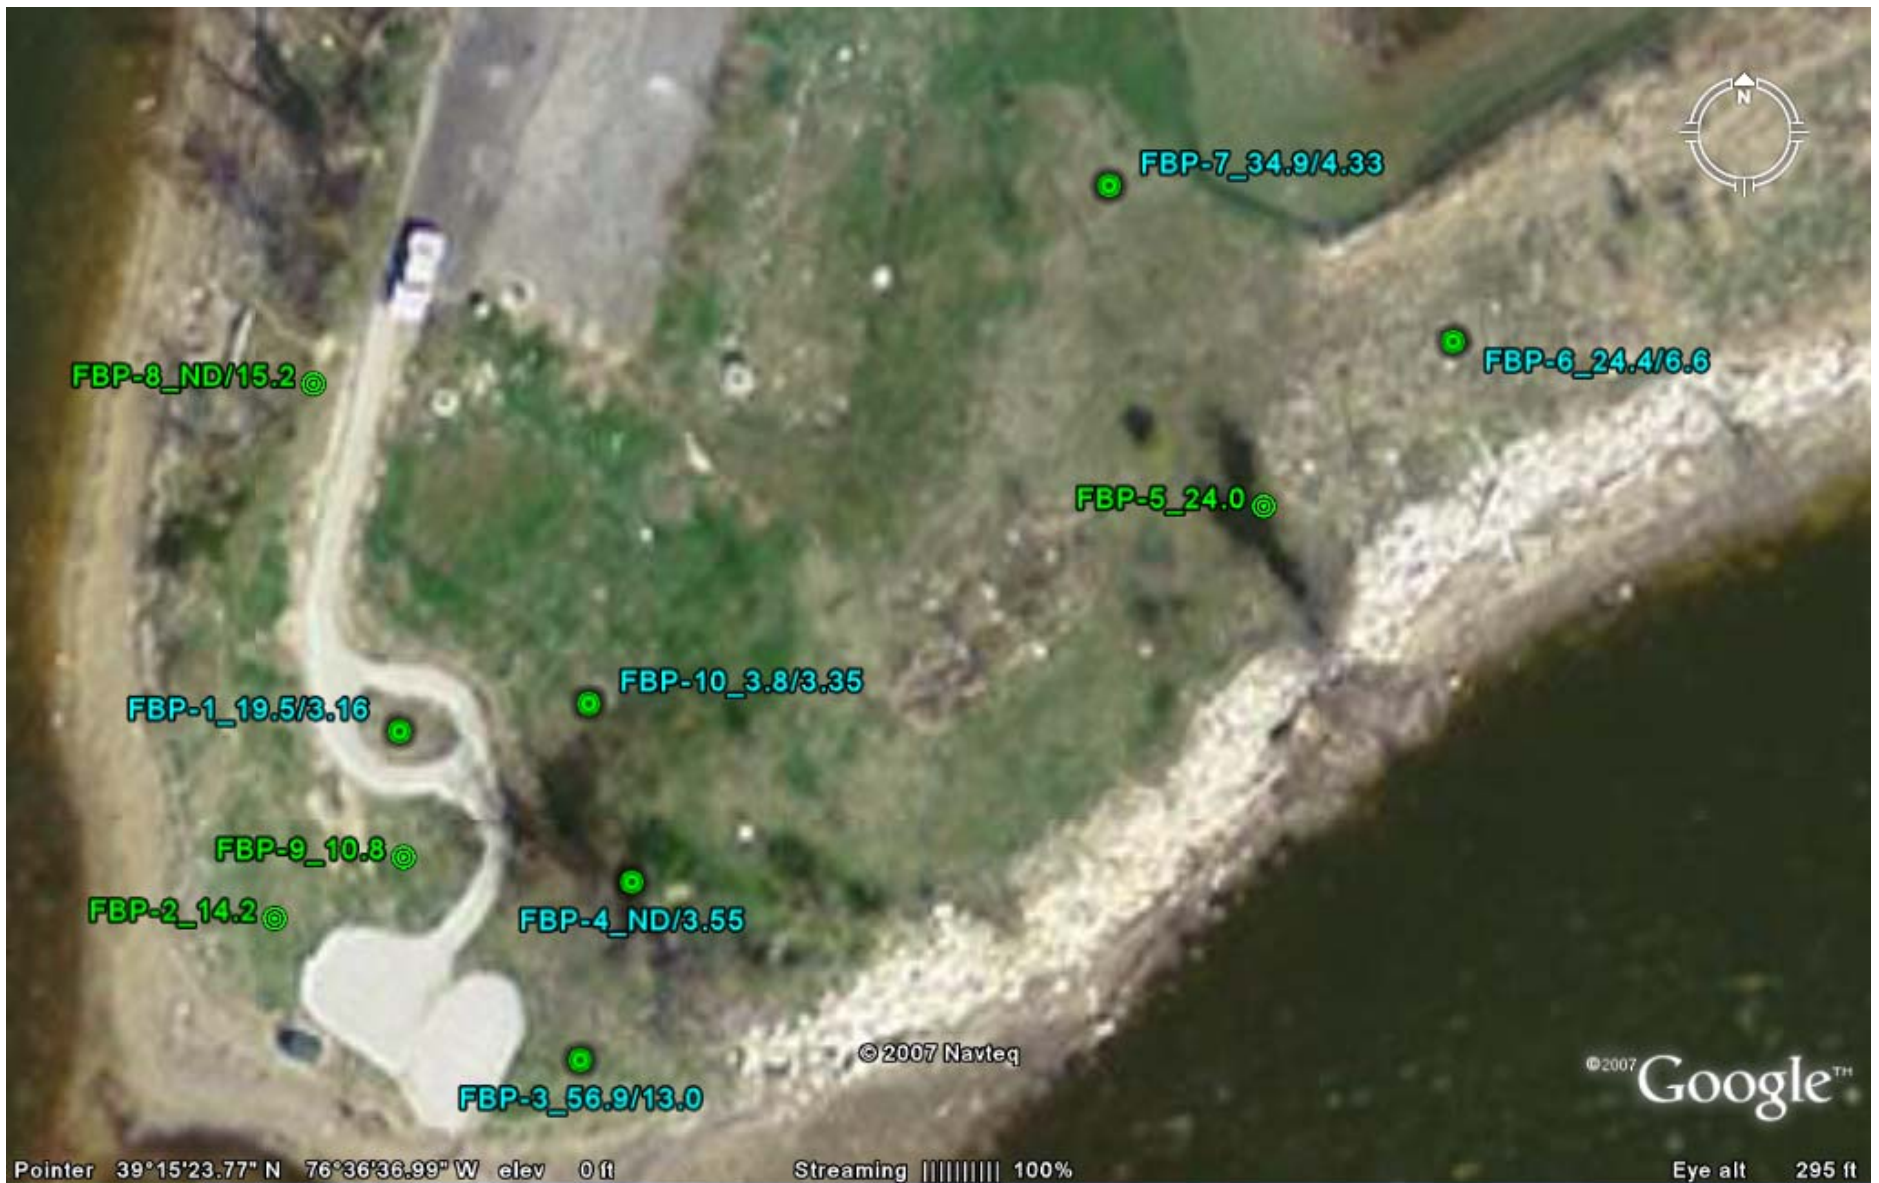
Ferry Bar Park, Arsenic Concentrations in mg/kg

Green text – XRF data. Blue text - both MDE XRF and DHMH analysis run (XRF/DHMH).

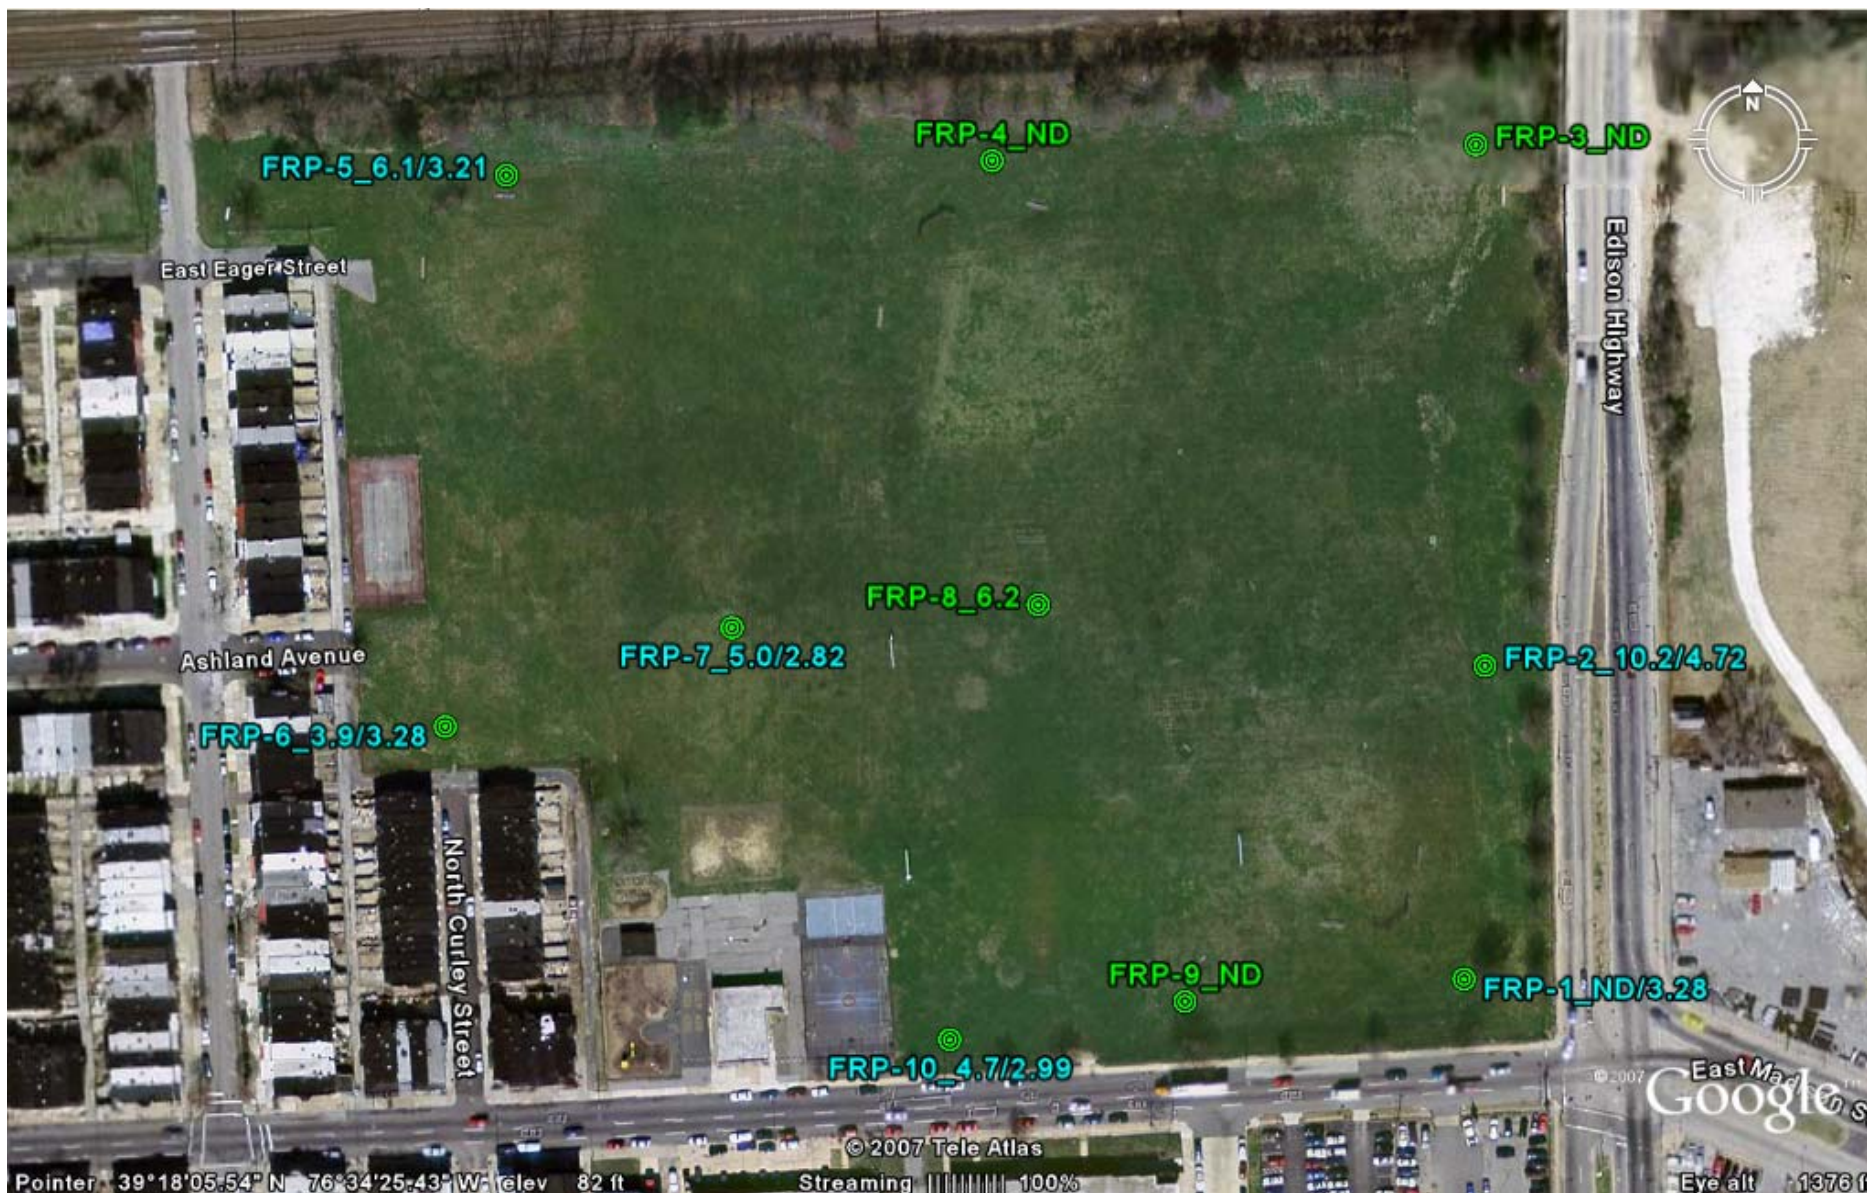
Frank Bocek Park, Arsenic Concentrations in mg/kg

Green text – XRF data. Blue text - both MDE XRF and DHMH analysis run (XRF/DHMH).

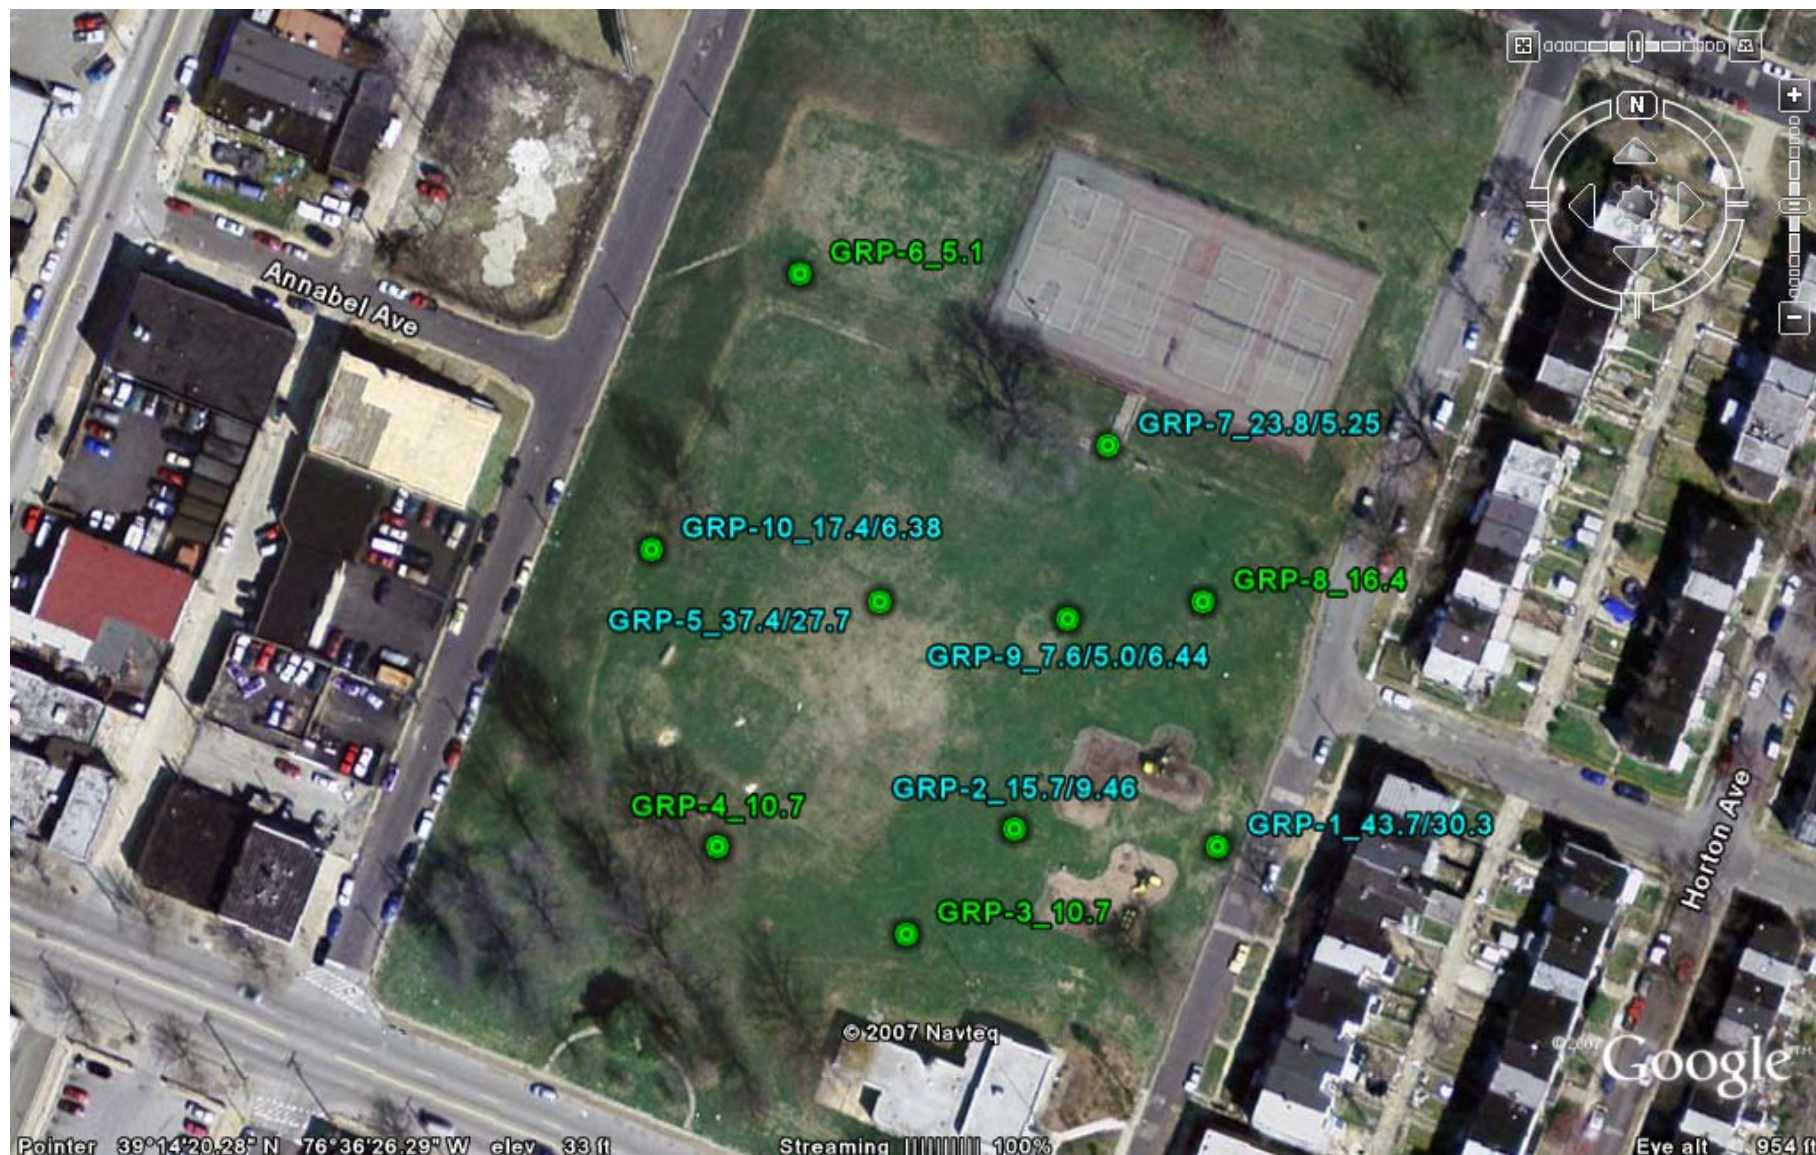
Garrett Park, Arsenic Concentrations in mg/kg

Green text – XRF data. Blue text - both MDE XRF and DHMH analysis run (XRF/DHMH). Note for sample GRP-9, results are as follows: XRF / XRF DUP / DHMH.

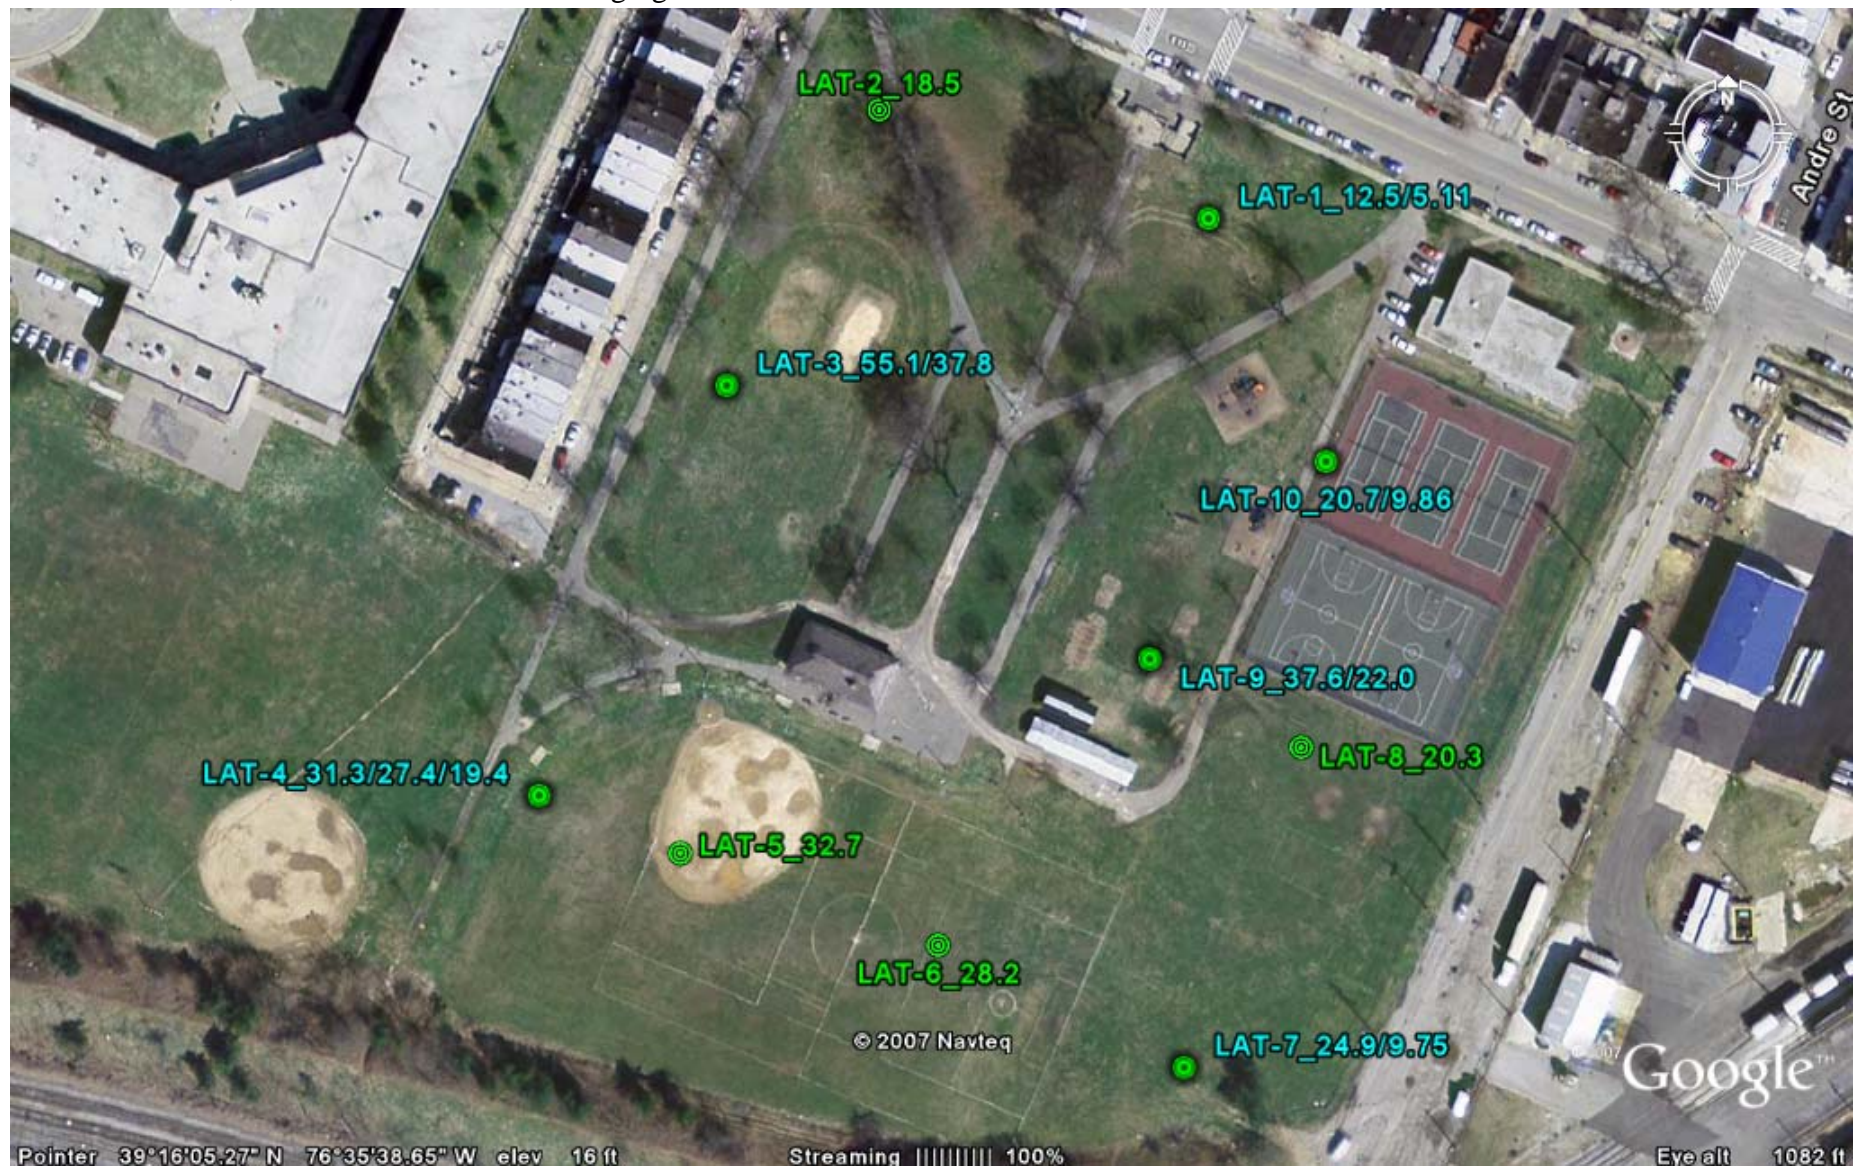
Latrobe Park, Arsenic Concentrations in mg/kg

Green text – XRF data. Blue text - both MDE XRF and DHMH analysis run (XRF/DHMH). Note for sample LAT-4, results are as follows: XRF / XRF DUP / DHMH.

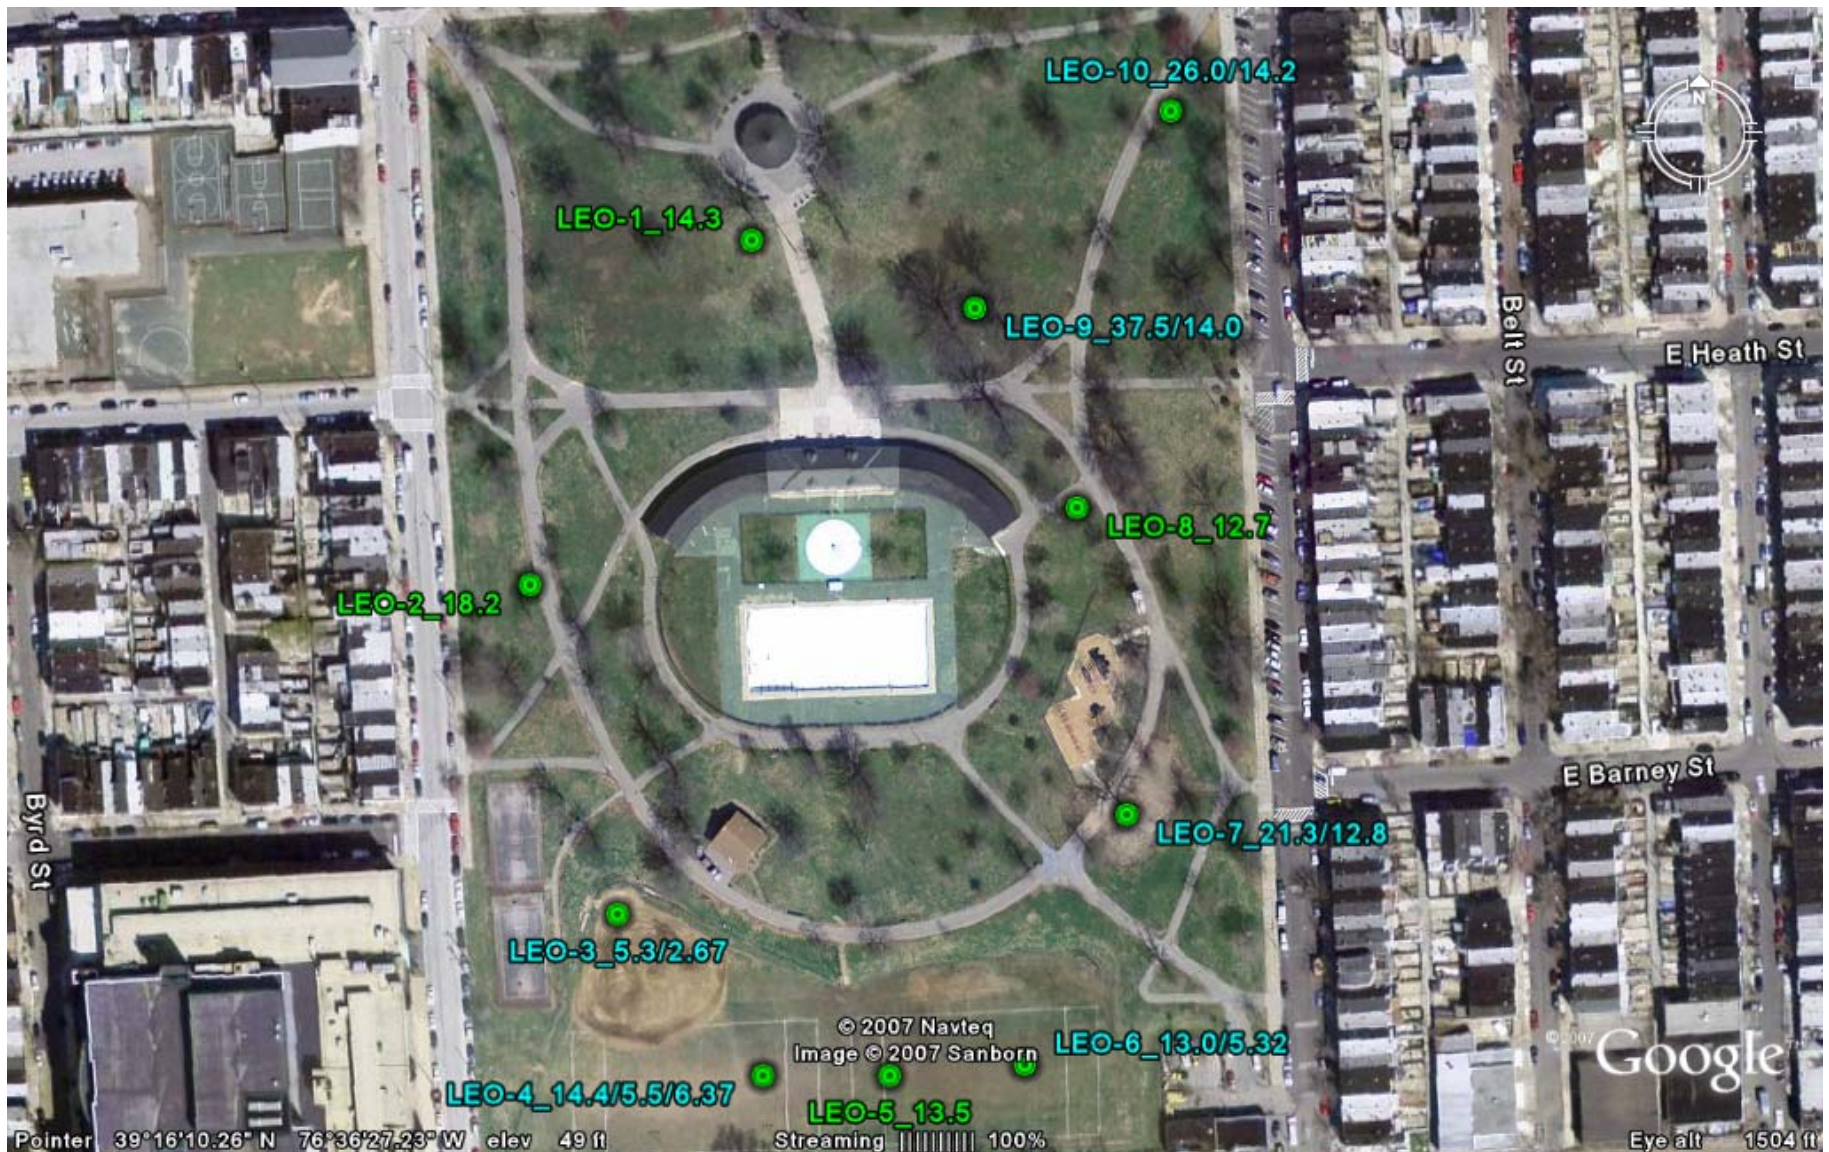
Leone Riverside Park, Arsenic Concentrations in mg/kg

Green text – XRF data. Blue text - both MDE XRF and DHMH analysis run (XRF/DHMH). Note for sample LEO-4, results are as follows: XRF / XRF DUP / DHMH.

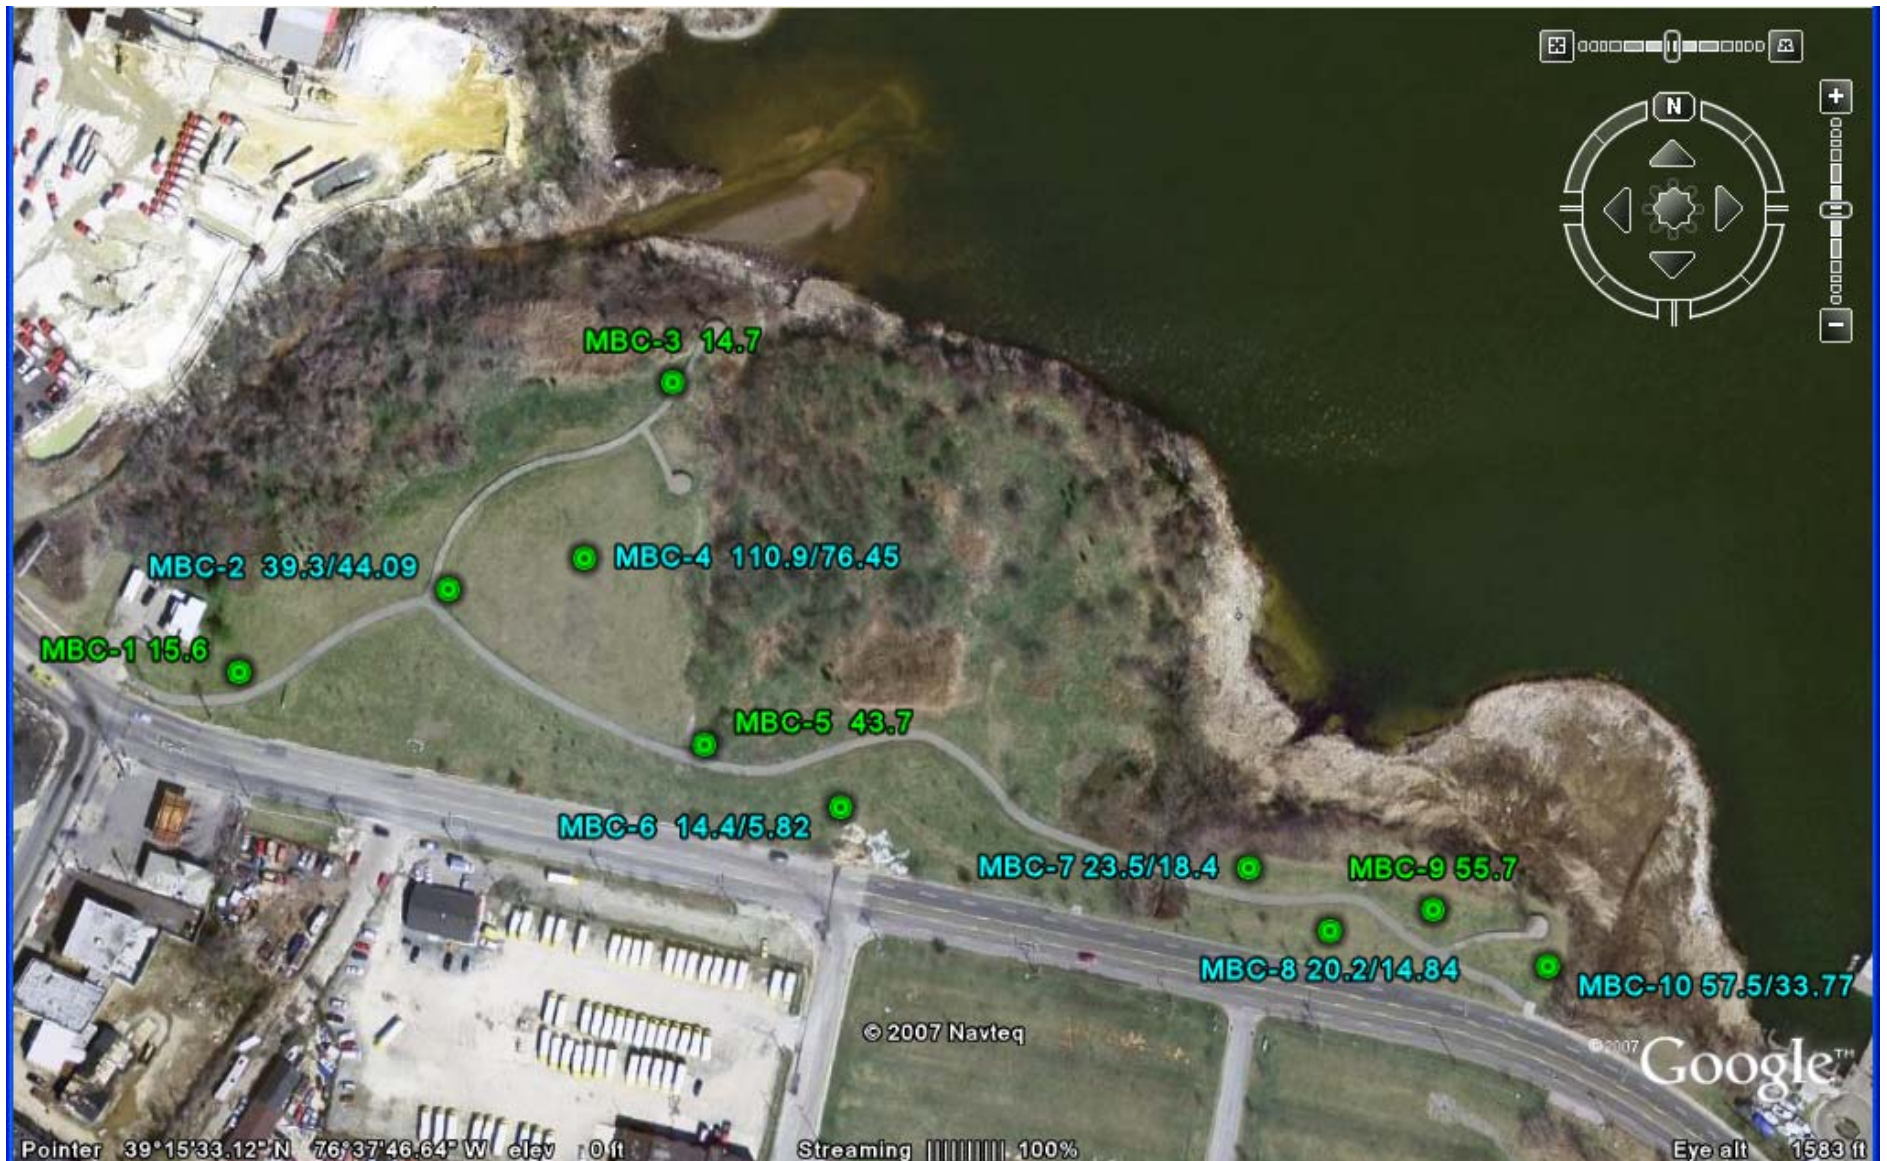
Middle Branch Park, Cherry Hill, Arsenic Concentrations in mg/kg

Green text – XRF data. Blue text - both MDE XRF and DHMH analysis run (XRF/DHMH).

The LRP screening study did identify certain locations in the Middle Branch Cherry Hill Park where the presence of arsenic in the surface soils appeared to be above and beyond the normal levels found in areas where pesticides and herbicides have been applied as products. LRP recommends that the City of Baltimore perform additional surface soil investigation of these areas to determine whether further action is necessary.
