**Screening Study of Surface Soil  
in Selected Baltimore City Parks**

**December 2007**

**Prepared by: Maryland Department of the Environment  
Waste Management Administration  
Land Restoration Program  
1800 Washington Blvd.  
Baltimore, MD 21230**

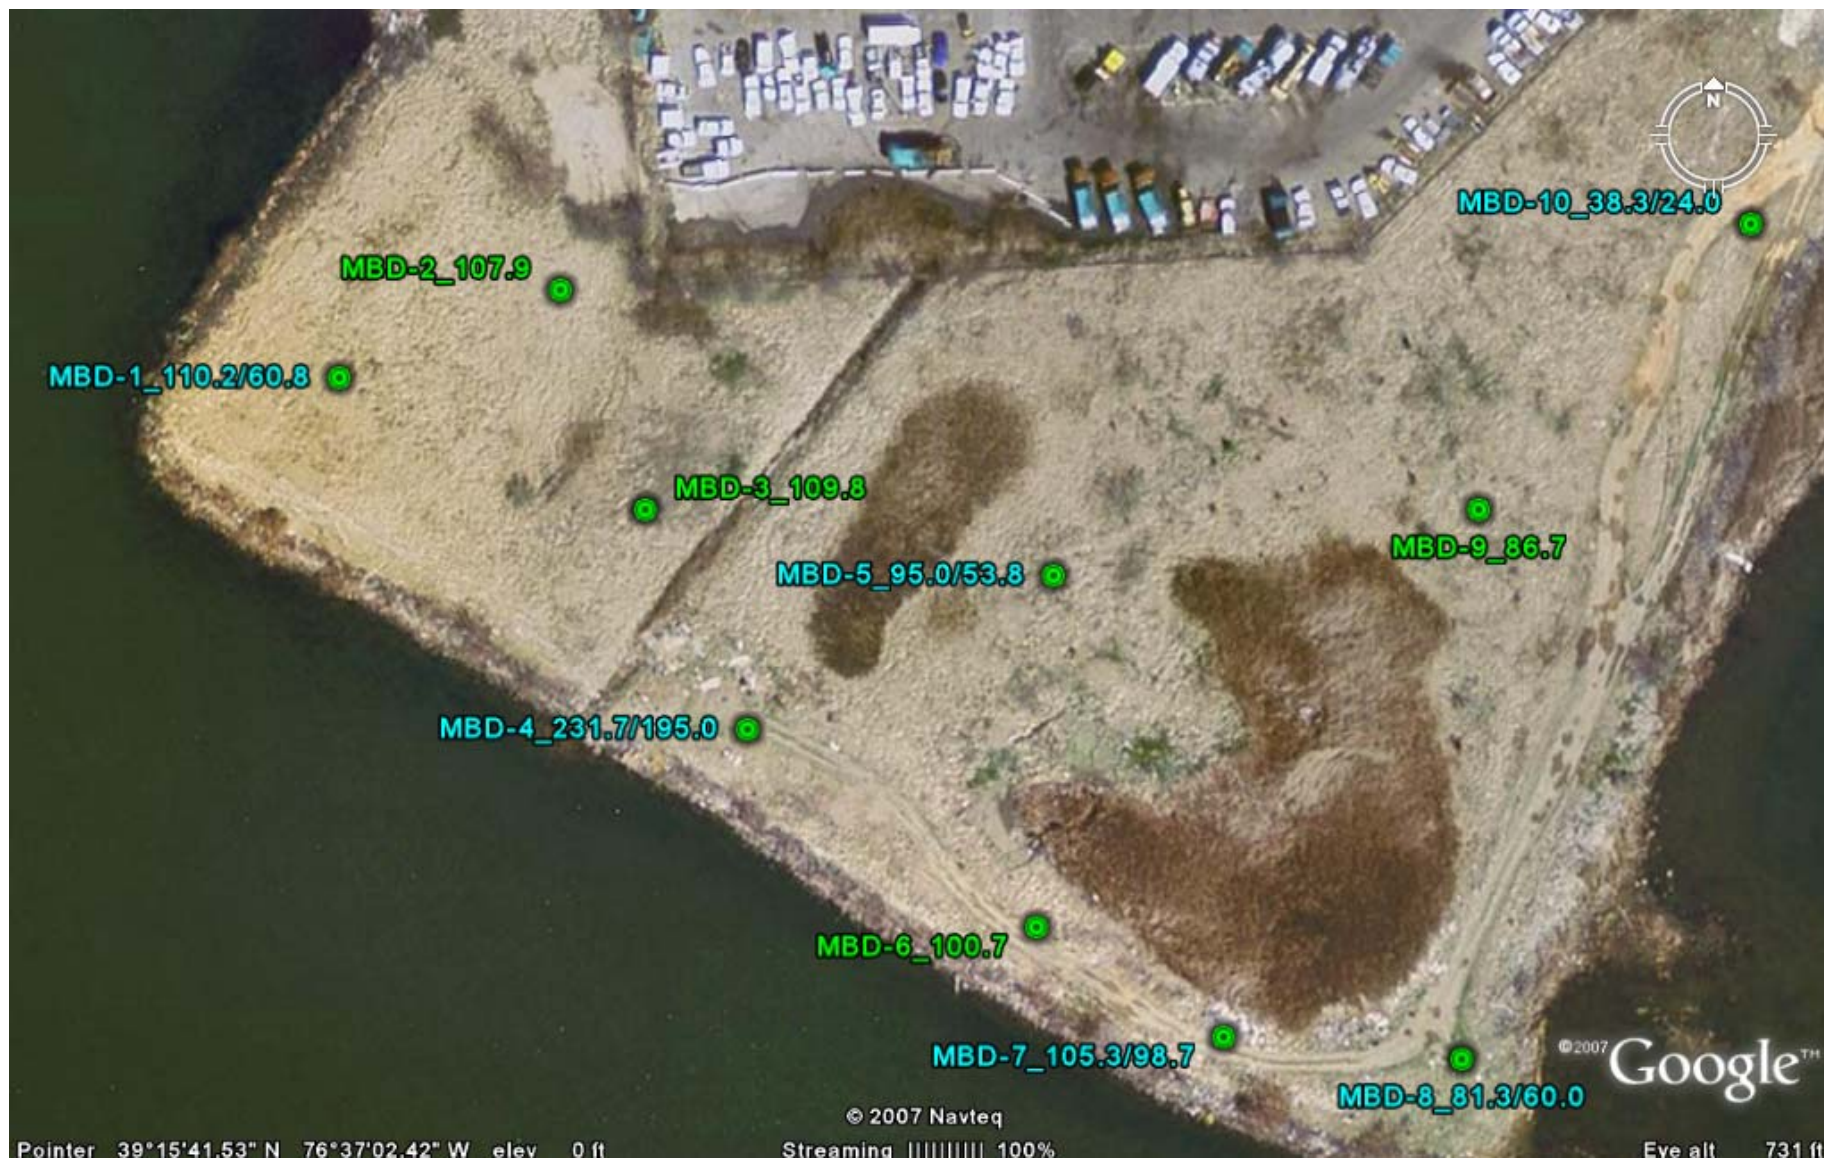
Middle Branch Park, Dickman Street, Arsenic Concentrations in mg/kg

Green text – XRF data. Blue text - both MDE XRF and DHMH analysis run (XRF/DHMH).

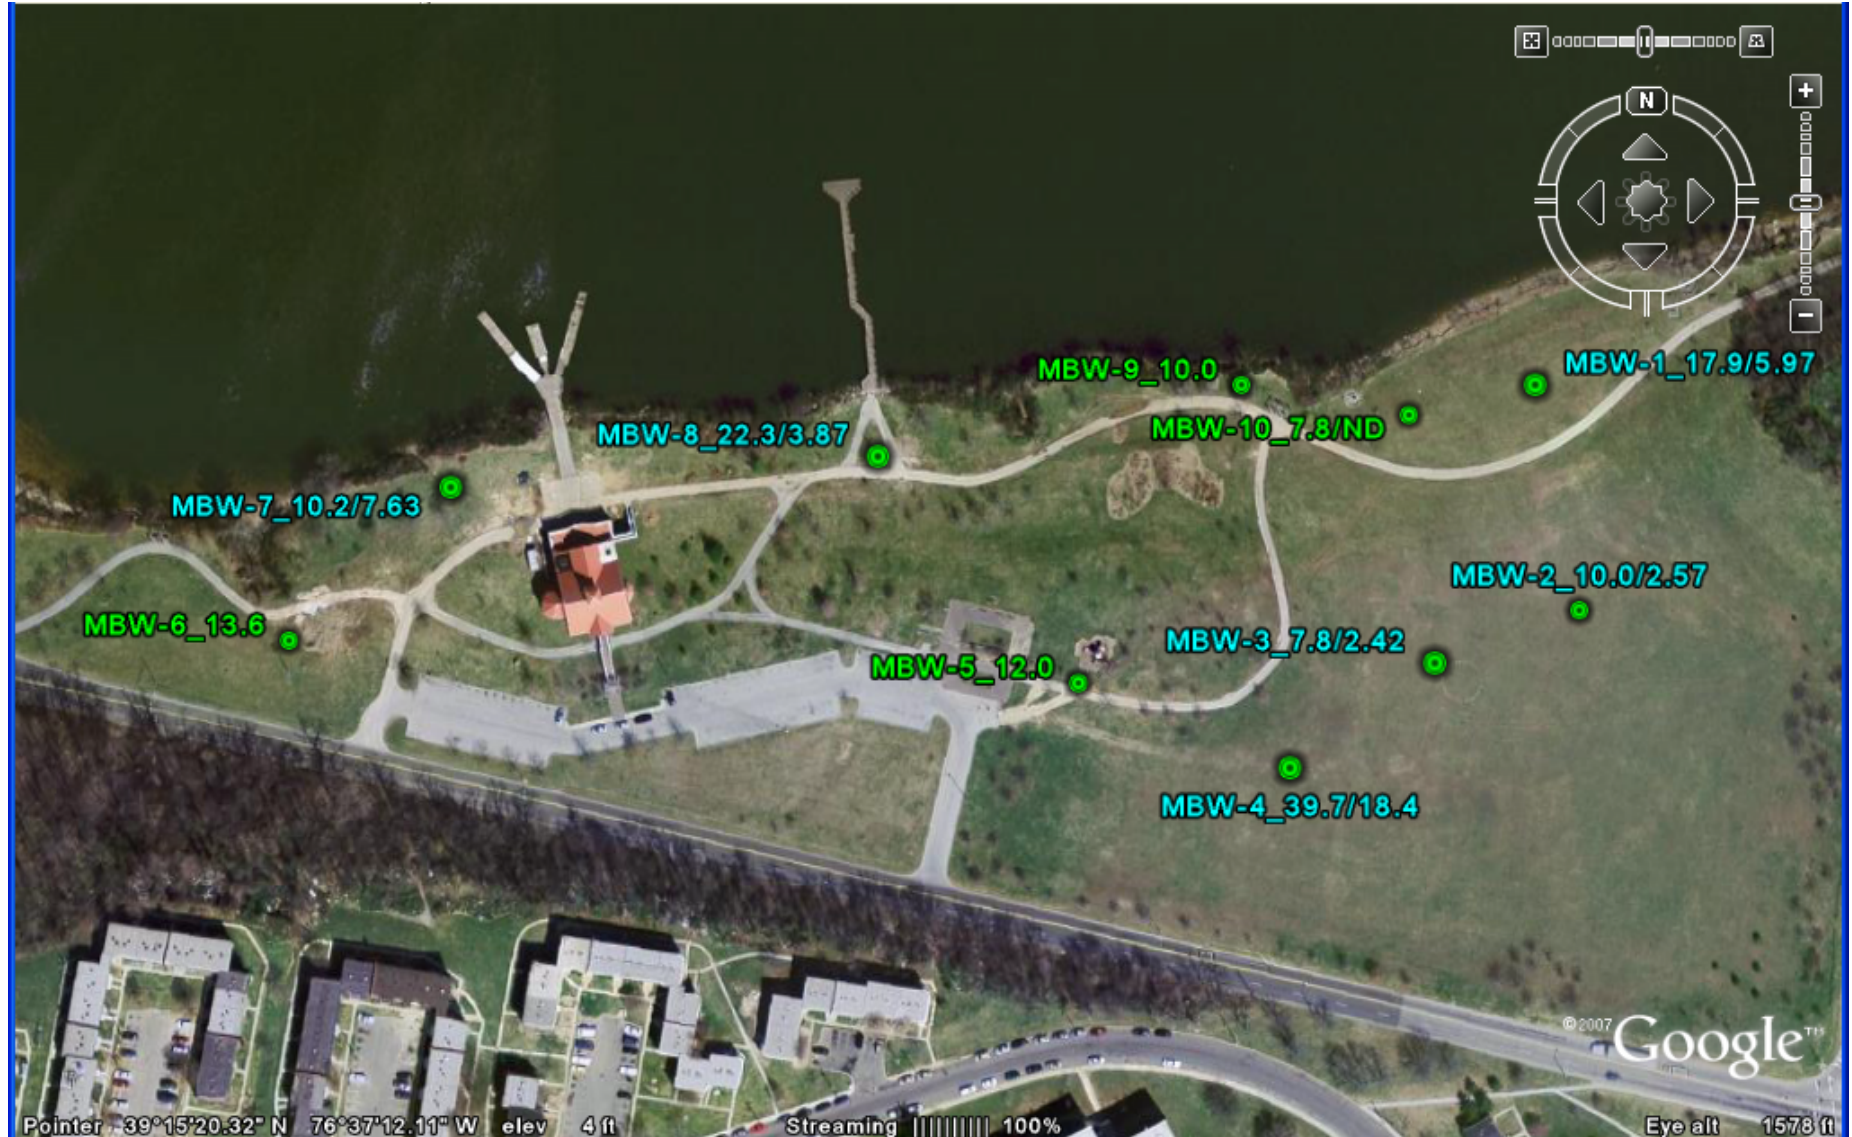
Middle Branch Park, Waterview Avenue, Arsenic Concentrations in mg/kg

Green text – XRF data. Blue text - both MDE XRF and DHMH analysis run (XRF/DHMH).

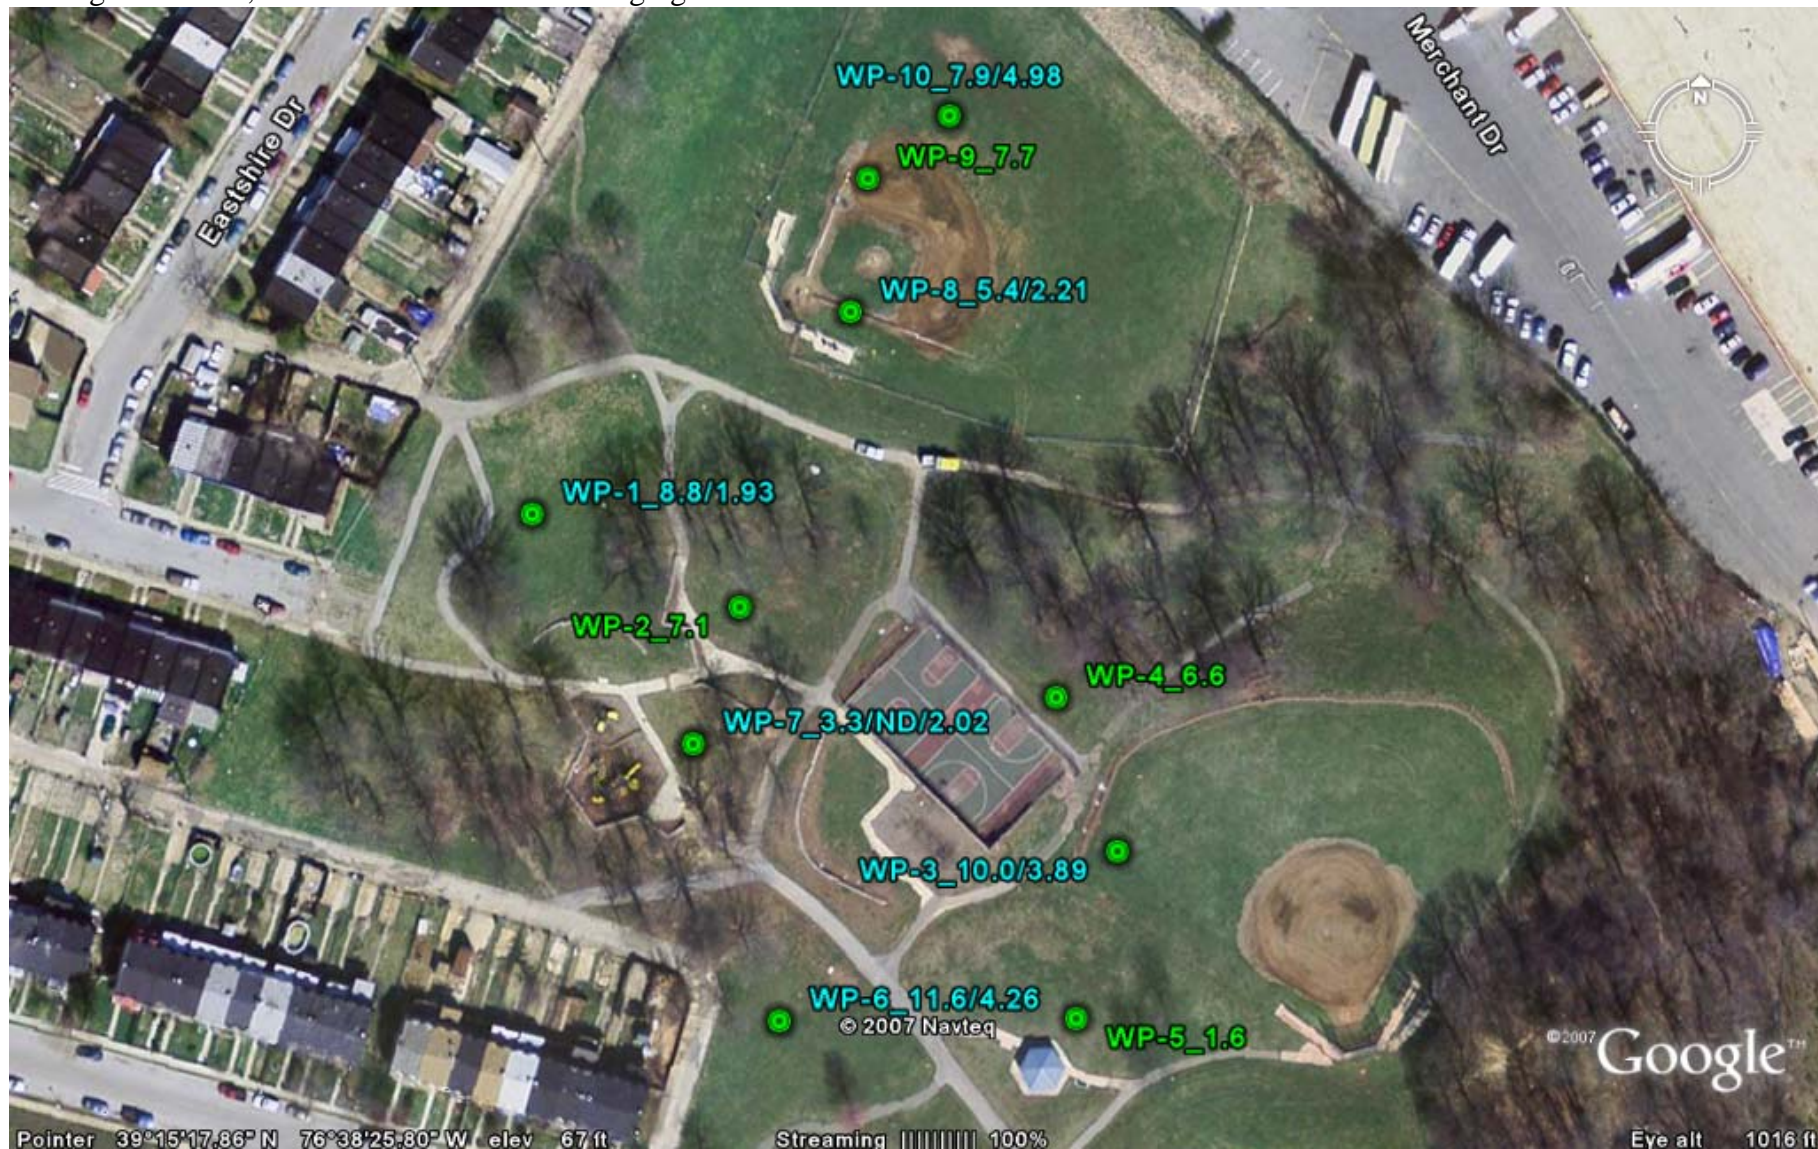
Wegworth Park, Arsenic Concentrations in mg/kg

Green text – XRF data. Blue text - both MDE XRF and DHMH analysis run (XRF/DHMH). Note for sample WP-7, results are as follows: XRF / XRF DUP / DHMH.

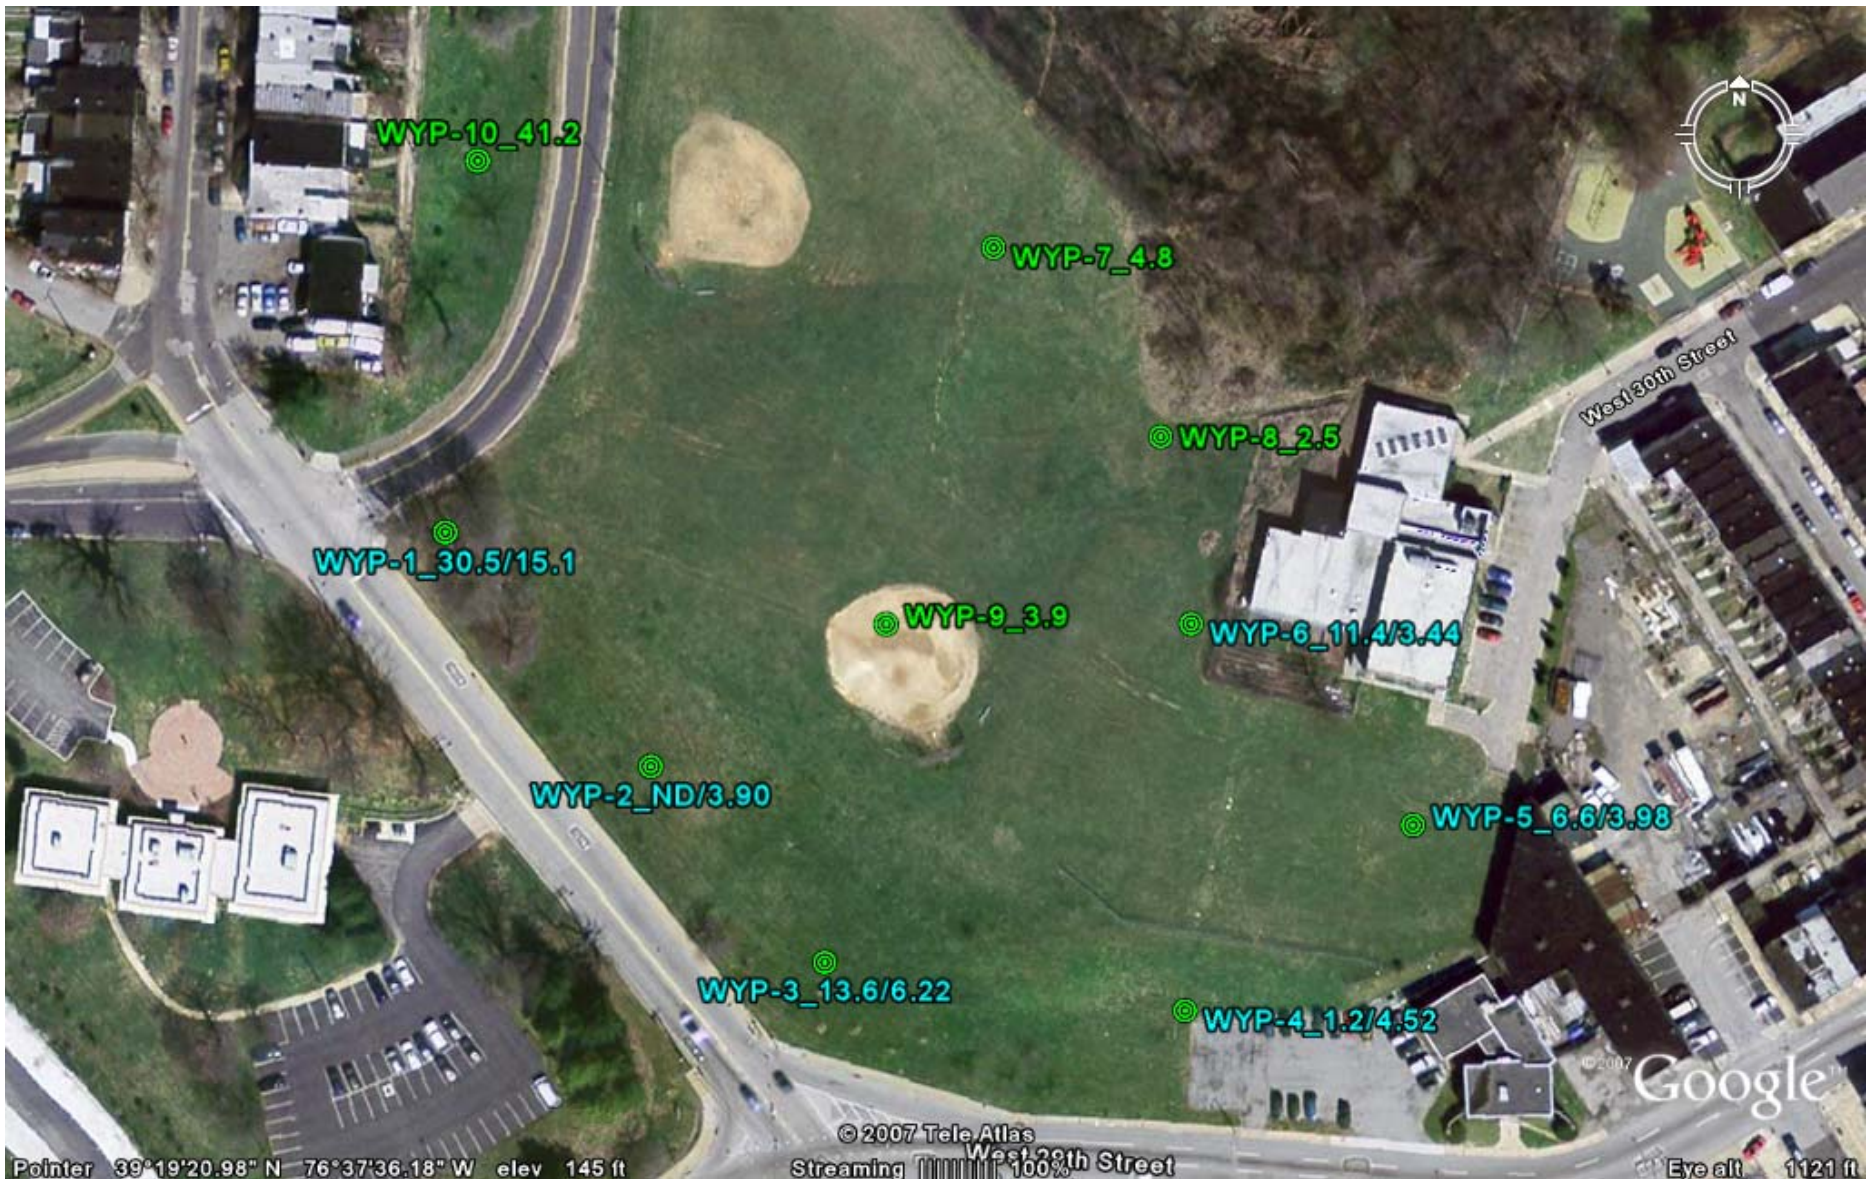
Wyman Park, Arsenic Concentrations in mg/kg

Green text – XRF data. Blue text - both MDE XRF and DHMH analysis run (XRF/DHMH).
