**Maryland Department of Environment**  
**Water and Science Administration**  
**Compliance Program**  
**1800 Washington Blvd, Suite 420**  
**Baltimore, MD 21230-1719**  
**410- 537-3510, 1-800-633-6101**

**Site Name:** Patapsco WWTP  
**Facility Address:** 3501 Asiatic Ave, Curtis Bay, MD 21226  
**County:** Baltimore City County

**Start Date/Time:** March 21, 2024 09:30 AM  
**End Date /Time:** March 21, 2024 12:00 PM  
**Media Type(s):** NPDES Municipal Major Surface Water

**Permit / Approval Numbers:** 15DP0850  
**NPDES Numbers:** MD0021601  
**Inspection Reason:** Follow-up  
**Site Status:** Active  
**Compliance Status:** Compliance  
**Site Condition:** Additional Investigation Required  
**Recommended Action:** Continue Routine Inspection  
**Evidence Collected:** Photos or Videos Taken, Record Review, Visual Observation  
**Delivery Method:** Email  
**Weather:** Clear, Breezy, Good

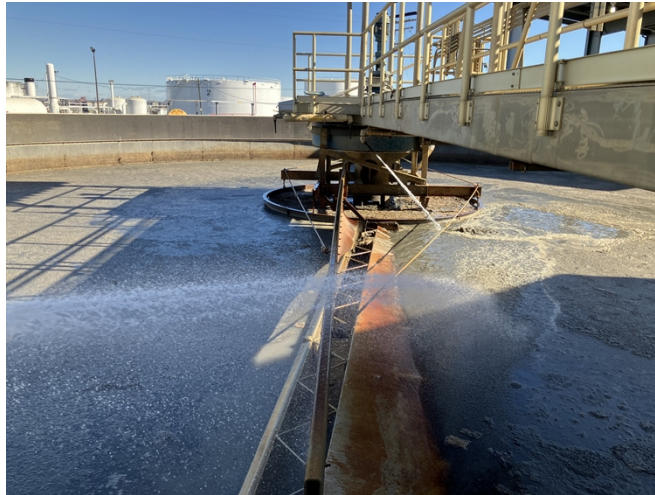
Image 01: GST #1

There are three (3) 65-ft diameter gravity sludge thickeners (GSTs) in the sludge handling area of the plant. The GSTs are numbered #1, #2, and #4. GSTs #1 and #2 are built on grade and GST #4 is elevated above grade. The skimming arms of GST #1 and #2 are missing significant portions of the rubber flaps which should extend down to the liquid surface to effectively remove surface scum. Currently, staff spray water on the surface of GST #1 and #2 in order to manually remove surface scum. Repairs for the skimming arms are reportedly planned and a vendor has been selected to complete the repairs.

At the time of the site inspection, GST #1 was observed as having a heavy layer of floating scum on the surface. GST #2 had a layer of floating scum that appeared to have less solids and more grease than what was observed in GST #1. It was reported that Synagro's sludge processing operations has been keeping up with the plant's sludge production; however, at the time of the site inspection, Synagro was reportedly down and would be starting back up shortly. The vertical sludge storage tanks are empty and Synagro is able to pull directly from GST's #1 and #2. The scum troughs on GST #1 and GST #2 were clear and operational. GST #4 is operational but not in use and is kept as a back up for GSTs #1 and #2.

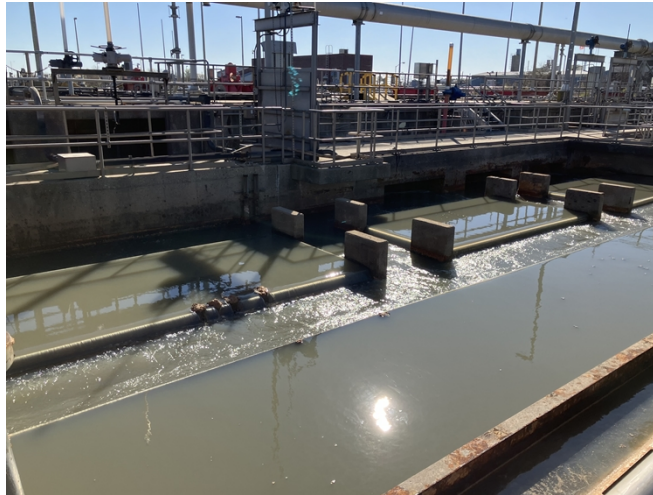
Image 02: PST # 4, Effluent.

At the time of the site inspection, PSTs #1, #4, and #6 were in service. PST #3 was in the process of being cleaned. PSTs #2 and #5 were operating as flow-thru until they can be drained, cleaned, and repaired. The facility is still dealing with the effects of significant rainfall events.

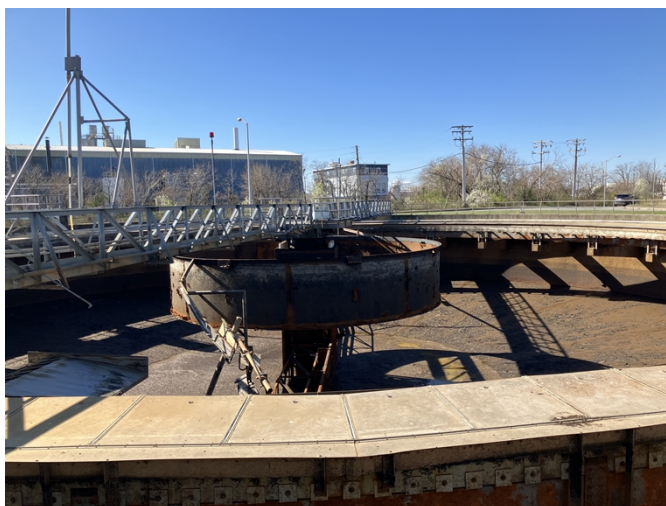
Image 03: Clarifier #6b, empty, bent / twisted skimmer arm.

Secondary clarifier #4 has a section of the skimmer arm missing. It was reported that parts are on order. At the time of the inspection, technicians were making repairs to the scum pump on Clarifier #2. Clarifier #6b was empty due to repairs needed on its skimmer arm. It was reported that the skimmer arm hung up on the scum trough and was severely bent / twisted from the torque.

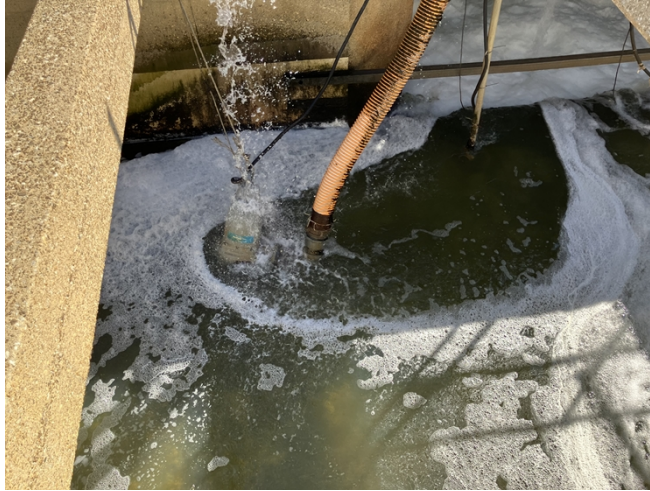
Image 04: Final effluent.

Foam was observed on the surface of the final discharge channel which appeared to disperse rapidly. BAF media and FOGs were not observed to be leaving the site via the effluent channel.
