ENVIRONMENTAL COVENANT

HOLDER: EASTALCO ALUMINUM COMPANY

PROPERTY ADDRESS: 5601 MANOR WOODS ROAD, FREDERICK, MARYLAND 21701

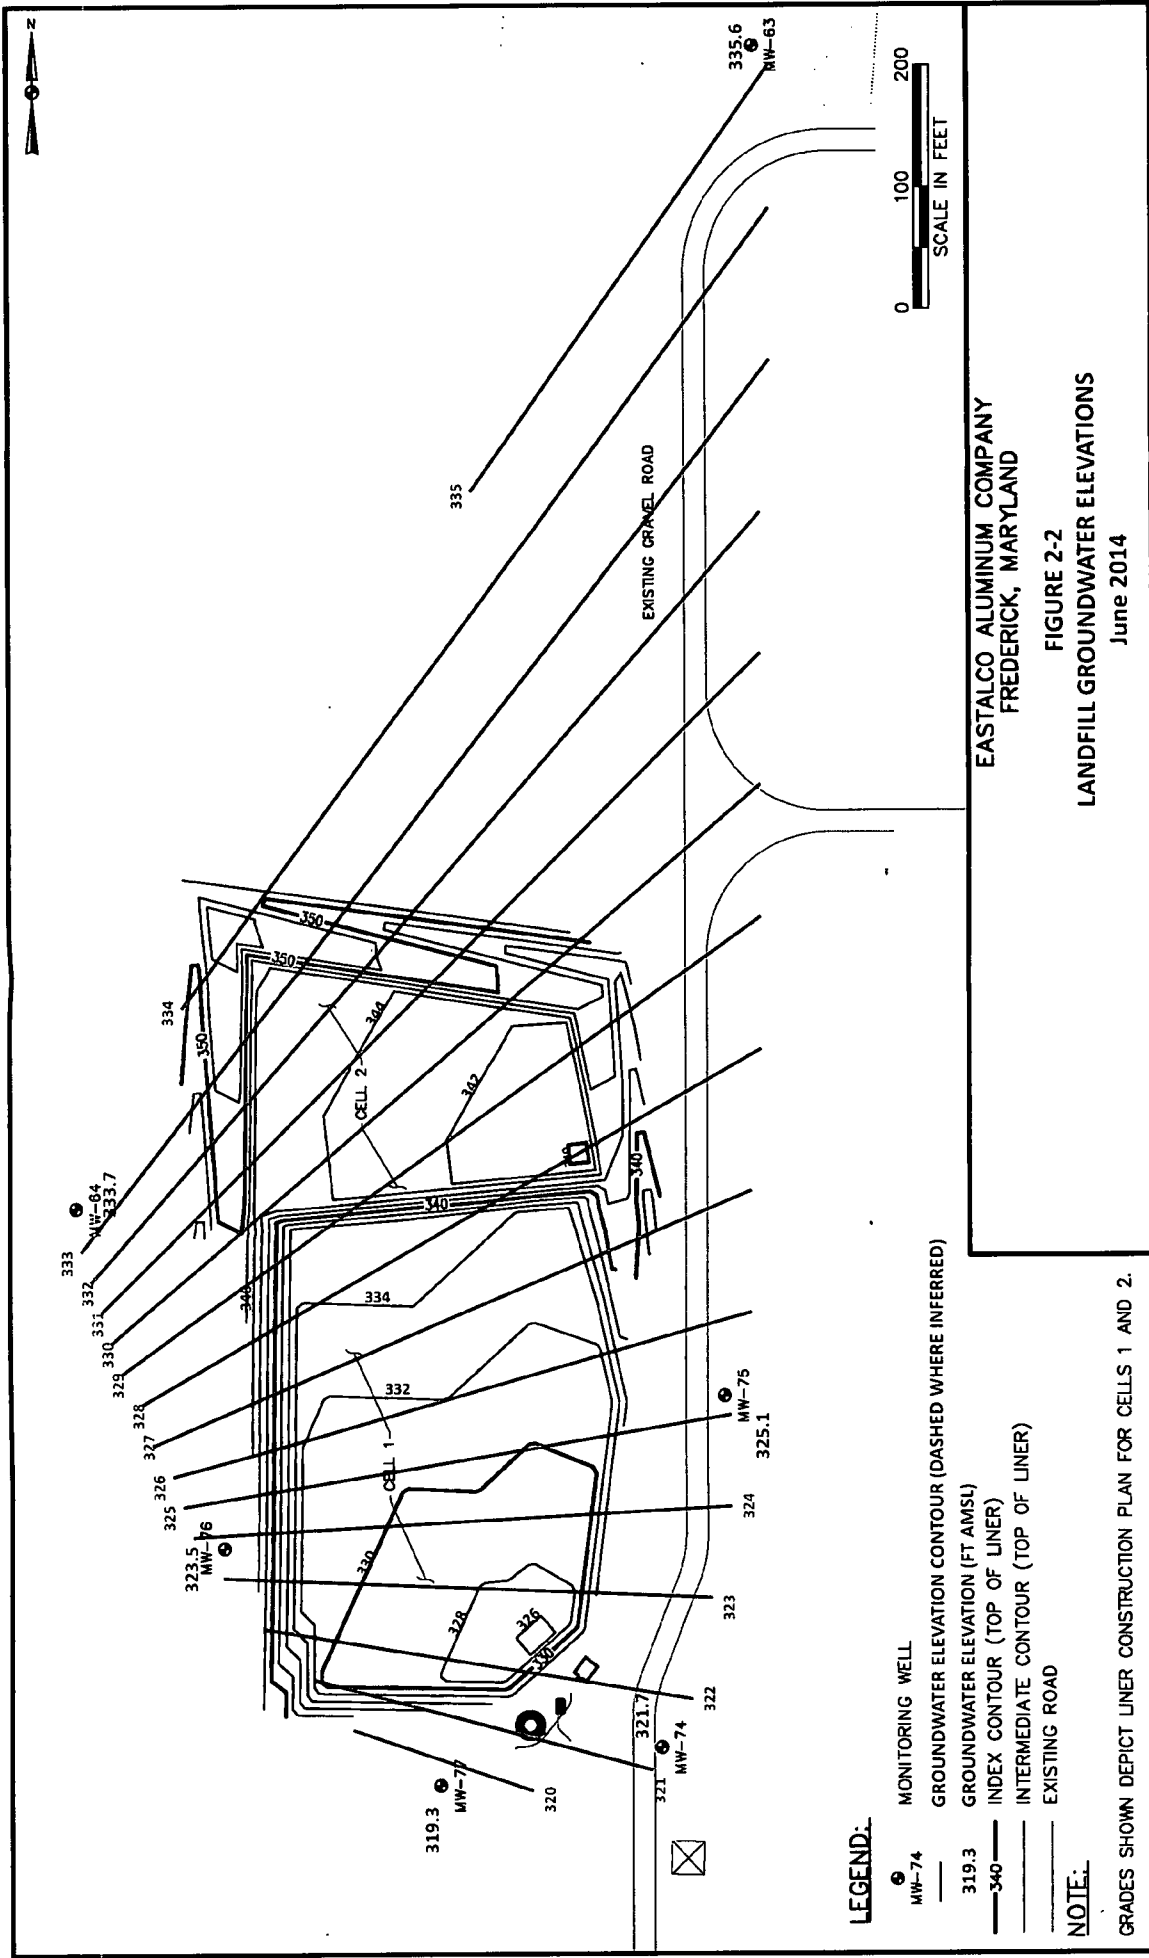
- MW-74 MONITORING WELL
- GROUNDWATER ELEVATION CONTOUR (DASHED WHERE INFERRED)
- 319.3 GROUNDWATER ELEVATION (FT AMSL)
- 340 INDEX CONTOUR (TOP OF LINER)
- INTERMEDIATE CONTOUR (TOP OF LINER)
- EXISTING ROAD

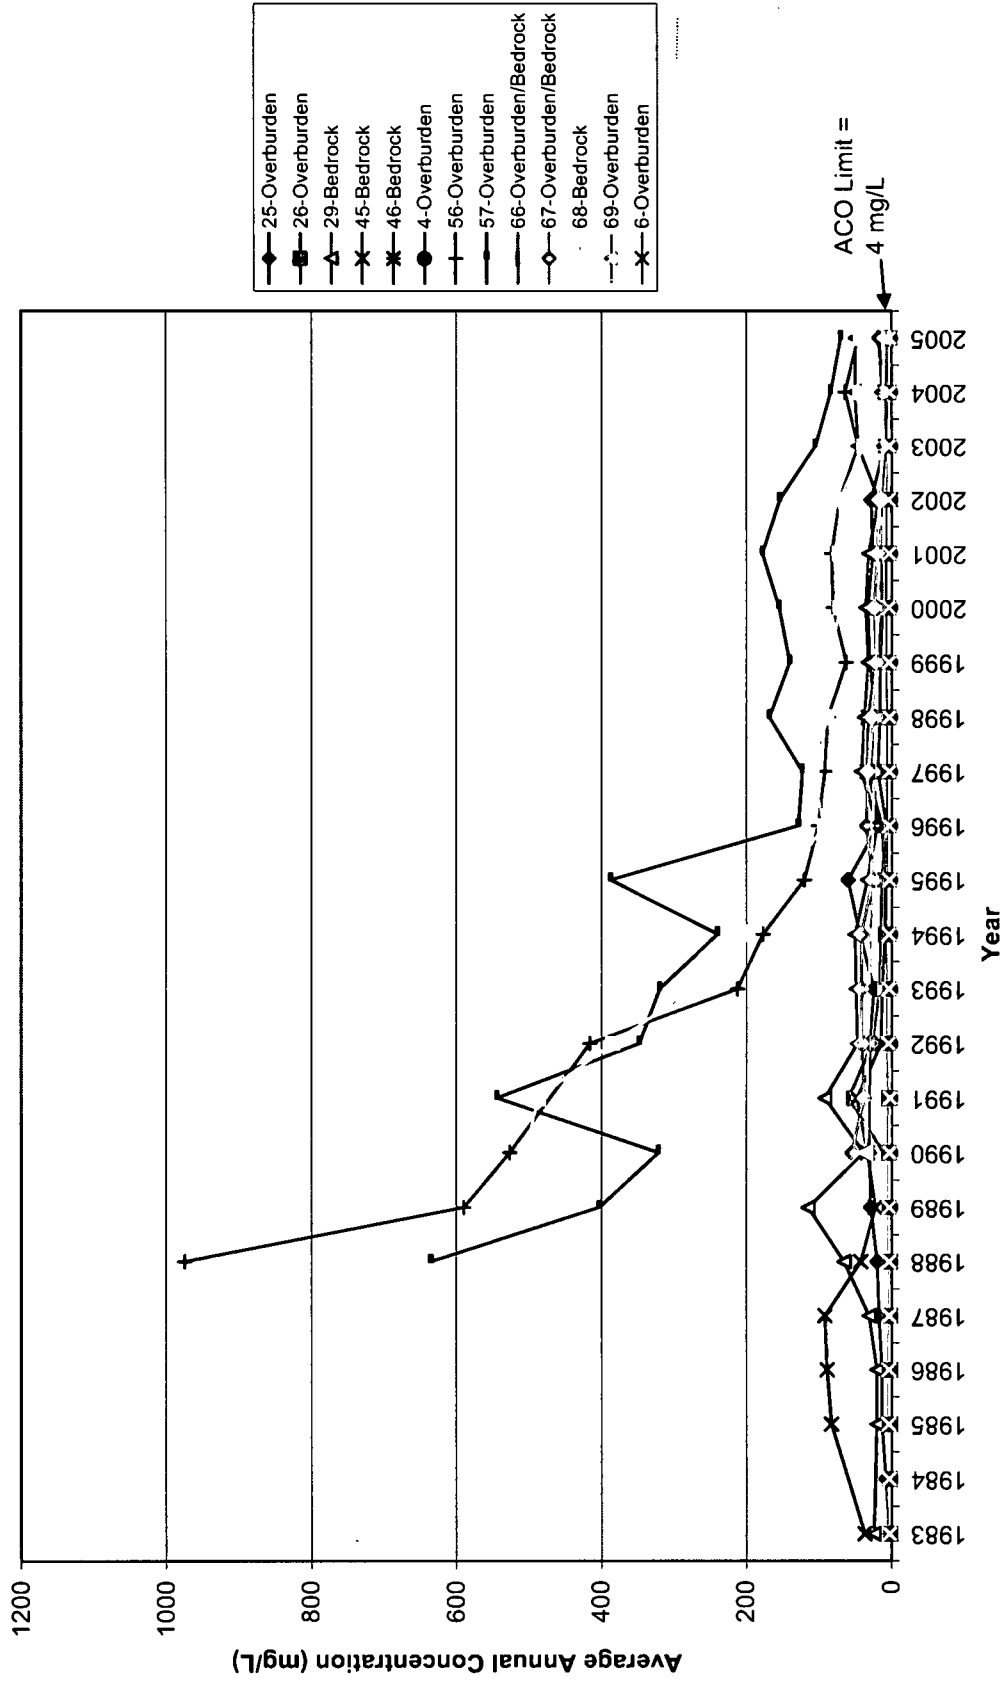
Figure 3-3

Fluoride in Groundwater near Primary Source Area

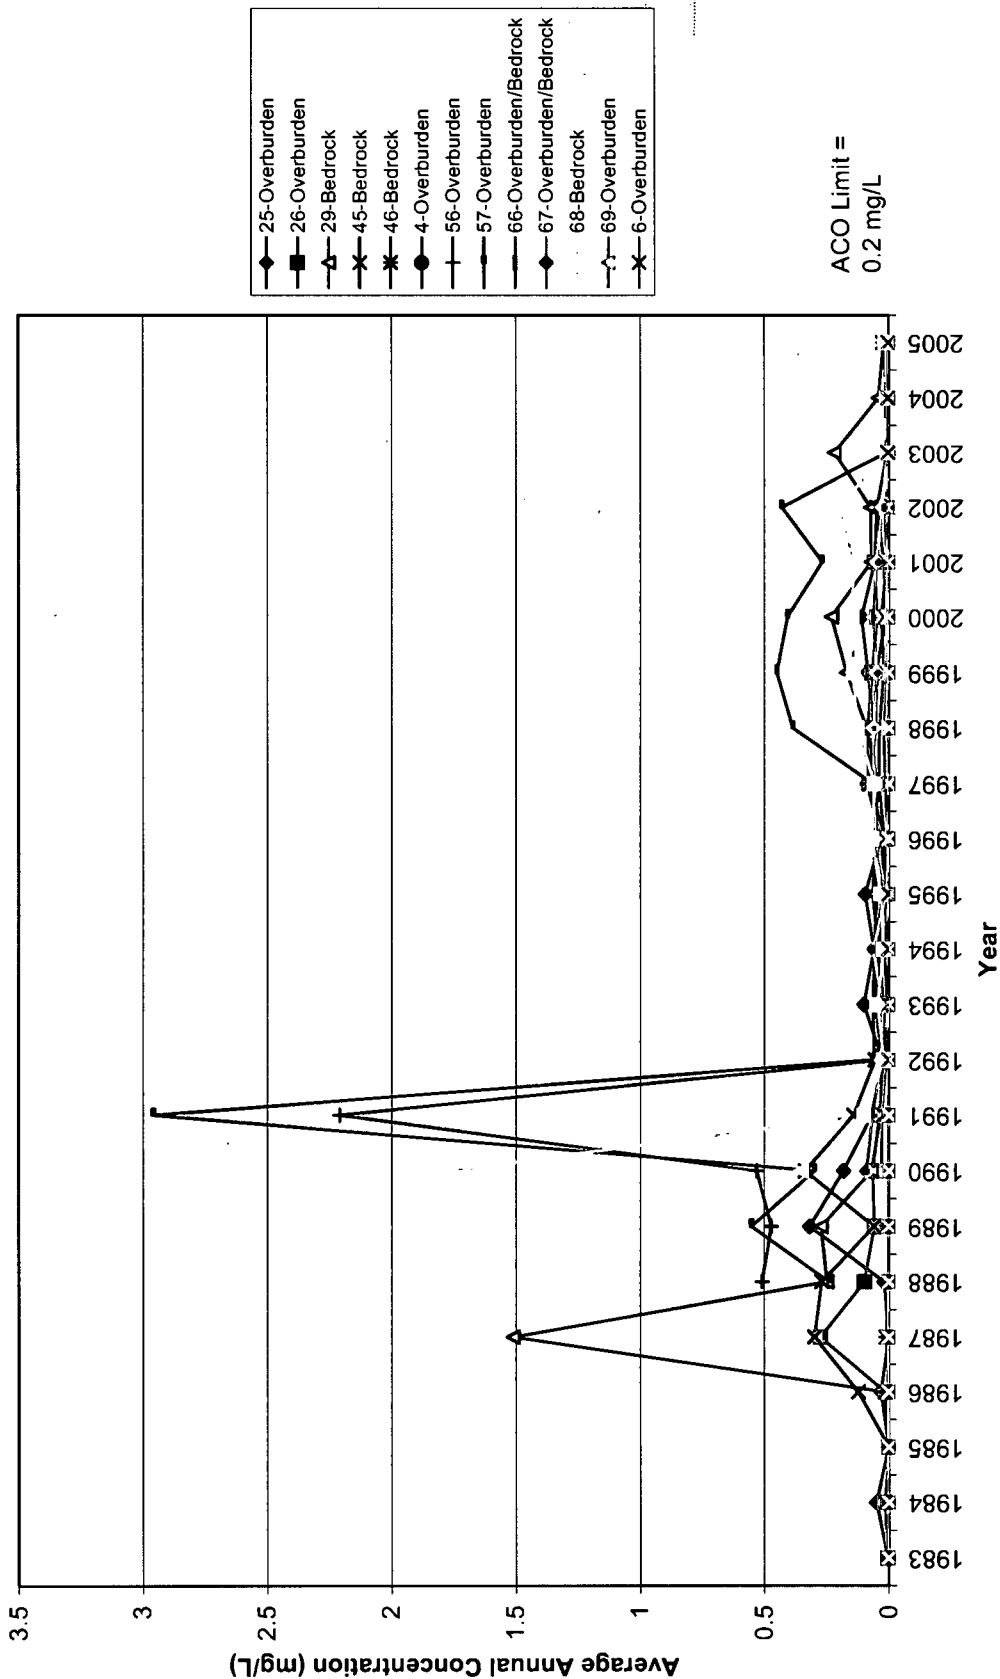
Figure 3-4

Free Cyanide in Groundwater near Primary Source Area

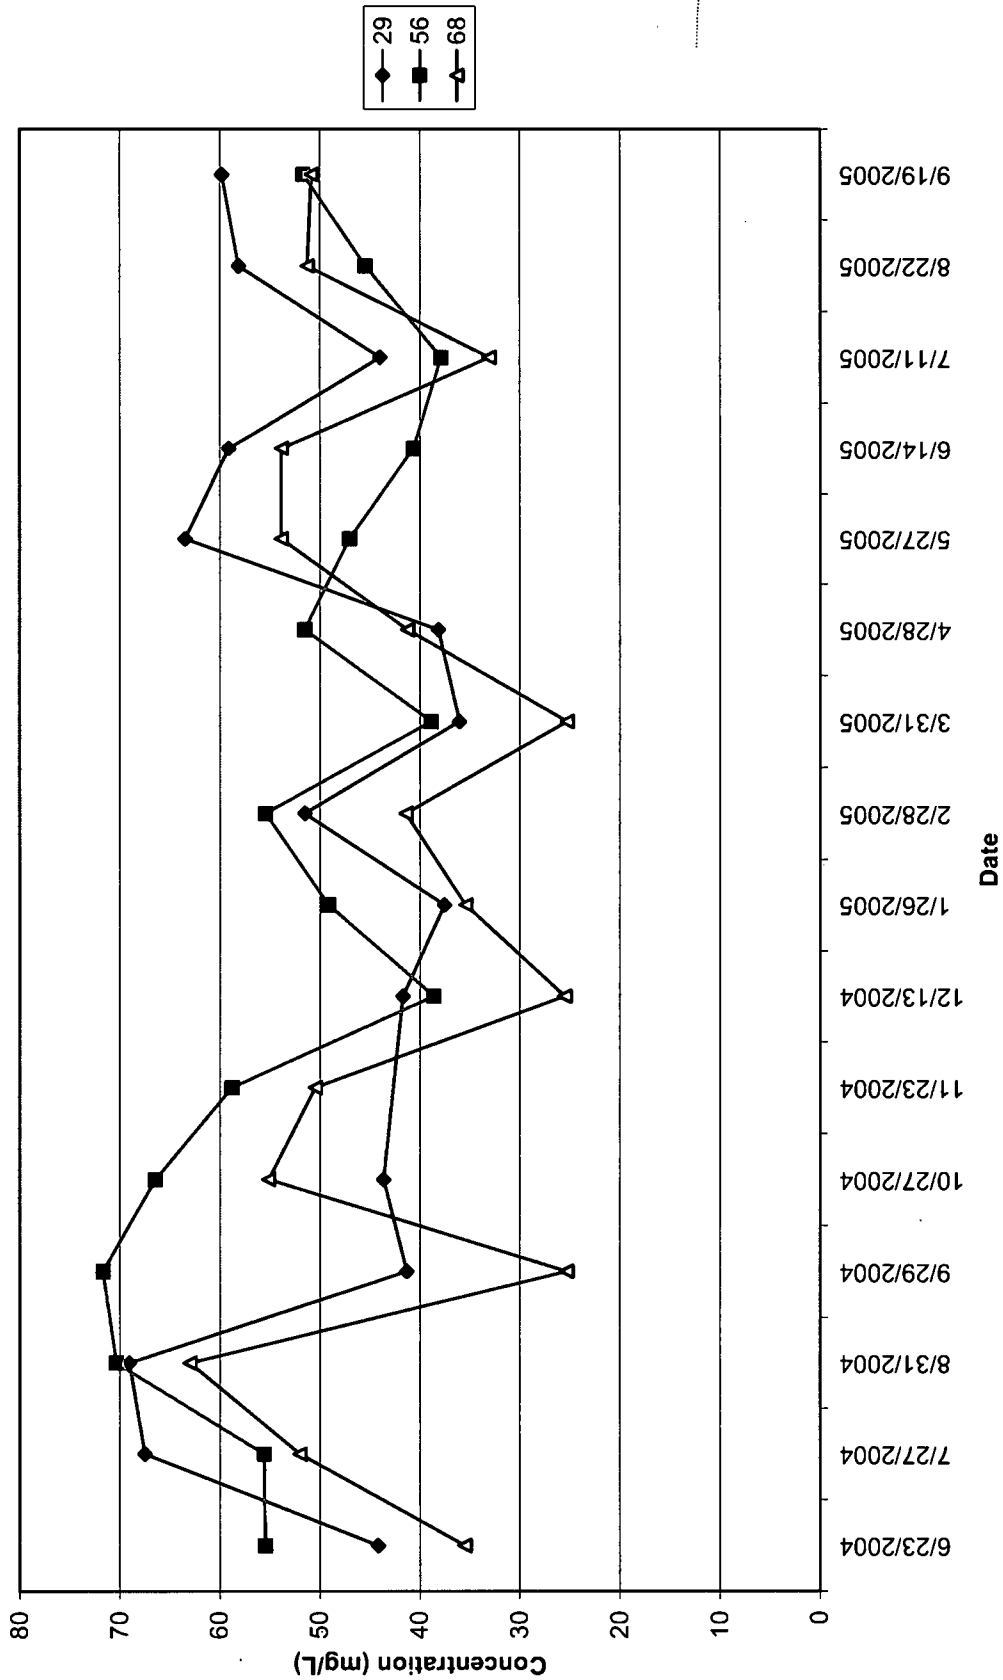
Figure 3-5

Comparison of Fluoride Concentrations in Former Recovery Wells

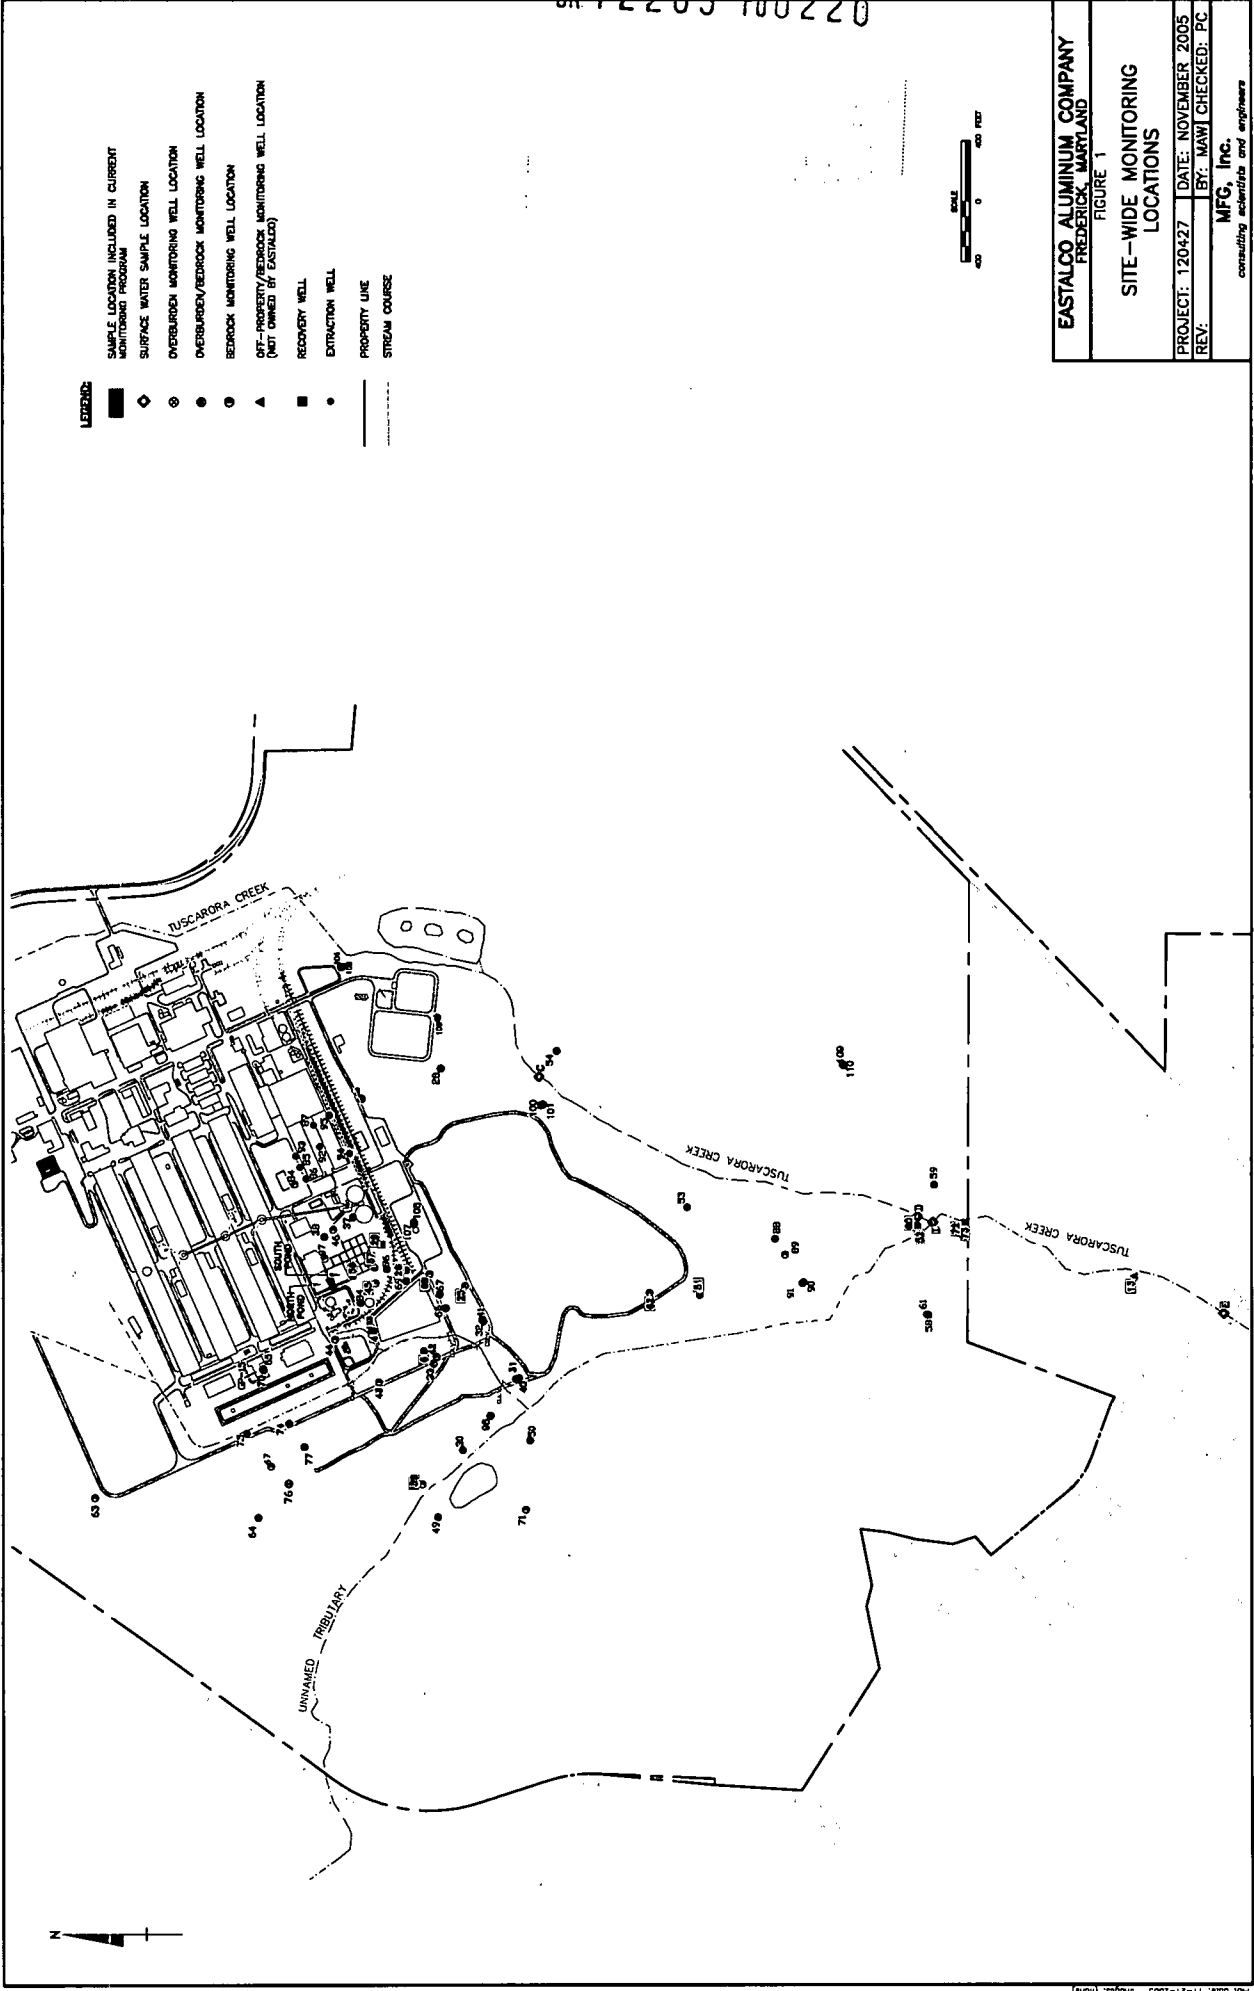
- SAMPLE LOCATION INCLUDED IN CURRENT MONITORING PROGRAM
- ◊ SURFACE WATER SAMPLE LOCATION
- ⊙ OVERBURDEN MONITORING WELL LOCATION
- ⊖ OVERBURDEN/BEDROCK MONITORING WELL LOCATION
- ⊙ BEDROCK MONITORING WELL LOCATION
- ▲ OFF-PROPERTY/BEDROCK MONITORING WELL LOCATION (NOT OWNED BY EASTALCO)
- RECOVERY WELL
- EXTRACTION WELL
- - - - - PROPERTY LINE
- - - - - STREAM COURSE

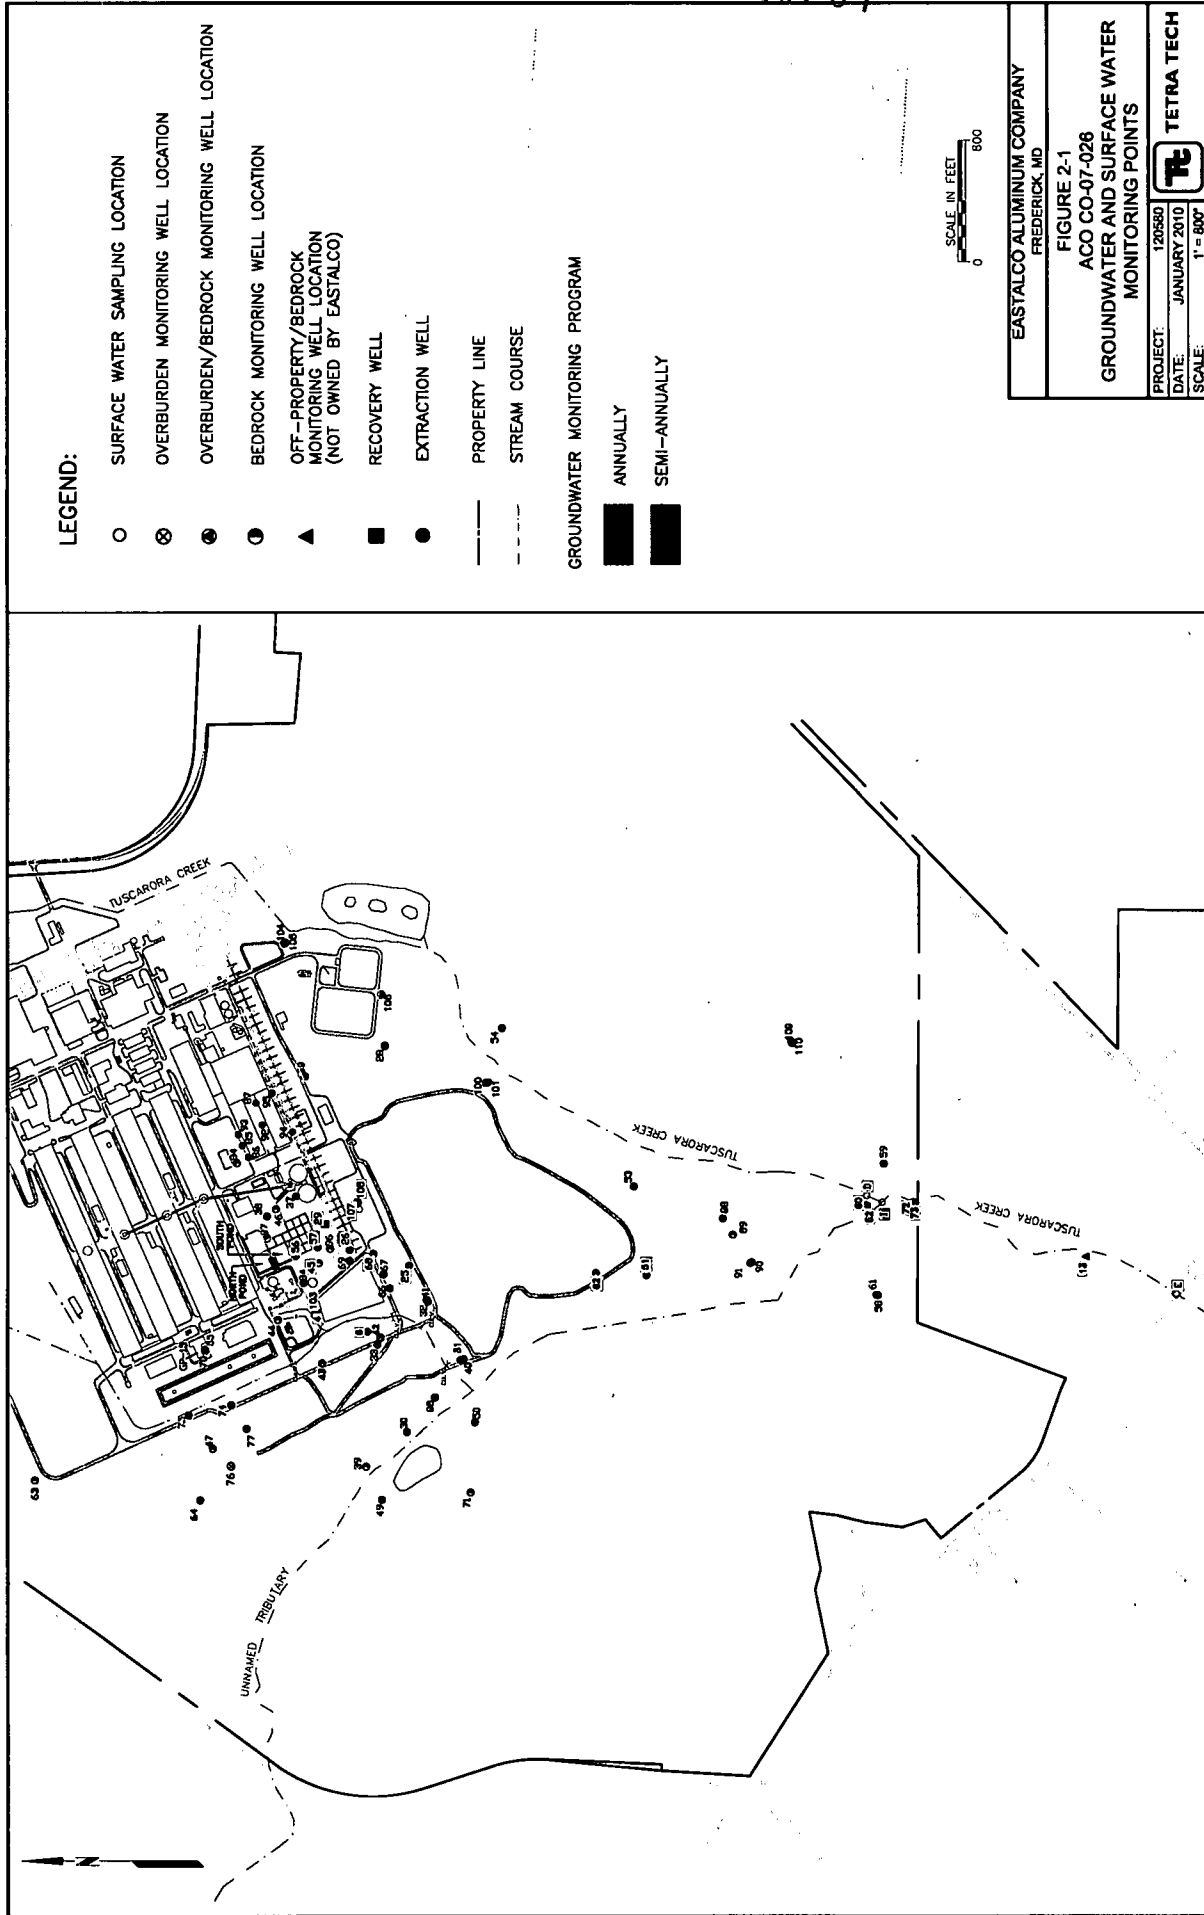
FIGURE
 1-1

This monitoring plan was prepared by Tetra Tech, Inc. (MFG) for Alcoa Eastalco (Eastalco) to provide the scope of work and procedures for monitoring groundwater and surface water in accordance with Administrative Consent Order CO-07-026 (ACO). The Alcoa Eastalco facility is a closed aluminum smelter located in Frederick, Maryland (Figure 1-1).
