# **Maryland Department of Environment**

Inspector: AI ID:	Christopher Lepadatu 3076
Site Name:	Patapsco WWTP
Facility Address:	3501 Asiatic Ave, Curtis Bay, MD 21226
County:	Baltimore City County
Start Date/Time: End Date /Time: Media Type(s):	November 27, 2023 11:45 AM November 27, 2023 01:00 PM NPDES Municipal Major Surface Water
Contact(s):	Neal Jackson, Plant Manager, Patapsco WWTP Chris Saunders, Senior Associate of Hazen & Sawyers Scott Moffatt, Policy Analyst, Environmental Compliance, Baltimore City

# **NPDES Municipal Major Surface Water**

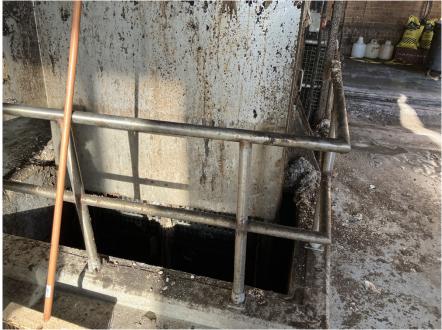
The Industrial Plant Influent (IPI) contains two (2) fine screens and four (4) pumps for conveying flow to the primary clarifiers. The IPI building has approximately 2-3 MGD capacity for industrial influent. Bar screen #1 was not in use during the time of the inspection. The two (2) fine screens in the IPI building receive flow by means of individual channels and gates for flow control. The gate for Bar screen #1 is not functional and needs maintenance. Bar screen #2 was observed to be in operation. Screened and raked material is discharged into rolling dumpsters, one for each fine screen. The dumpsters rest in a concrete channel where they can be winched to the exterior of the IPI building for waste collection.

Image 1: IPI Building, Screen 2.

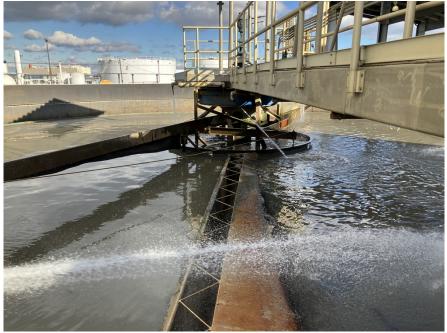
There are three (3) 65-ft diameter gravity sludge thickeners (GSTs) in the sludge handling area of the plant. The GSTs are numbered #1, #2, and #4. GSTs #1 and #2 are built on grade and GST #4 is elevated above grade. The skimming arms of GST #1 and #2 are missing significant portions of the rubber flaps which should extend down to the liquid surface to effectively remove surface scum. Currently, staff spray water on the surface of GST #1 and #2 in order to manually remove surface scum. Repairs for the skimming arms are reportedly planned and a vendor has been selected to complete the repairs.

Image 2: GST #1, Broken & missing skimmer flaps.

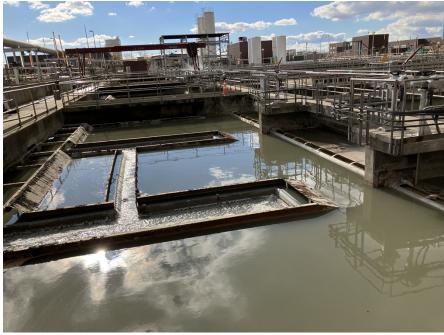
Image 3: PST # 2, Effluent.

At the time of the site inspection, PSTs #1, #2, #5, and #6 were in service. PSTs #3 and #4 were out of service for maintenance.

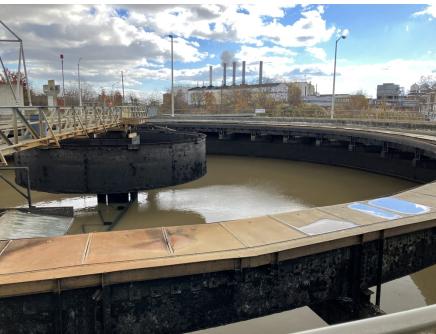
Secondary clarifier #5b was drawn down for repairs and maintenance.

Image 4: Clarifier #5b, Drawn down

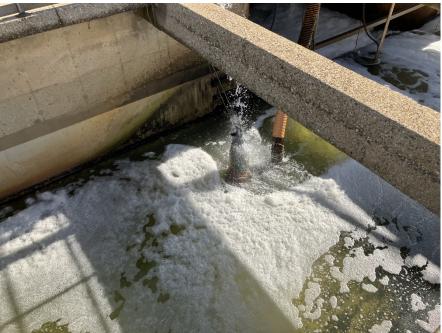
Foam was observed on the surface of the final discharge channel which appeared to disperse rapidly. BAF media and FOGs were not observed to be leaving the site via the effluent channel.

Image 5: Final effluent.
