**Exhibit E**  
**Aquatic Life Data**

# Maryland Stream Health

Drawing #'s are referenced from WQC Site Exhibits located in Appendix C.  
All potentially impacted streams within map extent are designated Stream Use Class I.

### MBSS Site Summary for: ANAC-326-R-2004

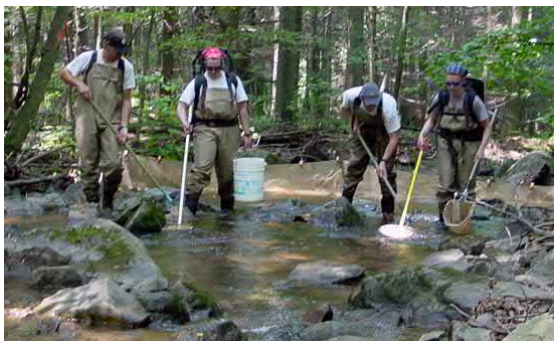
Electrofishing to sample fish communities.

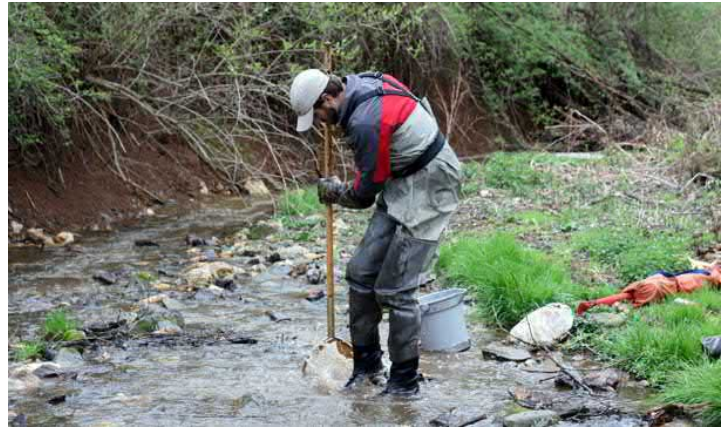
Sampling with a kick net for benthic macroinvertebrates.

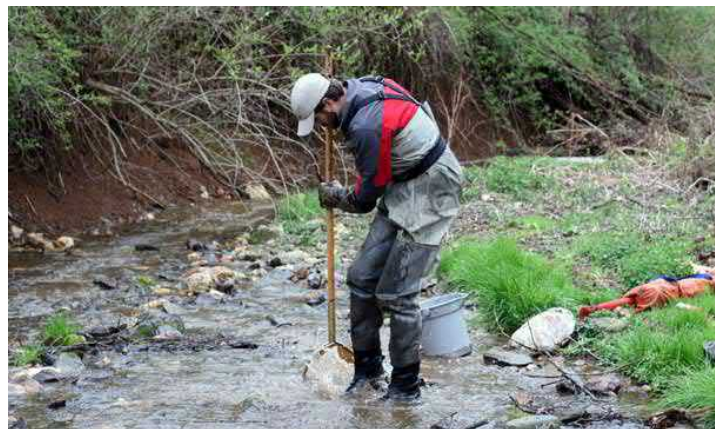
Sampling with a kick net for benthic macroinvertebrates.

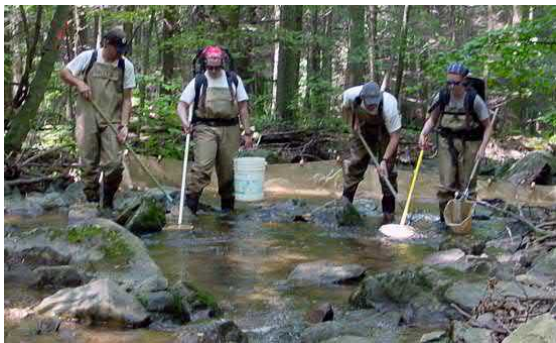
Electrofishing to sample fish communities.

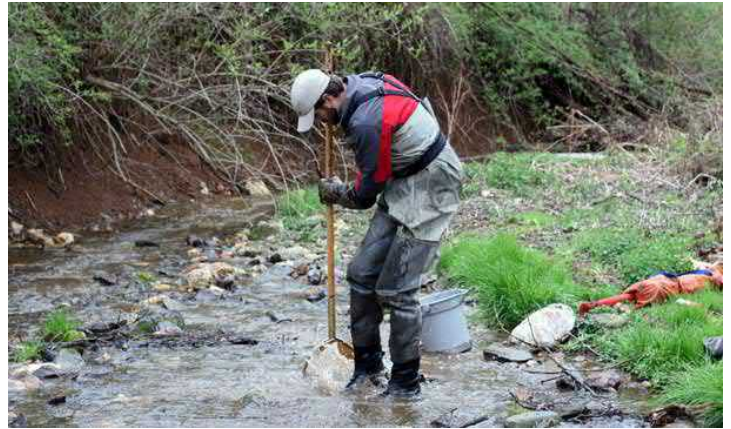
Sampling with a kick net for benthic macroinvertebrates.

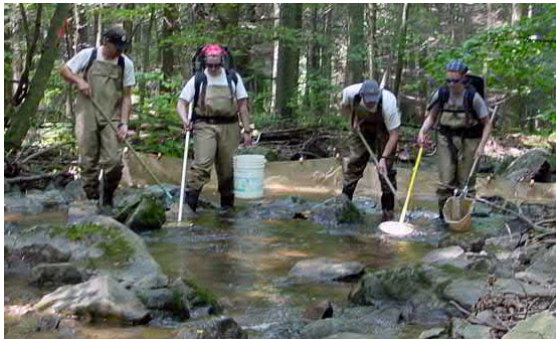
Electrofishing to sample fish communities.

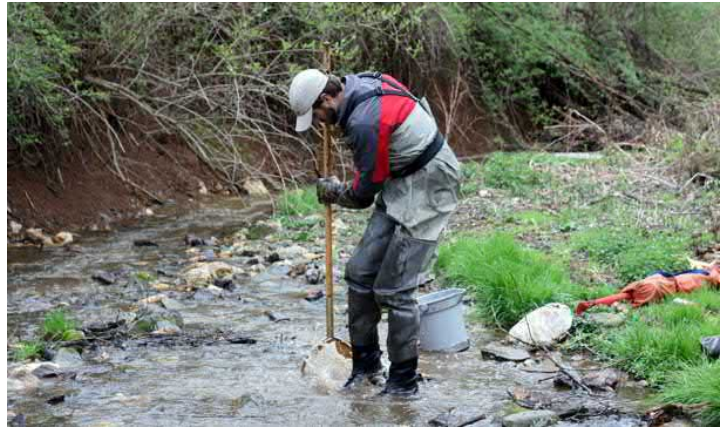
Sampling with a kick net for benthic macroinvertebrates.

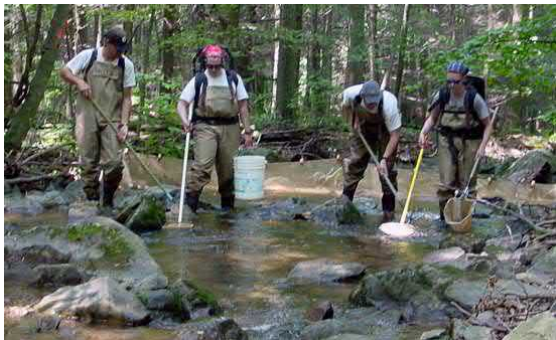
Electrofishing to sample fish communities.

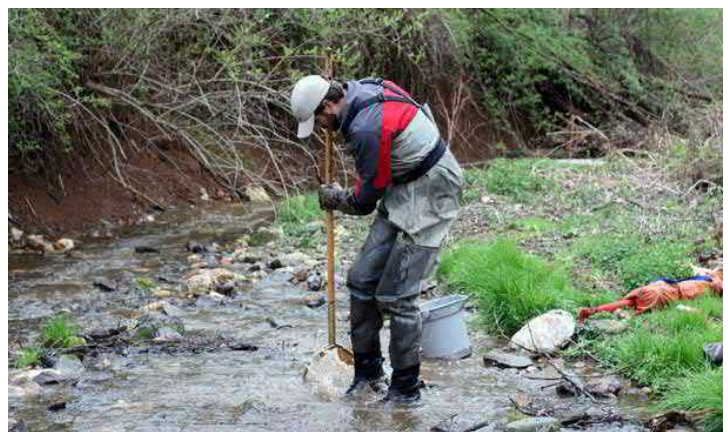
Sampling with a kick net for benthic macroinvertebrates.

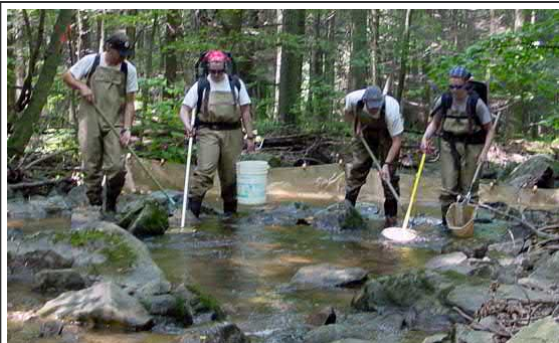
Electrofishing to sample fish communities.

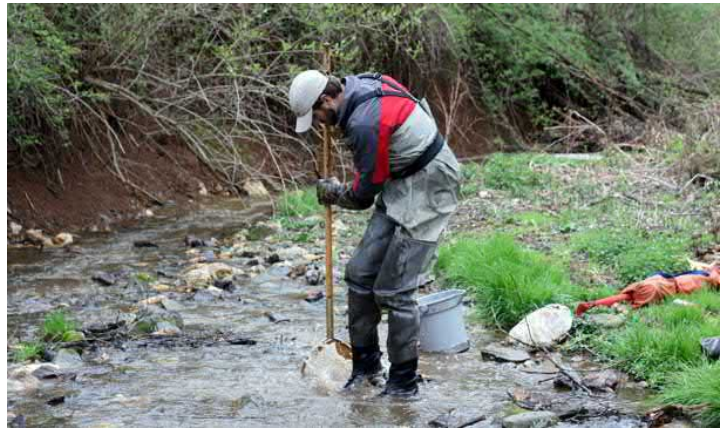
Sampling with a kick net for benthic macroinvertebrates.

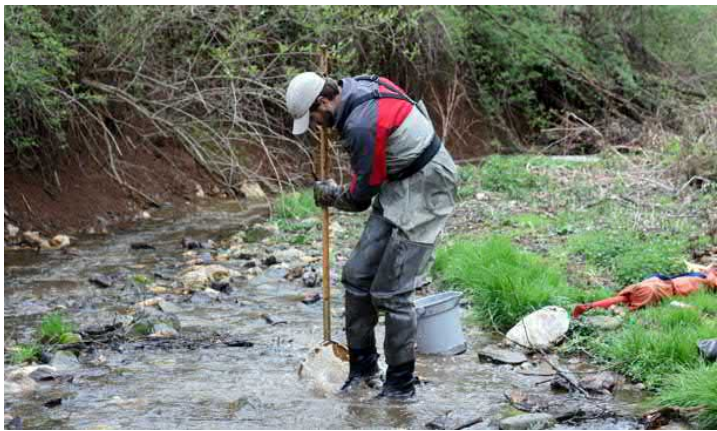
Sampling with a kick net for benthic macroinvertebrates.
