SOURCE WATER ASSESSMENT

For the Midland-Lonaconing Water System

Prepared By
Maryland Department of the Environment
Water Management Administration
Water Supply Program
December 2000

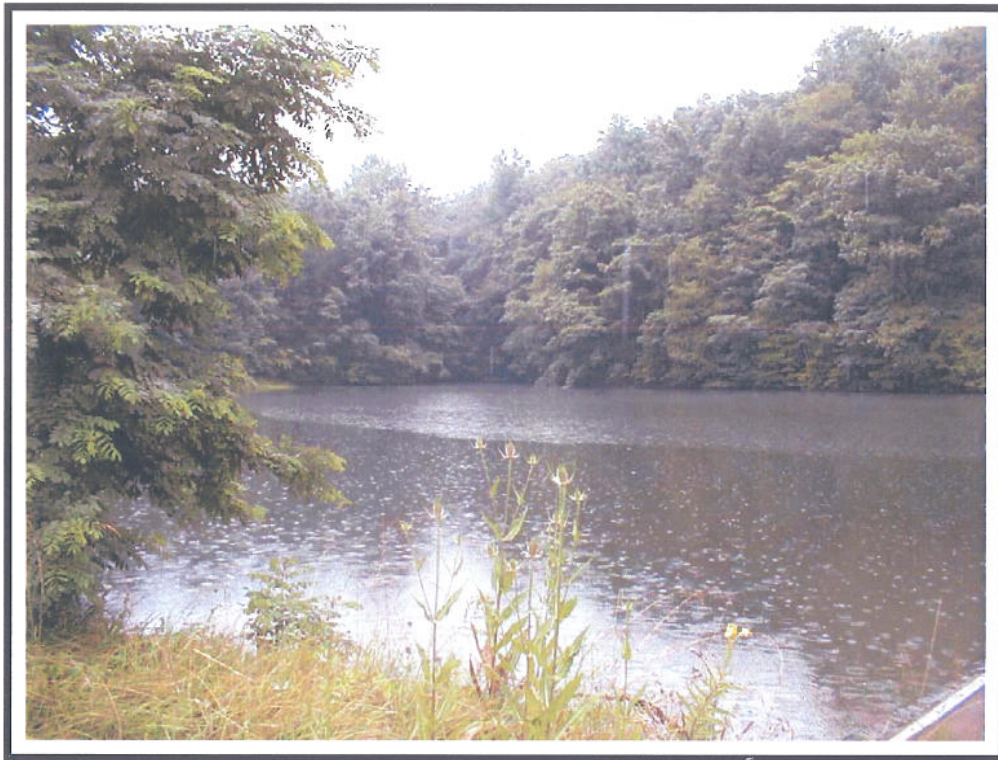
Photo of Midland-Gilmore Reservoir

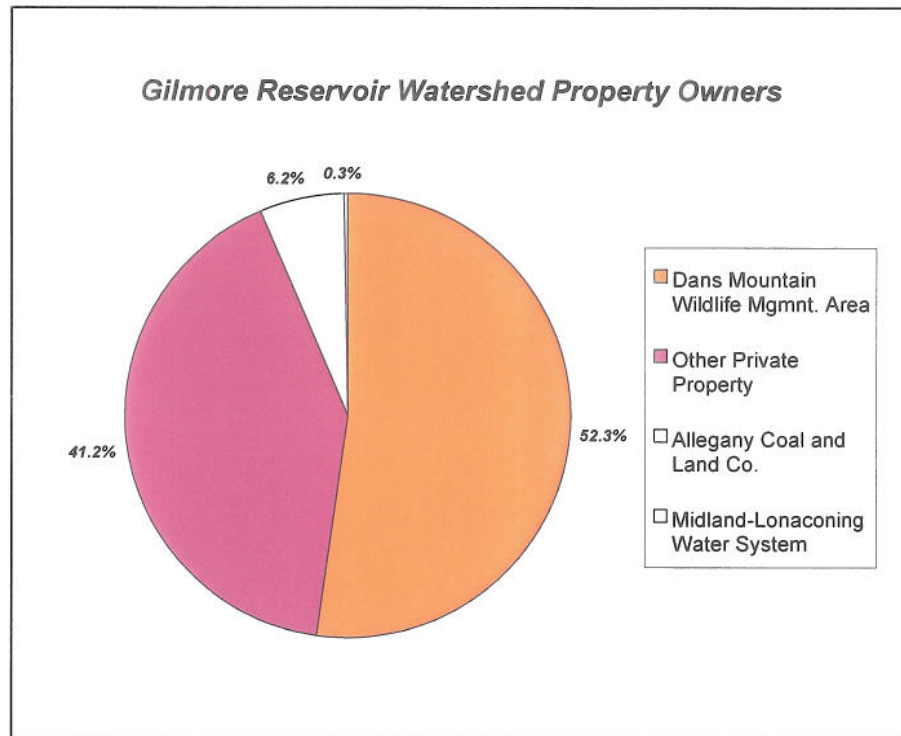
Chart2. Property Ownership

Based on the Maryland Office of Planning’s 1999 Property View, there are approximately 26 landowners in the watershed, including the State of Maryland and the Town of Lonaconing. The property breakdown is as follows:

Property	Type	Total Area in Acres	Percent of Total Watershed
Dans Mountain WMA	State Land	821	52%
Other Private Property	Private	646	41%
Allegany Coal and Land Co.	Private (Company)	97	6%
Town of Lonaconing	Municipal	5	<1%

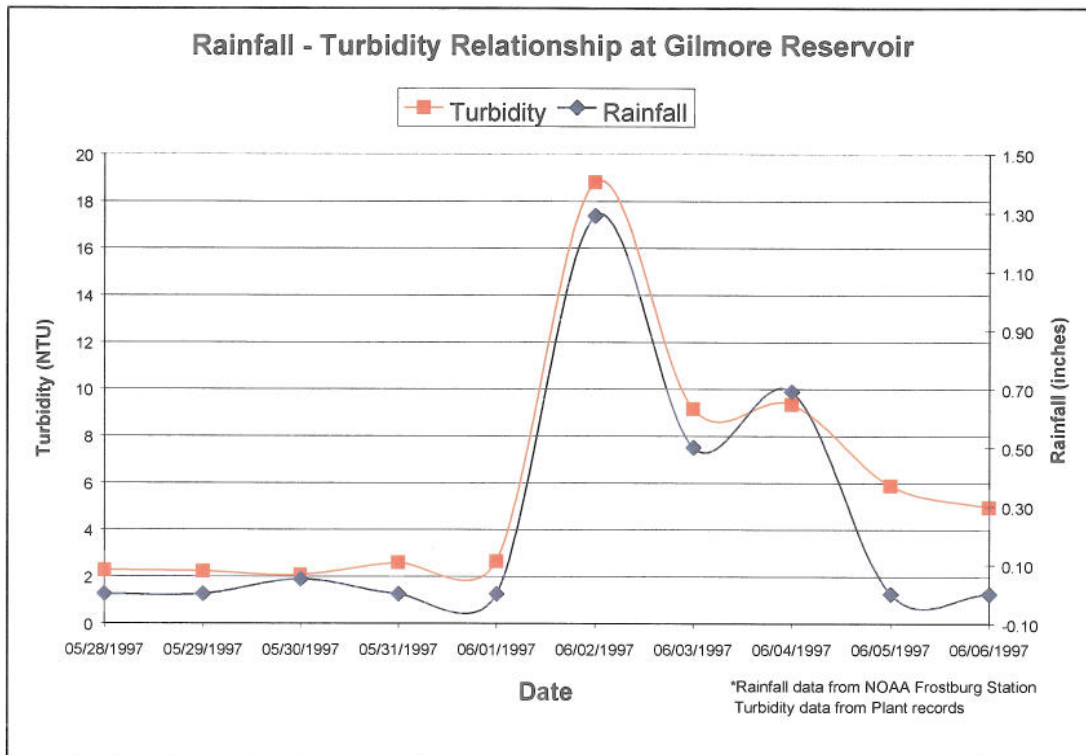
Chart3. Turbidity-Rainfall Relationship

Average turbidity in the reservoir for the past five years (1996-current) is approximately 4.6 NTU. Excessive turbidity can interfere with water treatment and can carry harmful microorganisms into drinking water supplies. The highest turbidity recorded in the reservoir, 100 NTU, occurred in August of 1996. Higher turbidity results from storm events, snowmelt, and by the addition of well water that when oxidized in the reservoir increases the iron and manganese concentrations. The turbidity problem in Midland-Gilmore reservoir is most likely caused by increased runoff during storm events. Storm events can quickly increase the turbidity of the reservoir. An example of a storm's effect on turbidity is shown below:

A significant amount of rainfall can increase the turbidity at the plant's intake within a 24-hour period. This re-occurring situation has caused operational problems at the Gilmore plant, and high turbidity events have resulted in numerous violations and boil-water advisories. The Midland-Gilmore system has received 35 violations for exceeding finished water turbidity limits since 1990. The system was in violation of turbidity standards for most of 1992-1993, and has been in violation as recently as February 2000.

The main source of turbidity contamination is most likely erosion from stream banks along Elklick Run. During one rain event, turbidity was measured in both tributaries just above the confluence. Continuous readings were measured for approximately 15 minutes, and the main stem turbidity ranged from 5.5-8.4 NTU. Turbidity on the southwest stem averaged around 1.5 NTU. Analysis of land use data and satellite spot images show that the main stem is comparatively closer to Bushkirk Hollow Rd, adjacent housing, and open agricultural land in the upper reaches of the watershed. This may contribute to more runoff during storm events resulting in increased erosion and higher turbidity. The access road that crosses Elklick Run and the access road to the reservoir, both unimproved, may also contribute. Overflow directly into the reservoir from the storm water drainage culvert along Bushkirk Hollow Rd. is also another potential source of turbidity contamination during storm events.

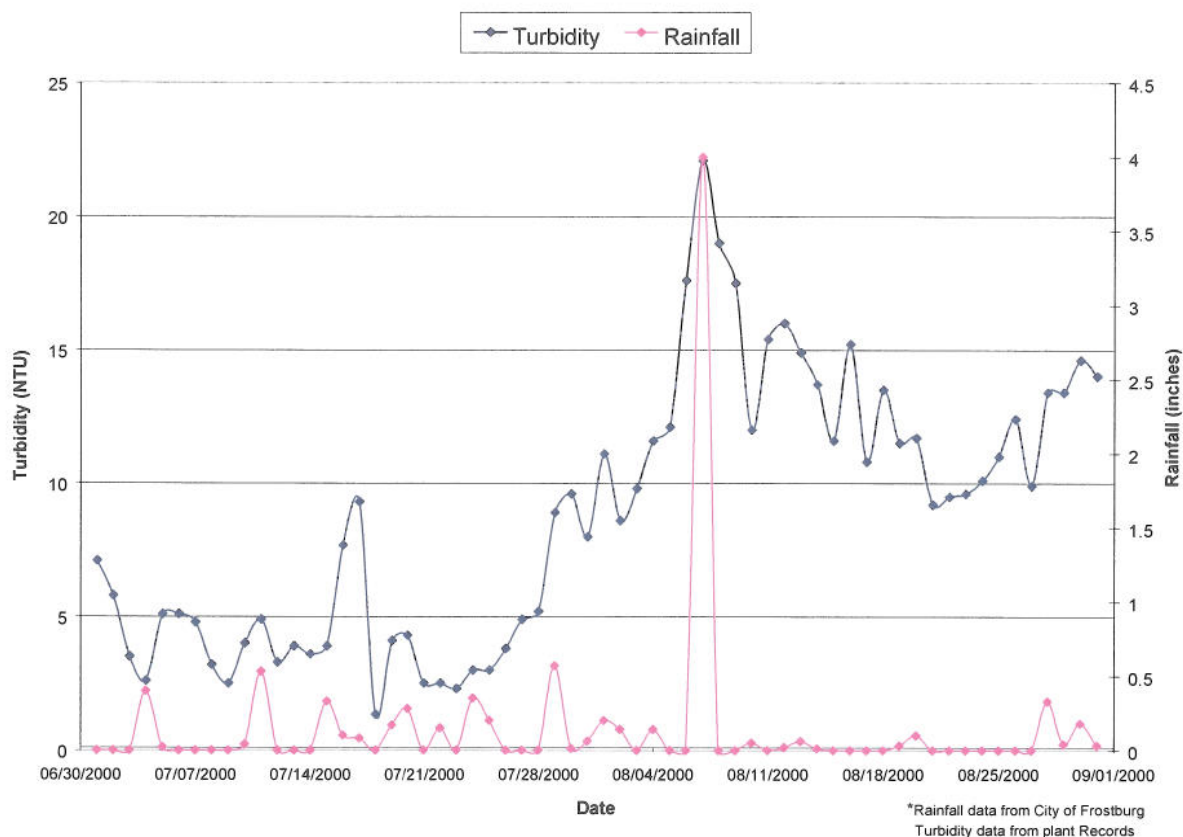
Rainfall - Turbidity Relationship at Charlestown Reservoir

Review of plant records and discussion with town officials indicate that periodic increases of

turbidity in the reservoir have been and continue to be a common occurrence. High turbidity can interfere with water treatment and is correlated with high levels of pathogenic microorganisms. This re-occurring situation has caused operational problems at the Gilmore plant, and high turbidity events have resulted in numerous violations and boil-water advisories. The Midland-Gilmore system has received 35 violations for exceeding finished water turbidity limits since 1990. The system was in violation of turbidity standards for most of 1992-1993, and has been in violation as recently as February 2000.

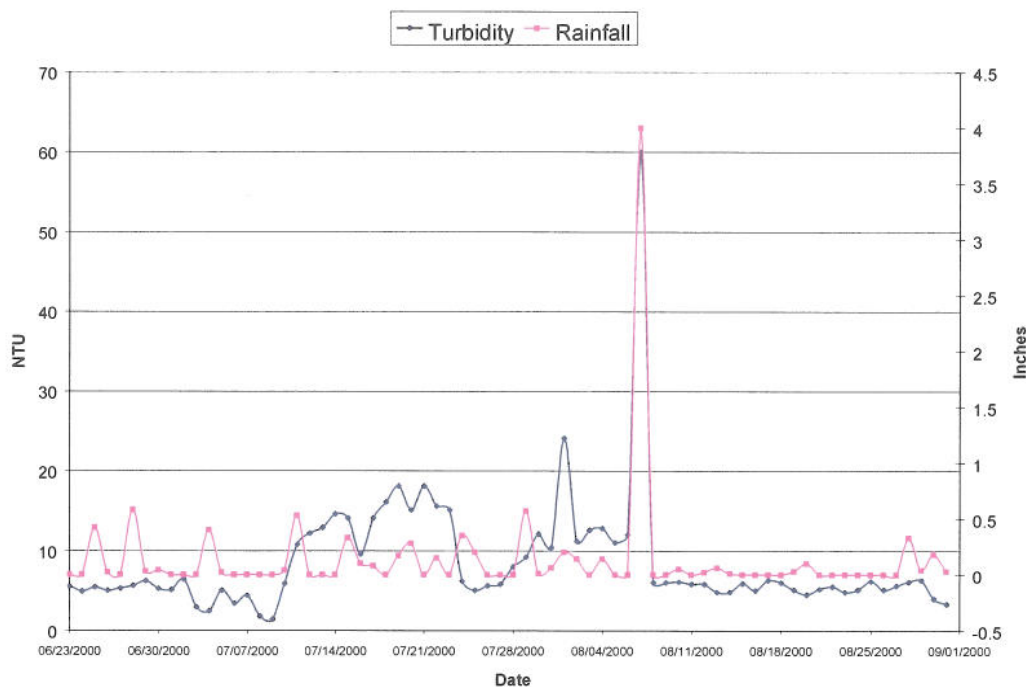
Rainfall-Turbidity Relationship at Koontz Reservoir

Average turbidity in the Koontz reservoir over the past two years has averaged 5.0 NTU, heightened by the 22 NTU average turbidity for January 1999. Like the other two Midland-Lonaconing reservoirs, Koontz is subject to periods of high turbidity, usually the as the result of a storm event or snowmelt. The graph below depicts plant turbidity data from a portion of the summer 2000; it is an example of the rainfall-turbidity relationship in the reservoir.

Koontz reservoir shares common turbidity characteristics with the other two reservoirs in the system. It has a history of periodic turbidity problems related to land use changes and storm water runoff, these instances can lead to operation problems at the water plant, and consequently cause Midland-Lonaconing to be in violation of finished turbidity standards (see discussions in Gilmore and Charlestown susceptibility analysis for more detail). Like Gilmore and Charlestown, these turbidity situations still occur periodically at Koontz reservoir.
