**WELLHEAD AREA SURVEY
GREEN ARROW RESTAURANT
ACHD SITE NO. 31
Mount Savage, Allegany County, Maryland**

ALWI Project No. AL7N001

NONCOMMUNITY WATER SUPPLY SANITARY SURVEY

**Figure 2.
Composite
Source Water
Protection Area
for Mount Savage**

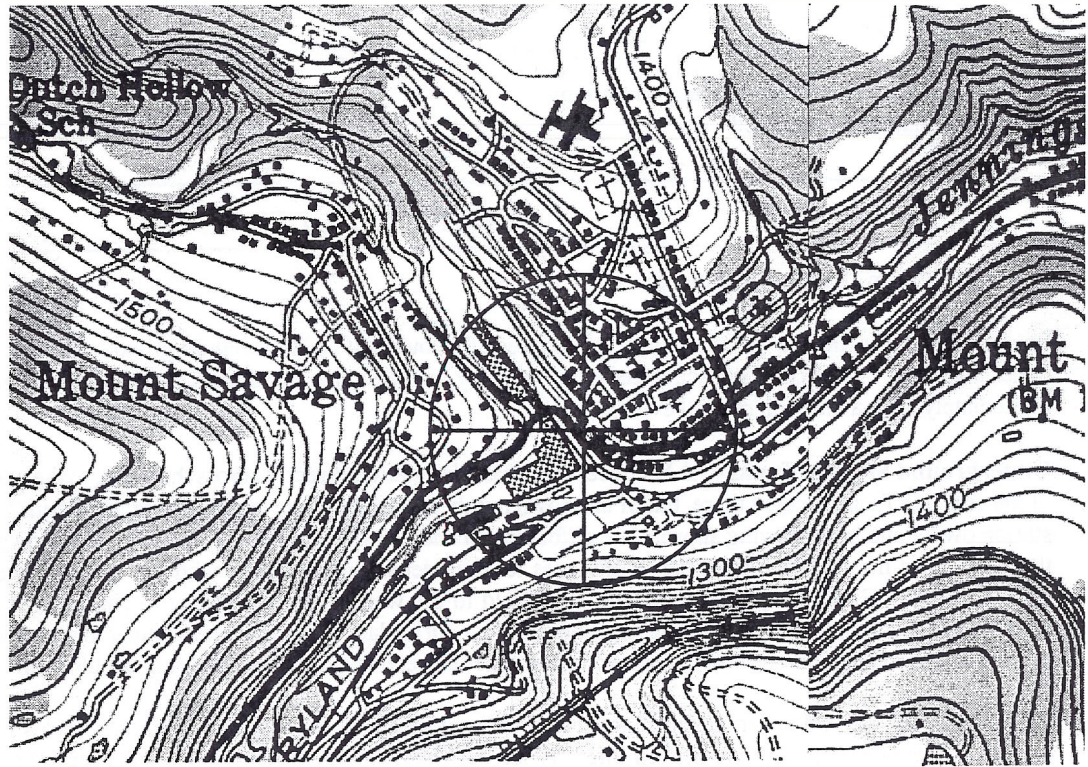
24. Well Location Diagram (1 in. = 1250 ft.) with Approximate Distances from Potential Contaminant Sources (i.e. septic, sewer lines, structures, petroleum storage, surface water bodies, etc.):

ALWI delineated an area of potential concern surrounding this site's well using generalized criteria developed by MDE for non-community supplies, as modified by ALWI (with ACHD consent) based on the specific topographic setting of the site. The resultant delineation is shown on the "Water Plant Information" survey form (Appendix B). ALWI used a fixed radius of 1,000 feet around the well, which creates an area of approximately 72 acres. Within an assumed 600 gallons per day per acre (gpd/ac) of annualized groundwater recharge (Slaughter and Darling, 1962, Table 37), slightly more than 43,000 gallons per day exists within the aquifer beneath this surveyed area. In actuality, the modest demand of this well (approximately 500 gpd) is more than one full order of magnitude smaller than the total available in the surveyed area, lending a high degree of conservatism to this analysis.

3. **Adjacent Well** - ALWI observed an adjacent well approximately 50 feet south of the Green Arrow well. The proximity of the two wells doubtlessly creates some degree of well interference, in which the operation of one well affects the operation of the other. Therefore, contaminants entering either well may adversely impact the other.

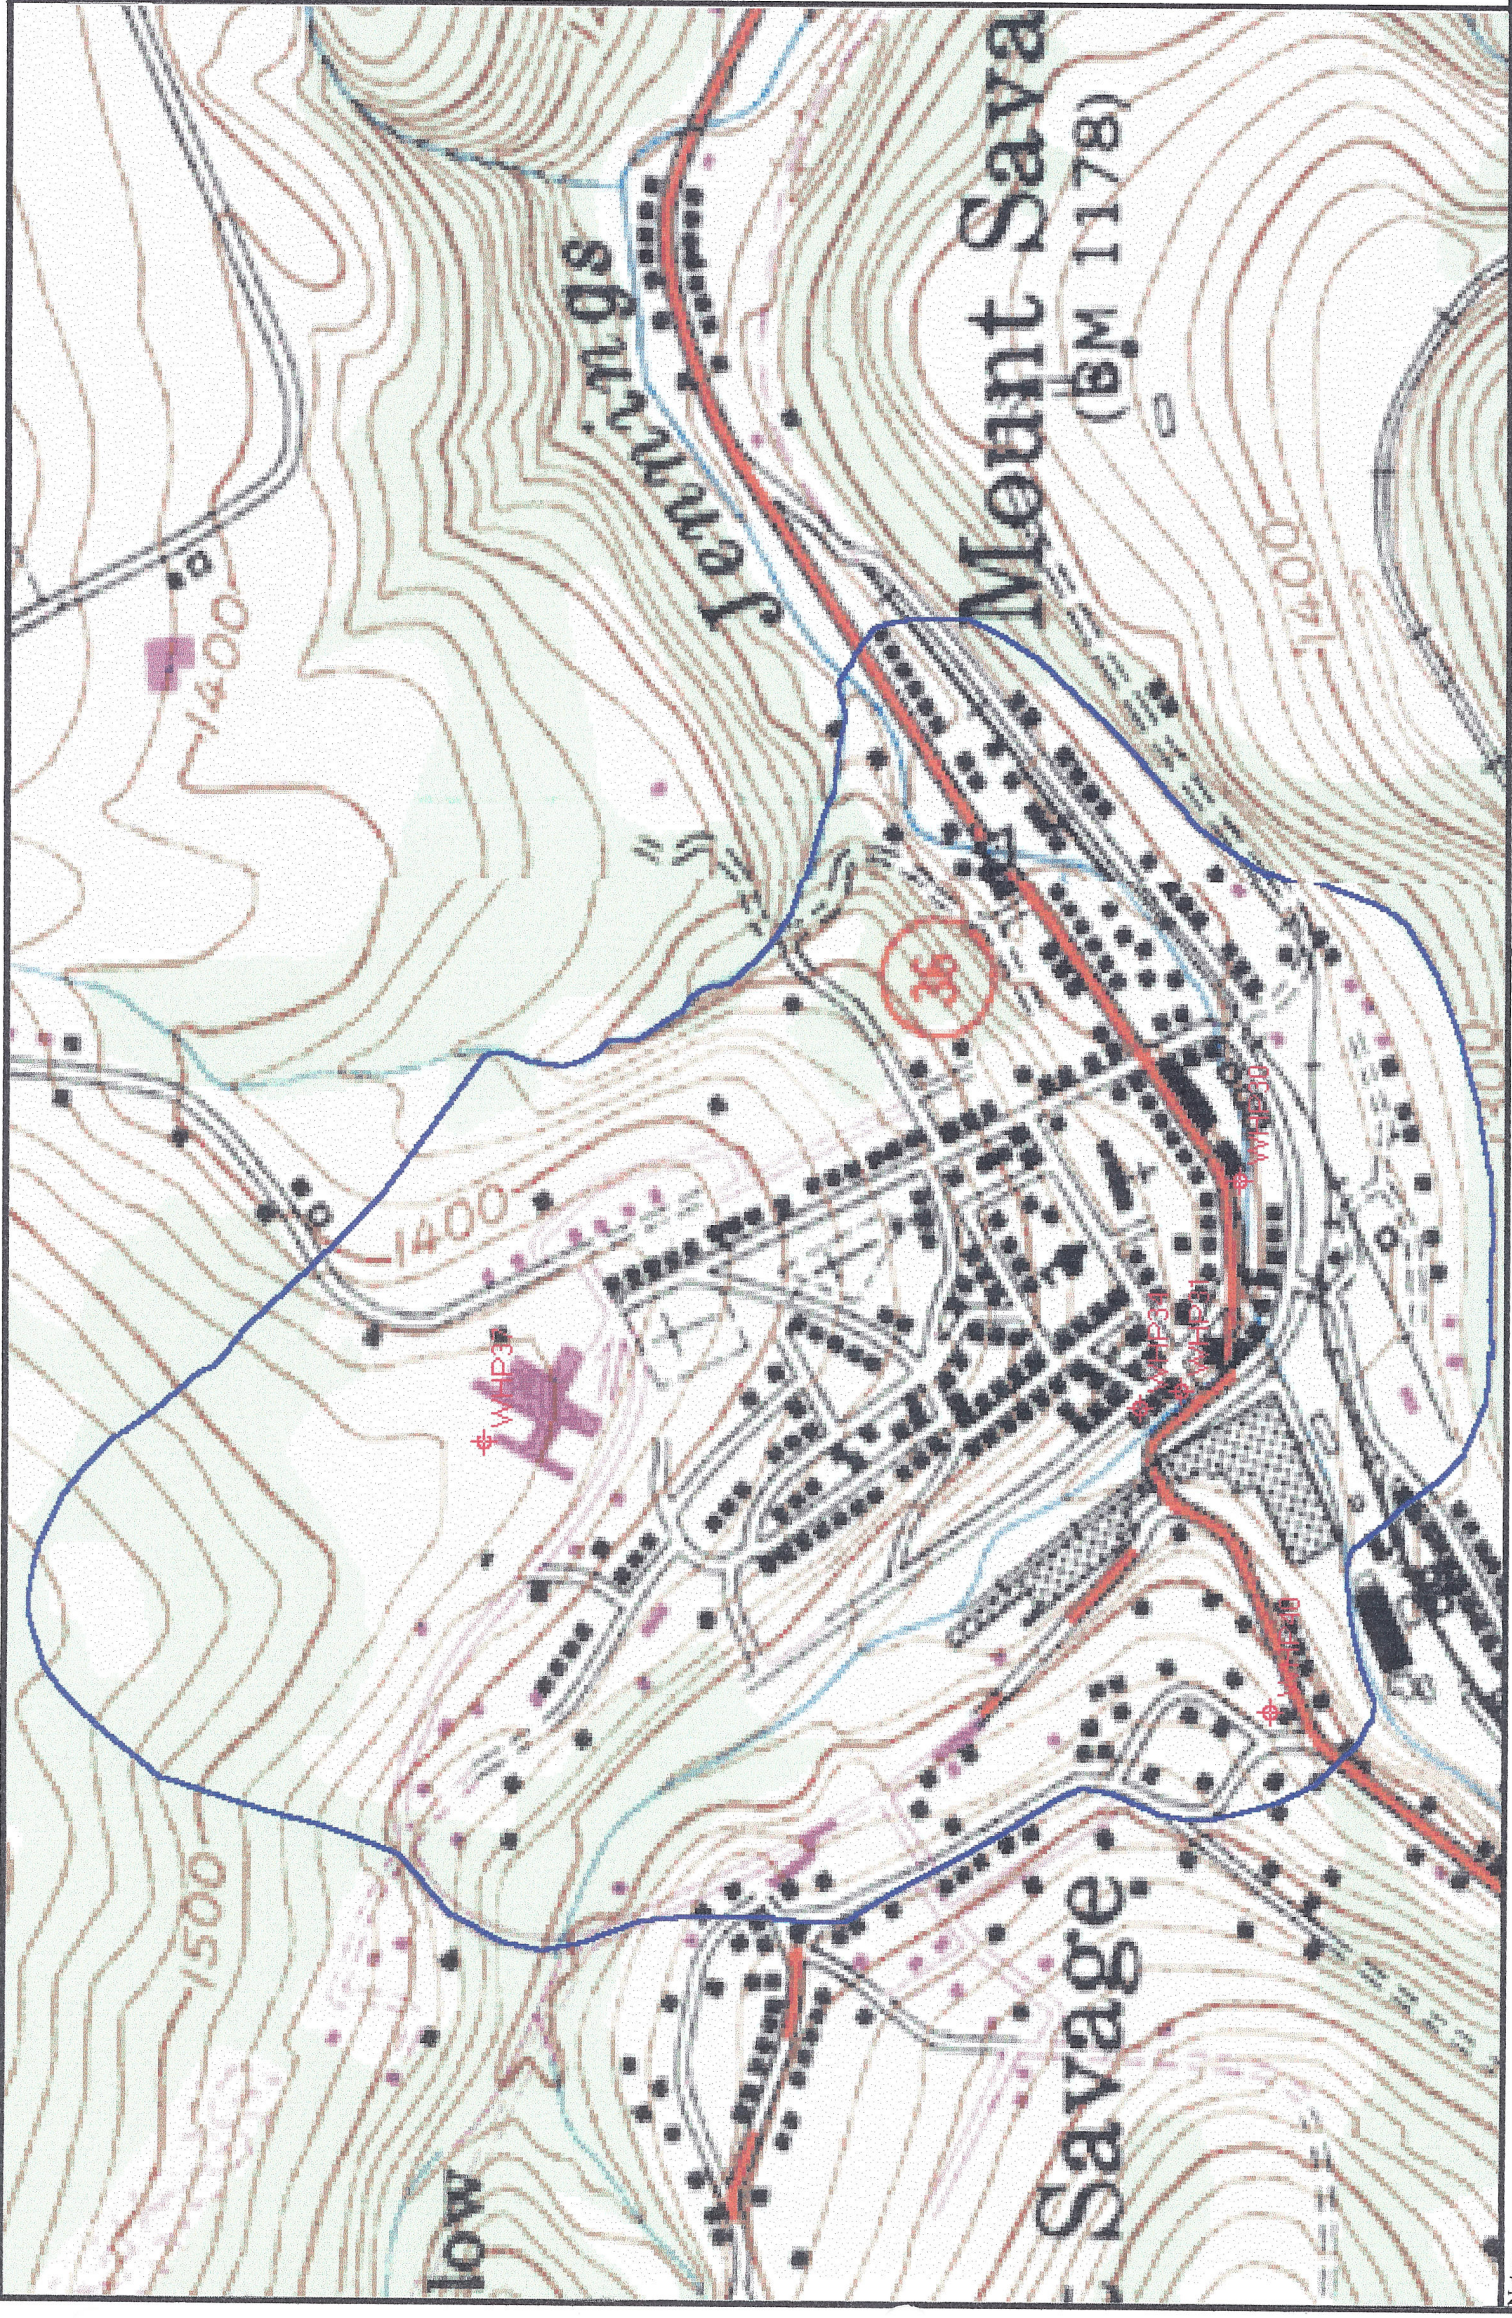
- ⊕ 30 TNC or NTNC well
- 31 Indian Cheers
- 34 Green Arrow Restaurant
- 37 Mount Savage Comm. Center
- 40 Mount Savage School
- The Castle

topographically-constrained sourced water protection area [includes areas within 1,000 feet of each surveyed well unless clear hydrogeologic evidence suggested a need for a site-specific modification of this MDE criterion.

APPROXIMATE SCALE 1"=1100 FT
