**WELLHEAD AREA SURVEY  
VANMETER'S GAS AND GROCERY STORE  
ACHD SITE NO. 83  
Flintstone, Allegany County, Maryland**

**ALWI Project No. AL7N001**

# NONCOMMUNITY WATER SUPPLY SANITARY SURVEY

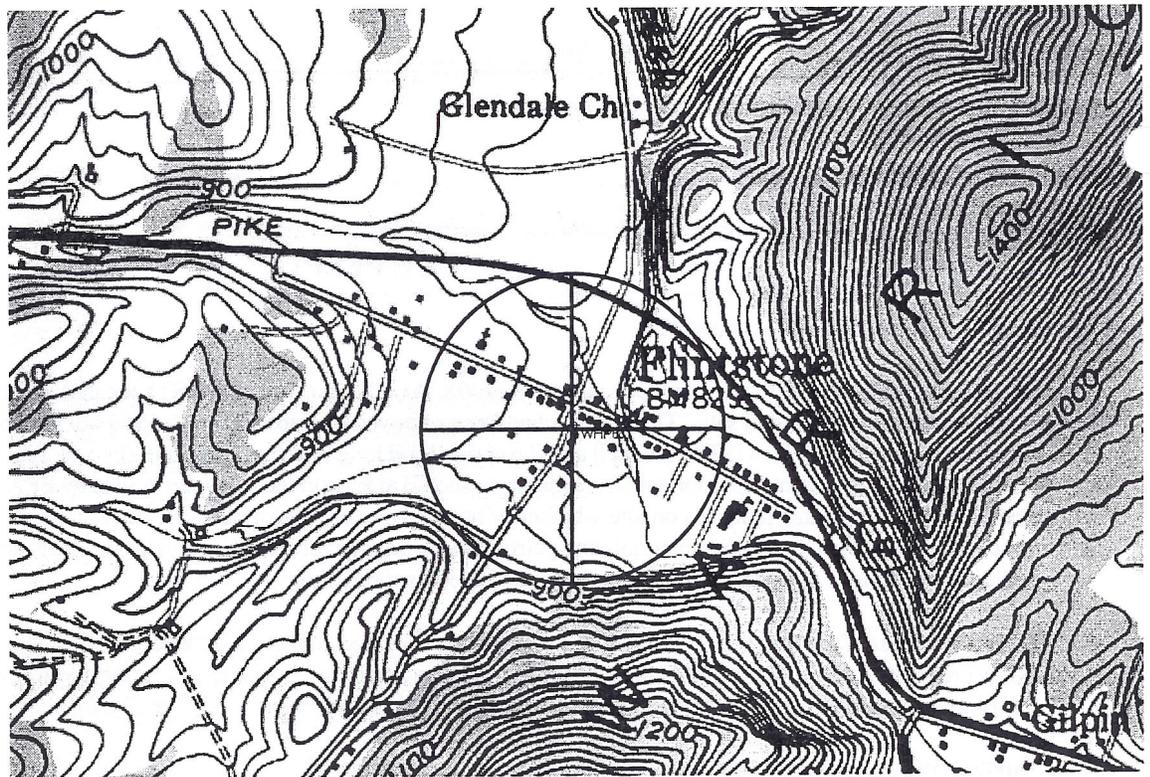
24. Well Location Diagram (1in. = 1250 ft.) with Approximate Distances from Potential Contaminant Sources (i.e. septic, sewer lines, structures, petroleum storage, surface water bodies, etc.):

1. **Underground Storage Tank** – On December 13, 1998, ALWI observed two USTs located less than 100 feet south of the well that contained gasoline for retail sale. These USTs had been removed by September 22, 1999 but no closure documentation was available. Given the proximity of the UST to the well and the understood long history of use, one-time analytical testing to confirm the absence of fuel oil constituents (e.g., benzene, toluene, ethylbenzene, xylene, methyl-tertiary-butyl ether [MTBE], naphthalene, and totals for both gasoline- and diesel-range petroleum hydrocarbon compounds seems appropriate<sup>1</sup>. Consideration should also be given to a solvent scan by EPA Method 524 considering the junked vehicle and parts storage practices on-site whether or not analyses are performed, ALWI recommends that site personnel fully drain and properly dispose of all

2. **Above-Ground Fuel Tank** – ALWI observed two above-ground fuel storage tanks (AST). This AST appeared in good condition. ALWI recommends regular maintenance of this fuel storage and delivery system, including applicable requirements set forth in COMAR 26.10 and the development of specific protocols to be employed in case of a leak or overflow.

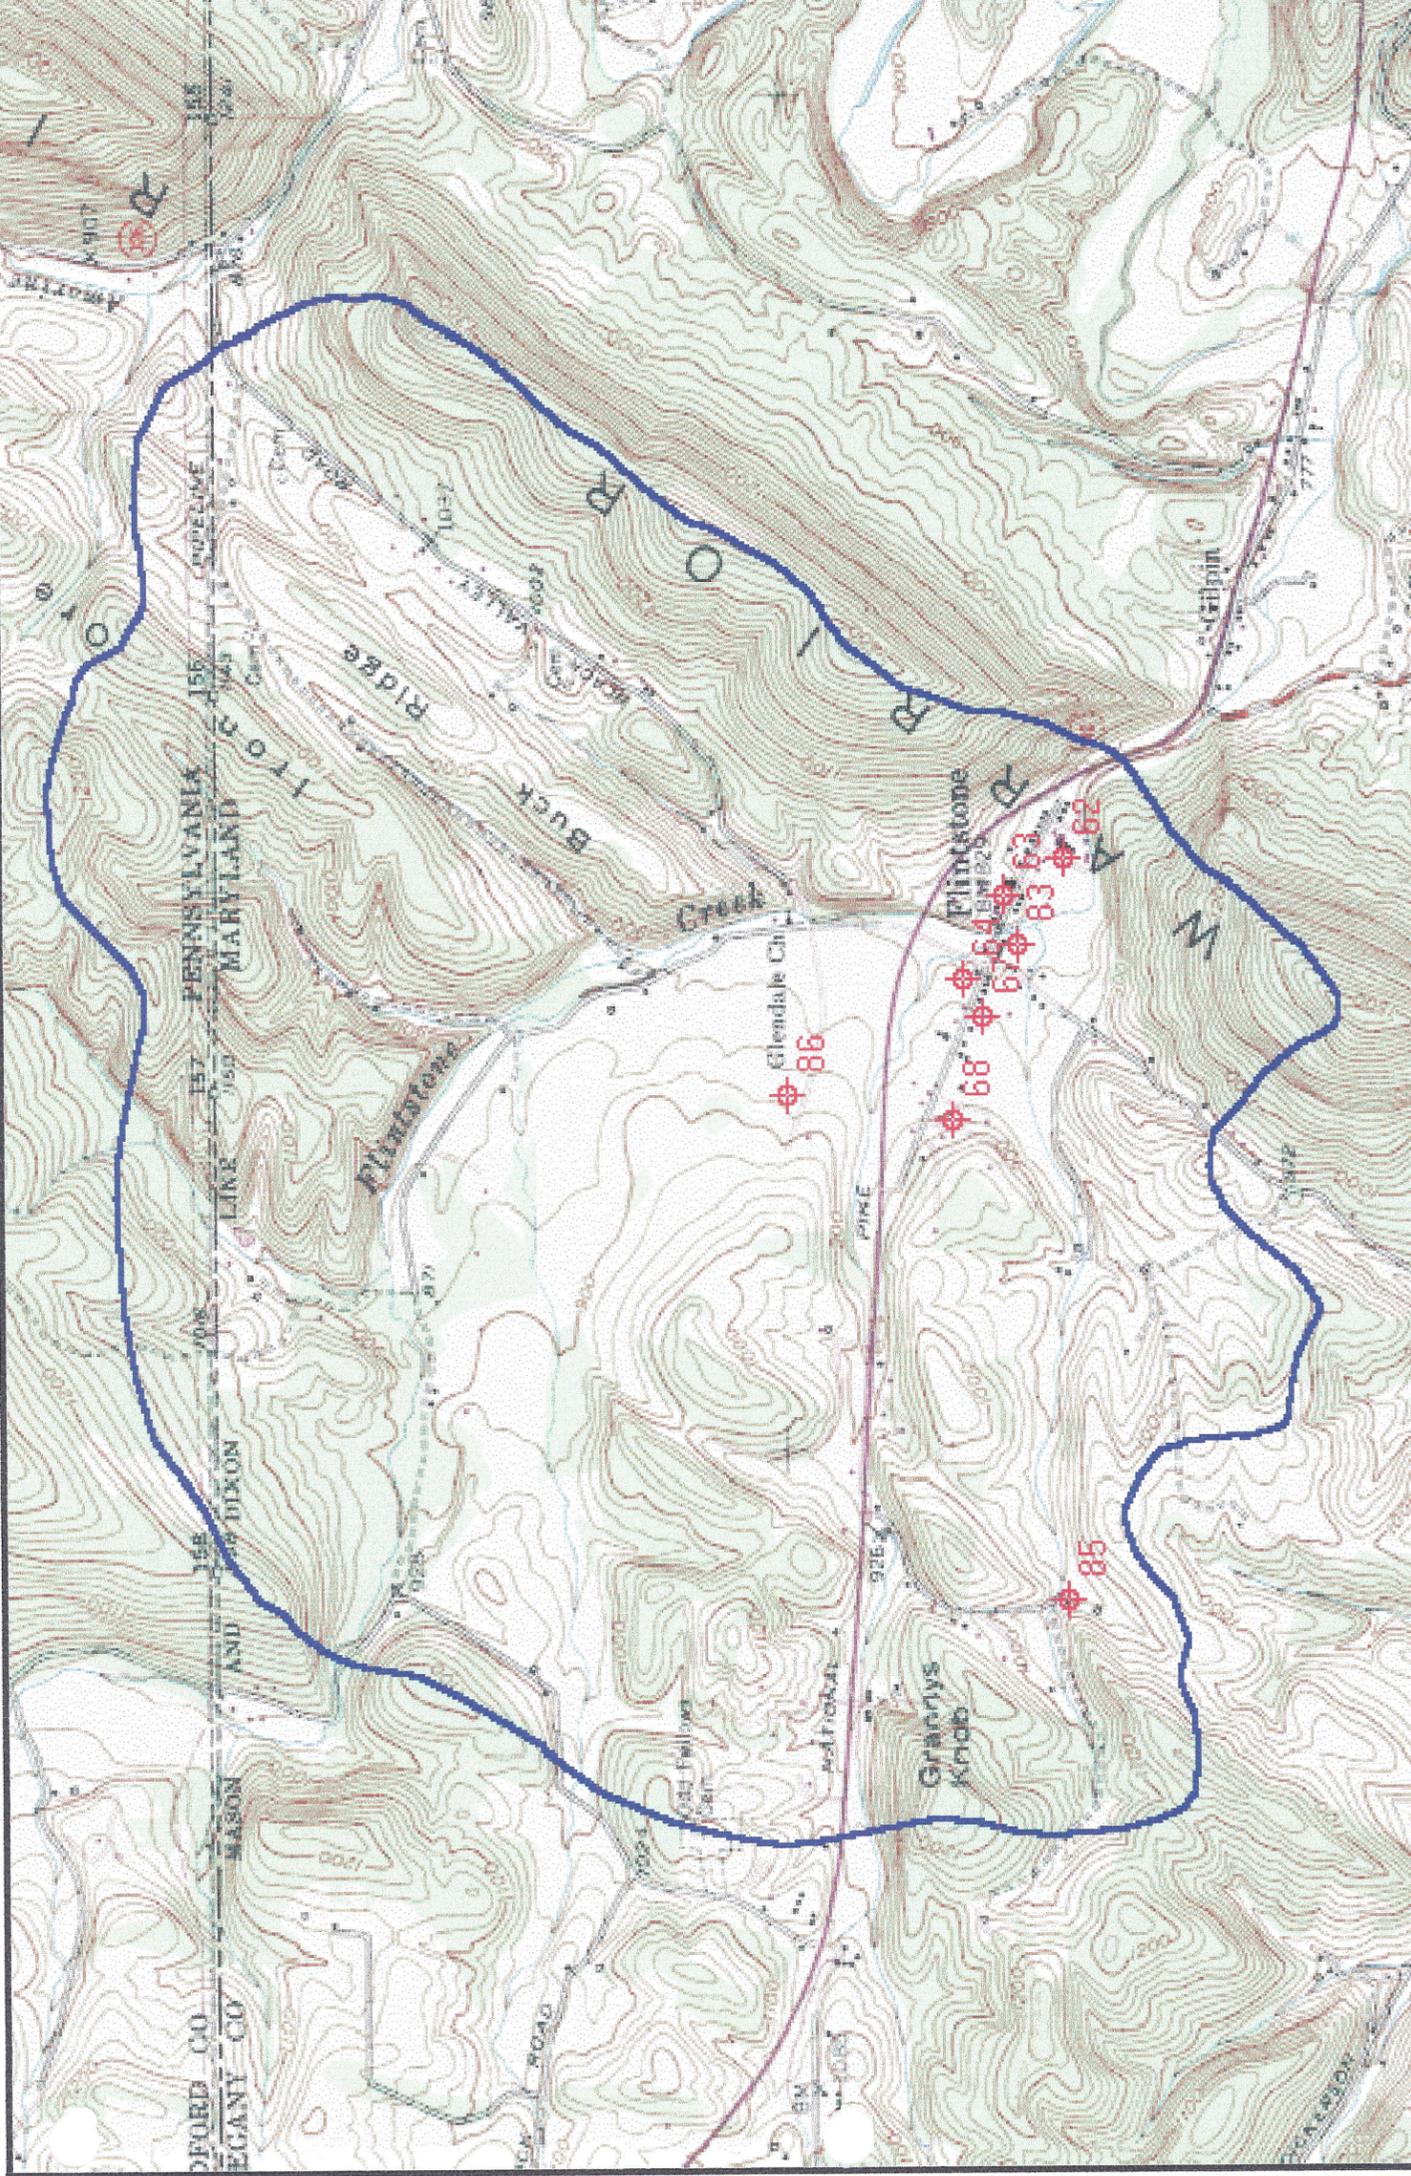
**Figure 3.  
Composite  
Source Water  
Protection Area  
for Flintstone**

ALWI delineated a surveyed area surrounding this site's well using generalized criteria developed by MDE for non-community supplies, as modified by ALWI (with ACHD consent) based on the specific topographic setting of the site. The resultant delineation is shown on the "Water Plant Information" survey form (Appendix B). ALWI used a fixed radius of 1,000 feet around the well, which creates an area of approximately 72 acres. Within an assumed 600 gallons per day per acre (gpd/ac) of annualized groundwater recharge (Slaughter and Darling, 1962, Table 37), slightly more than 43,000 gallons per day exists within the aquifer beneath this surveyed area. In actuality, the modest demand of this well (doubtlessly less than 100 gpd) is more than one order of magnitude smaller than the total available in the surveyed area, lending a high degree of conservatism to this analysis.

topographically-constrained sourced water protection area [includes areas within 1,000 feet of each surveyed well unless clear hydrogeologic evidence suggested a need for a site-specific modification of this MDE criterion.
