SOURCE WATER ASSESSMENT

CEDAR RIDGE CHILDREN'S HOME

Washington County, MD

**REPORT: CEDAR RIDGE CHILDRENS HOME
DYE STUDY**

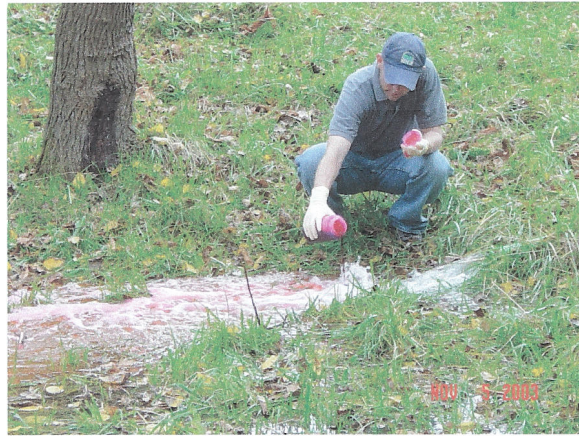
Figure 3. Illustration of Phloxine B inoculation of sinkhole 1

Dye inoculation of sinkholes and septic systems occurred on 11/5/03 (Table 4). Inoculation of *septic systems* with fluorescein dye occurred after collection of final background grab samples to avoid background sample contamination. Dye was introduced into a septic system through the septic tank via an indoor fixture draining into the tank. Two *sinkholes* required water supplied by a water delivery truck for dye transport. Approximately 1000 gallons of pure spring water were used to inoculate sinkholes with 250g of phloxine-b (Figures 3 and 4). Three liters of rhodamine dye were used to inoculate Meadow Brook (Figure 4). Table 4 lists details of each inoculation point.

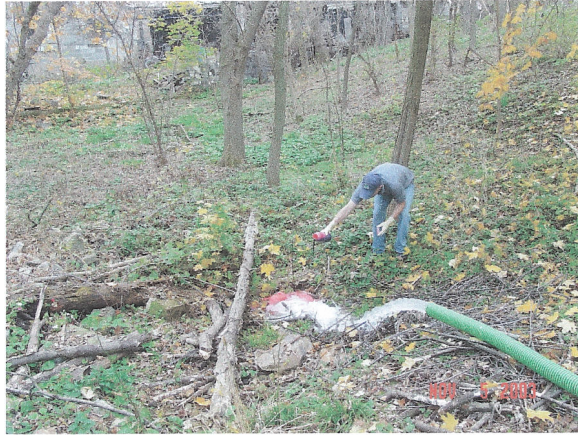
Figure 4. Illustration of Phloxine B inoculation of sinkhole 2

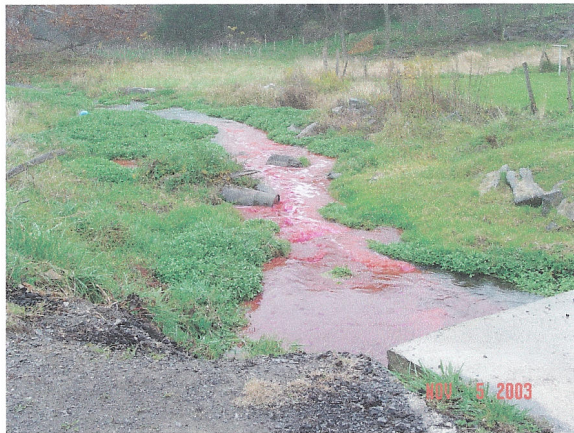
Figure 5. Illustration of rhodamine WT inoculation of Meadow-Brook

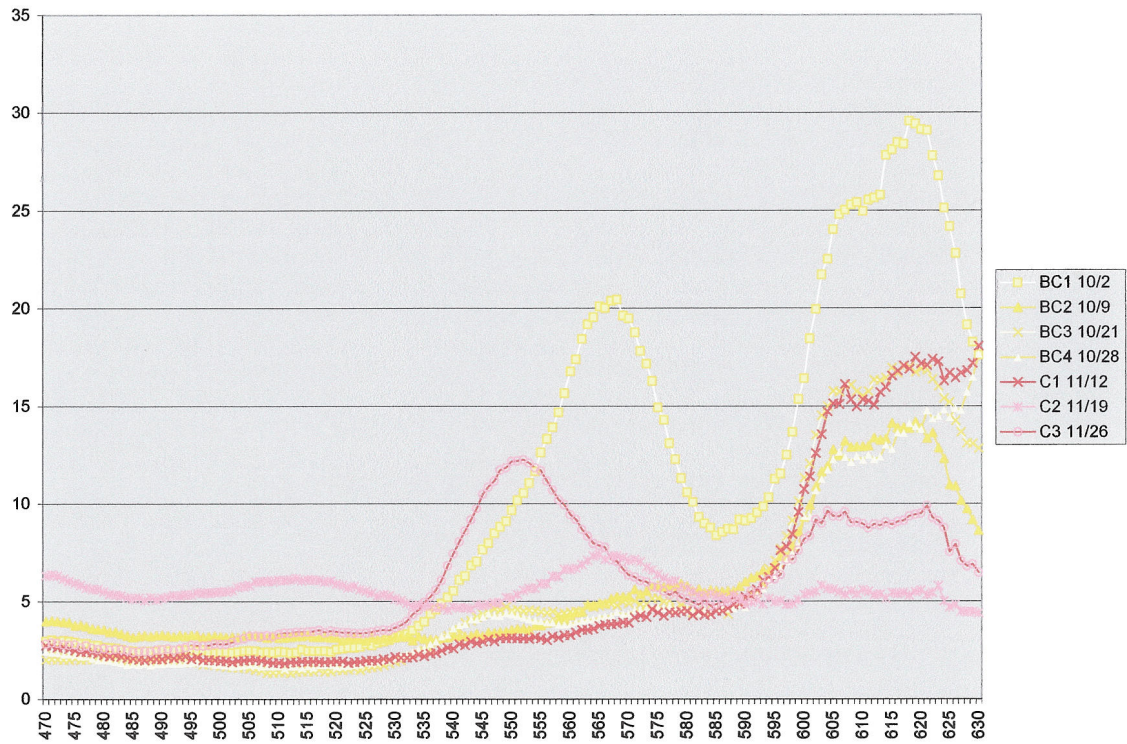
Figure 6. Graph illustrating fluorescence in the adventure charcoal receptors.

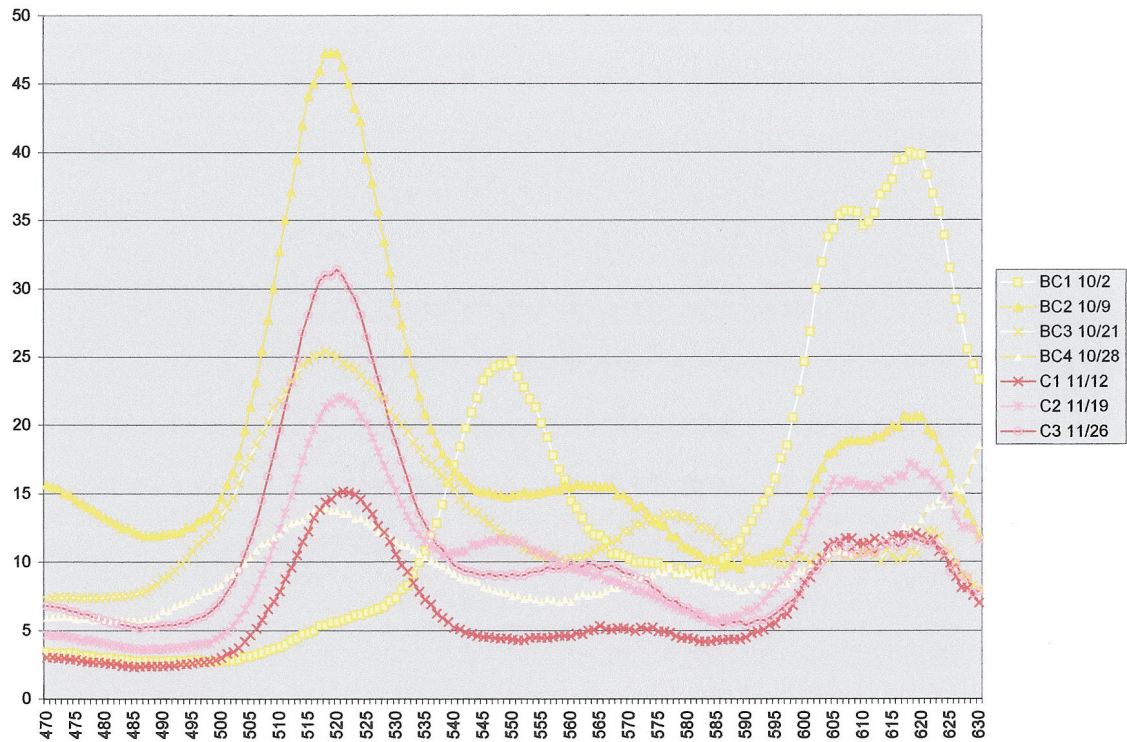
Figure 7. Graph illustrating fluorescence in the upper front charcoal receptors.

A small fluorescence peak at 552nm occurred in the third charcoal collected from the adventure well (Figure 7). While this peak could indicate a positive trace amount (>2x background fluorescence) of Phloxine B dye, the result is ambiguous because fluorescence was not detected in other charcoal receptors. Furthermore, the adventure well is not currently considered surface influenced, and background fluorescence is inconsistent.

Our initial conclusion that fluorescein entered the upper front was refuted by fluorescence peaks (520-521nm) that were outside the acceptable range for fluorescein when measured in an elutant (514-518nm). Furthermore, background fluorescence at this wavelength strongly confounds our initial conclusion. Background fluorescence sequentially decreases prior to dye inoculation. However, there is no way to distinguish the source of increased fluorescence after inoculation between our dye and the source of background fluorescence. The shop well (Figure 8) and the upper rear well (Figure 9) demonstrate no consistent patterns of fluorescence to indicate entry of dyes into the well water.

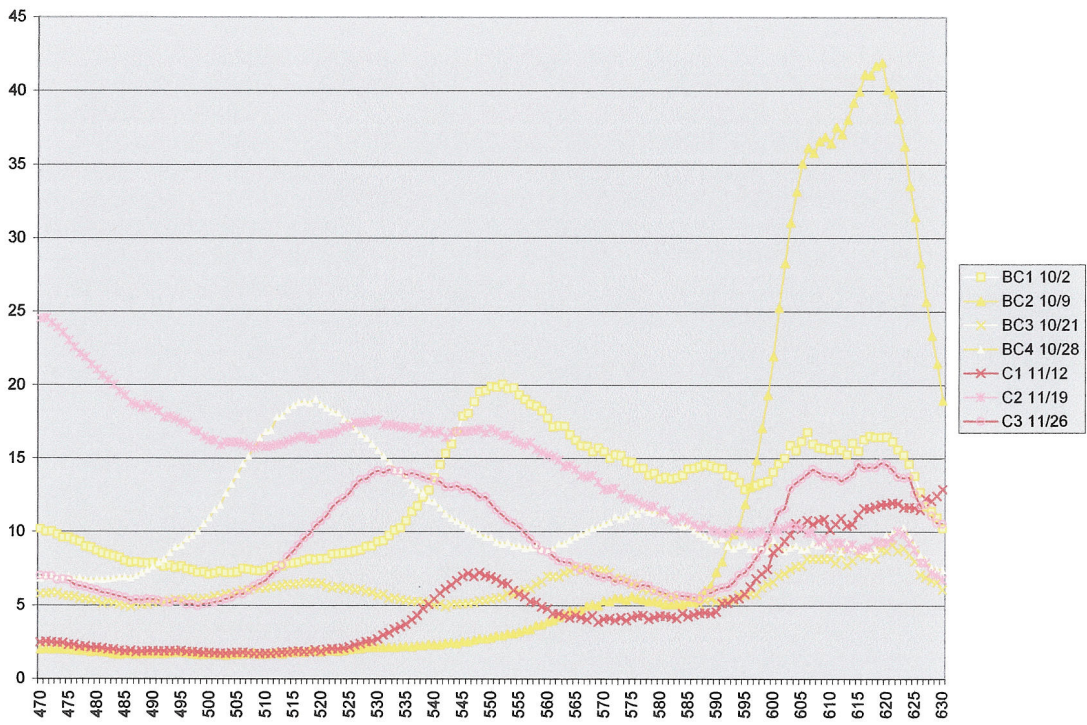
Figure 8. Graph illustrating fluorescence in the shop charcoal receptors.
