WELLHEAD AREA SURVEY
DAWN'S COUNTRY DINER
ACHD SITE NO. 64
Flintstone, Allegany County, Maryland

ALWI Project No. AL7N001

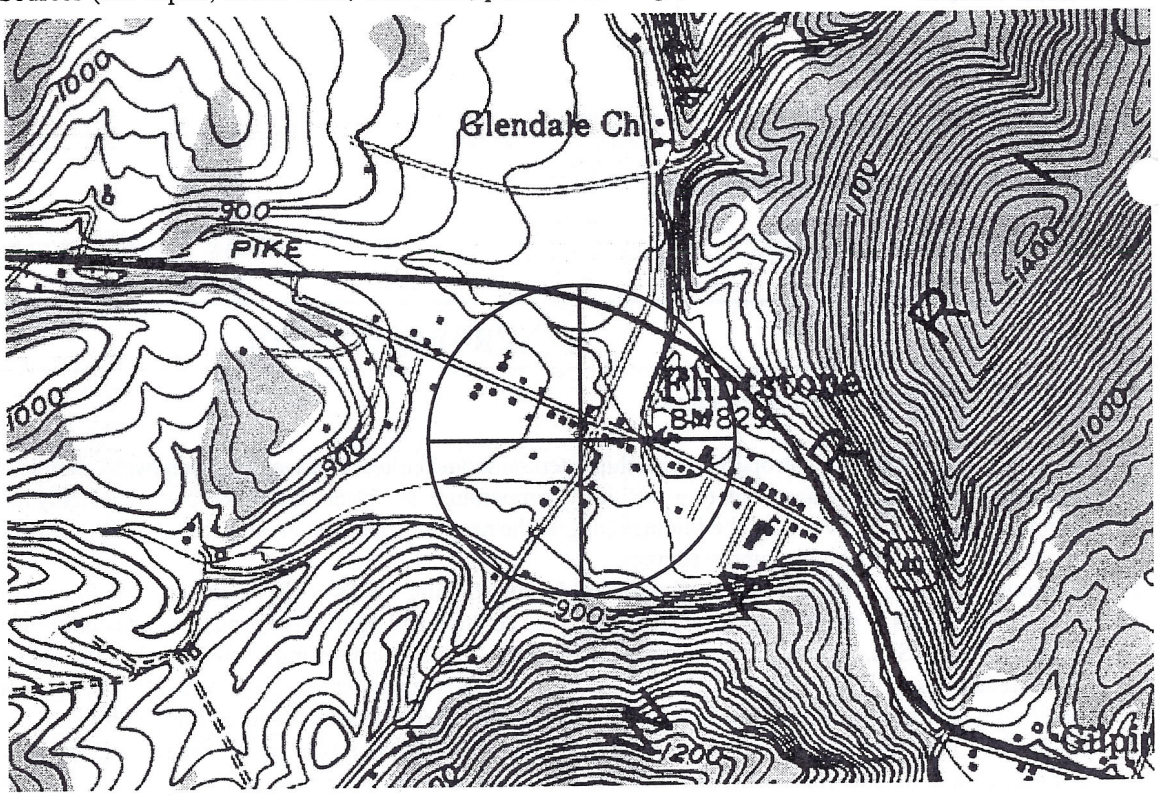
24. Well Location Diagram (1 in. = 1250 ft.) with Approximate Distances from Potential Contaminant Sources (i.e. septic, sewer lines, structures, petroleum storage, surface water bodies, etc.):

Design, construction and present condition are important factors in determining a well's susceptibility to contamination. No well tag was visible. Accordingly, ALWI could not assess the initial design nor present condition of the casing or grout seal. ALWI observed that the top of the well casing terminates in a shallow, dirt-filled, non-watertight subsurface vault. This in apparent violation of several provisions[1] within COMAR 26.04.04.07F.

On December 15, 1998, ALWI observed several potential contamination sources in the delineated area. ALWI identified the following potential sources of contamination within the surveyed area: former USTs located at nearby facilities and the location of the well in town and in a floodway. ALWI performed a site reconnaissance and conducted limited personal interviews to identify and describe these potential contaminant hazards.

3. **Subsurface Well Completion** – The wells should be retrofitted with a pitless adapter and casing extended to above-grade. Any exhumed pits or vaults should be backfilled with inert material with care taken to adhere to casing grouting requirements in doing so. Access for pump repairs and replacements should be maintained as well. Once the casing is extended, it may be located in the flow of traffic. If this should be the case, ALWI recommends appropriate protection from vehicular damage, such as concrete-filled posts surrounding the wellhead.

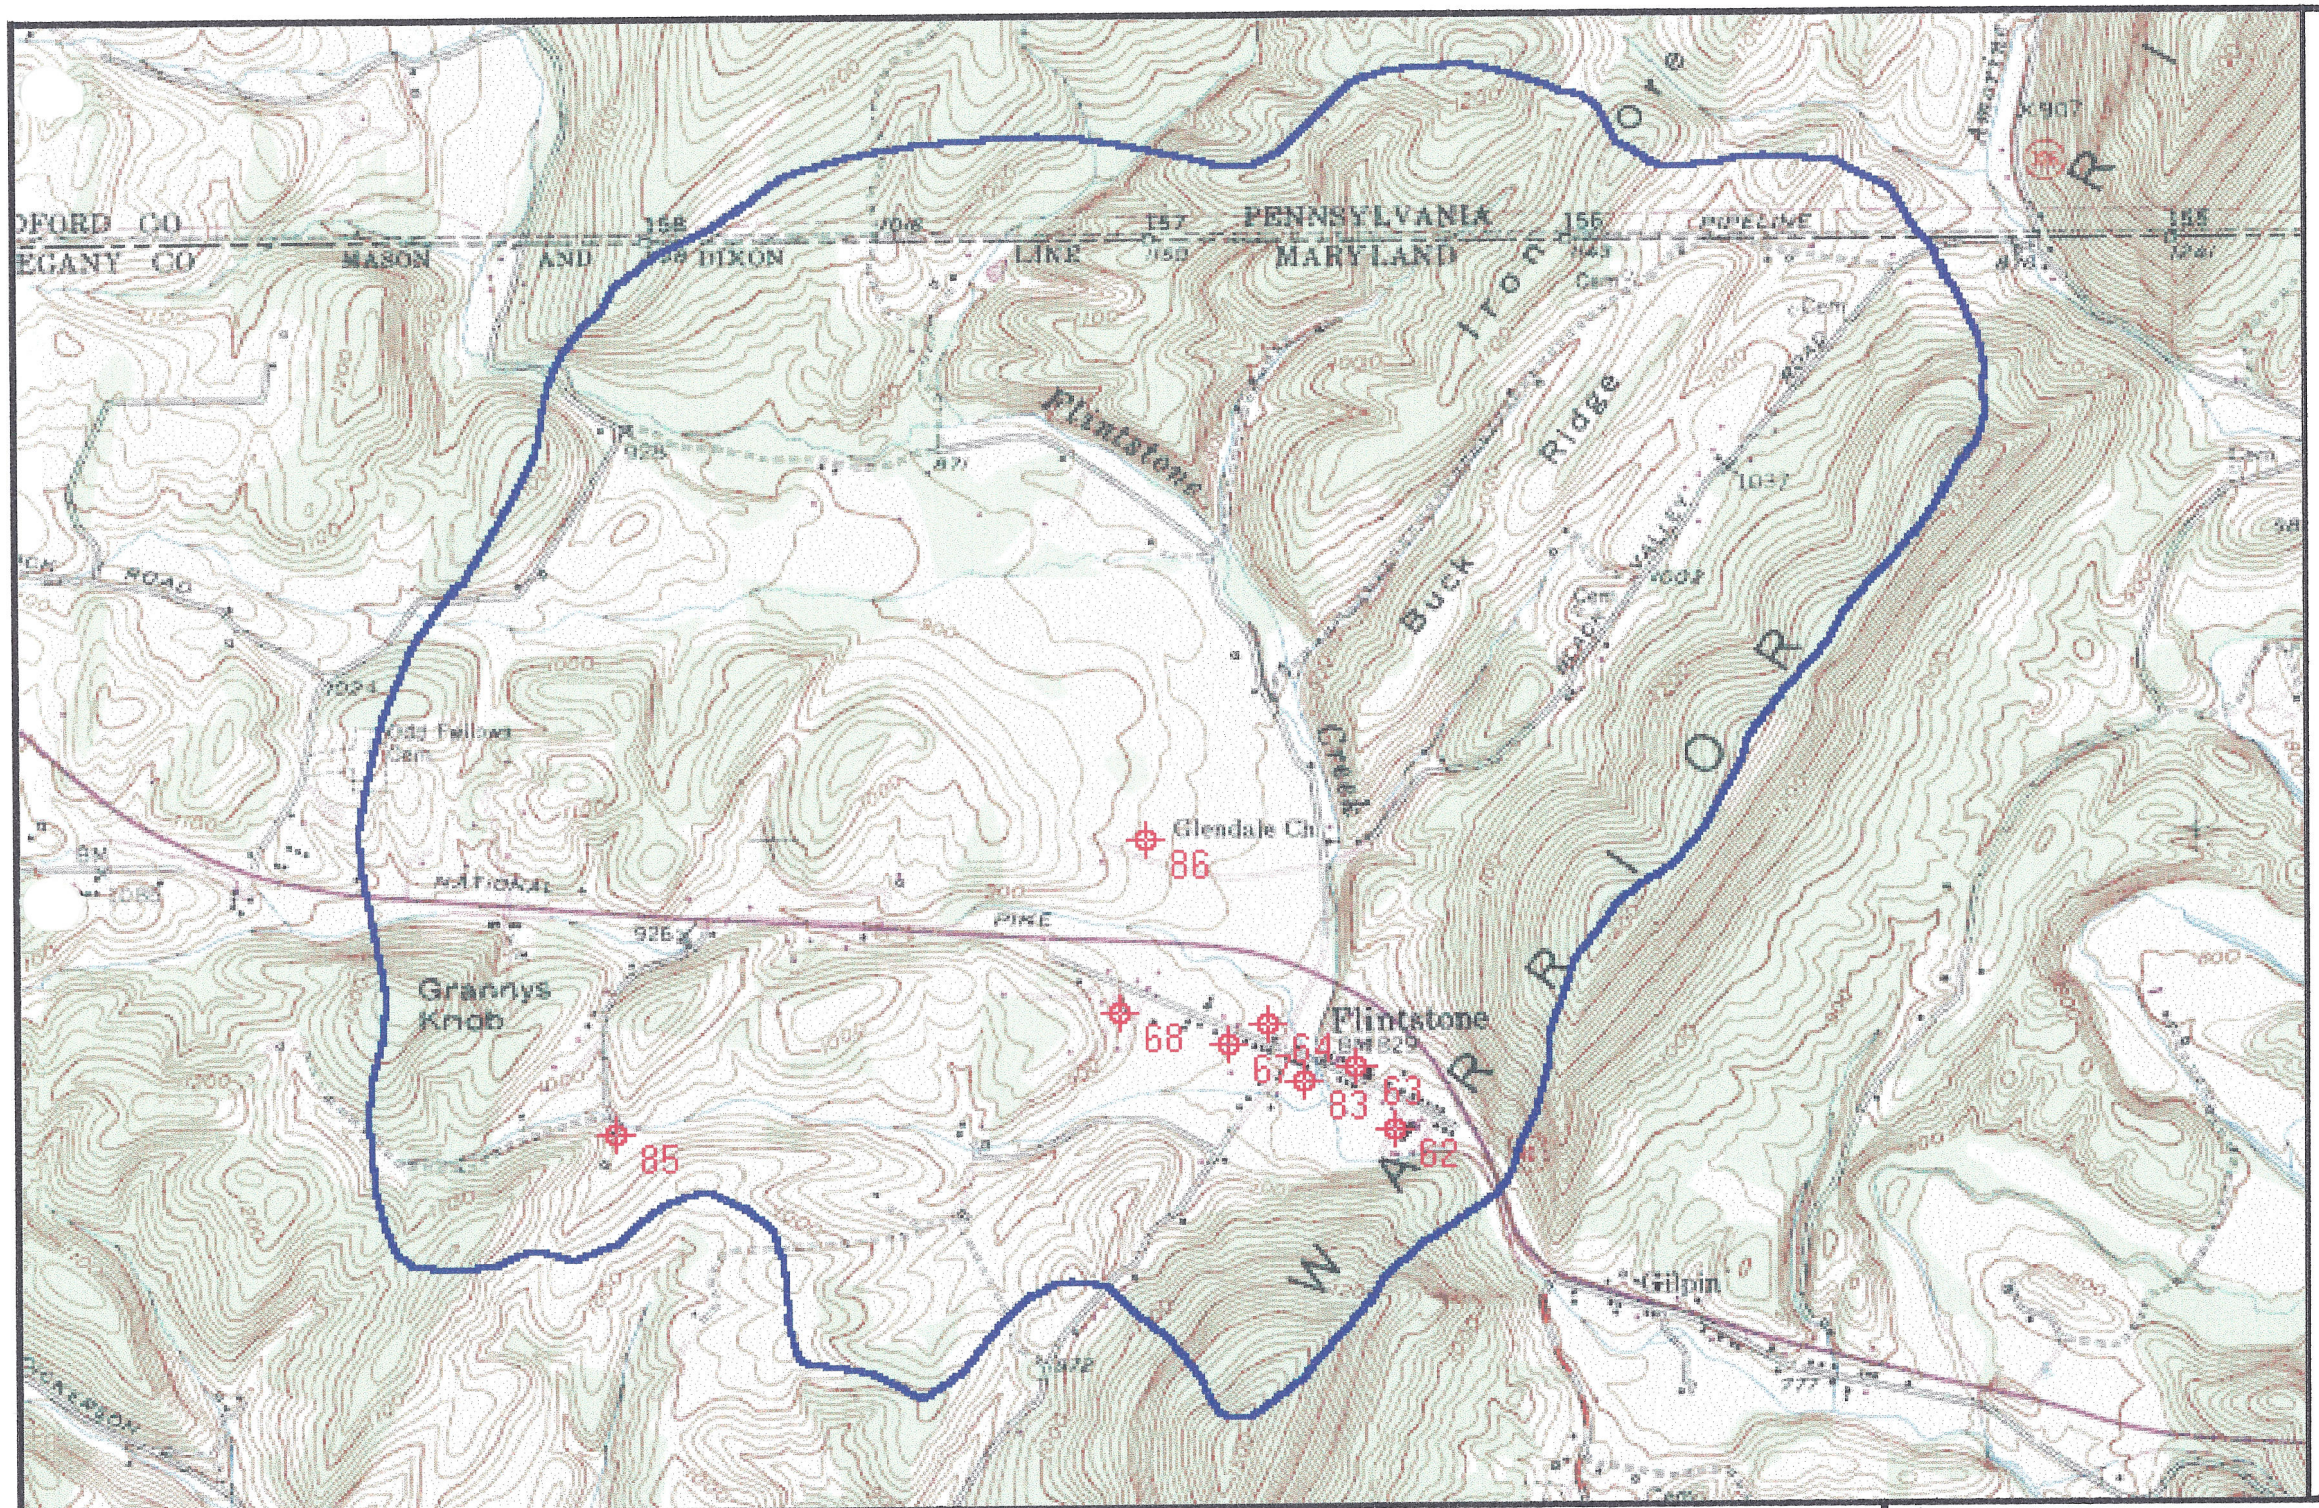
Figure 3. Composite Source Water Protection Area for Flintstone

topographically-constrained sourced water protection area [includes areas within 1,000 feet of each surveyed well unless clear hydrogoelogic evidence suggested a need for a site-specific modificaiton of this MDE criterion.
