# Public Informational Meeting on the Former Sparrows Point Steel Mill Environmental Cleanup

**October 3, 2019**

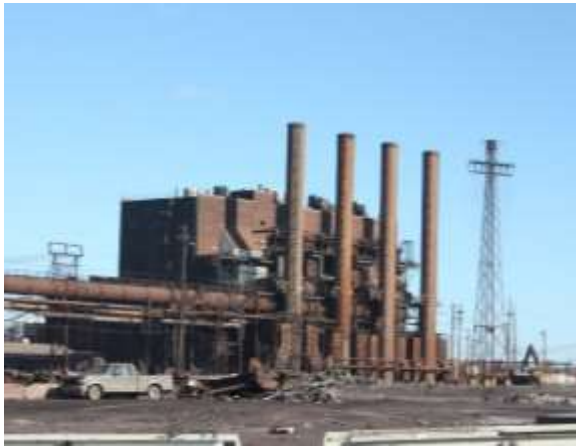
# Demolition Former Pennwood Power House

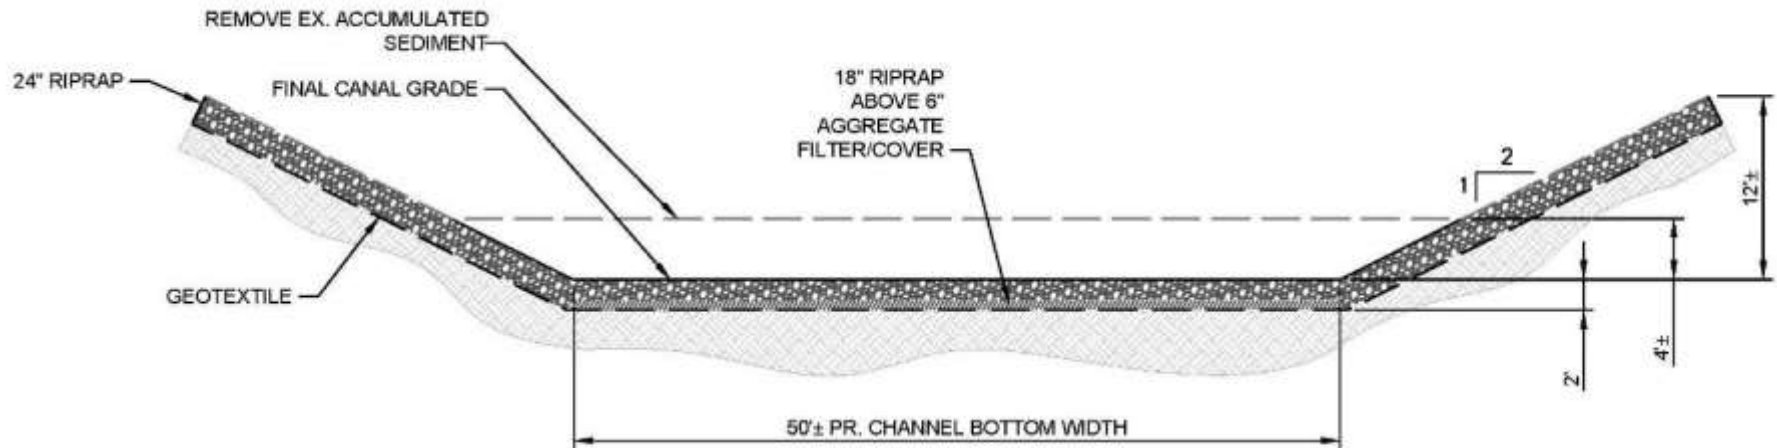
Excavation and removal of sediment from the TMC to address sediments with PCB concentrations greater than 50 mg/kg, and accumulated sediments that contain elevated levels of oil & grease that restrict the flow capacity of the canal

TYPICAL CANAL CROSS-SECTION AND 2-FOOT THICK CAP

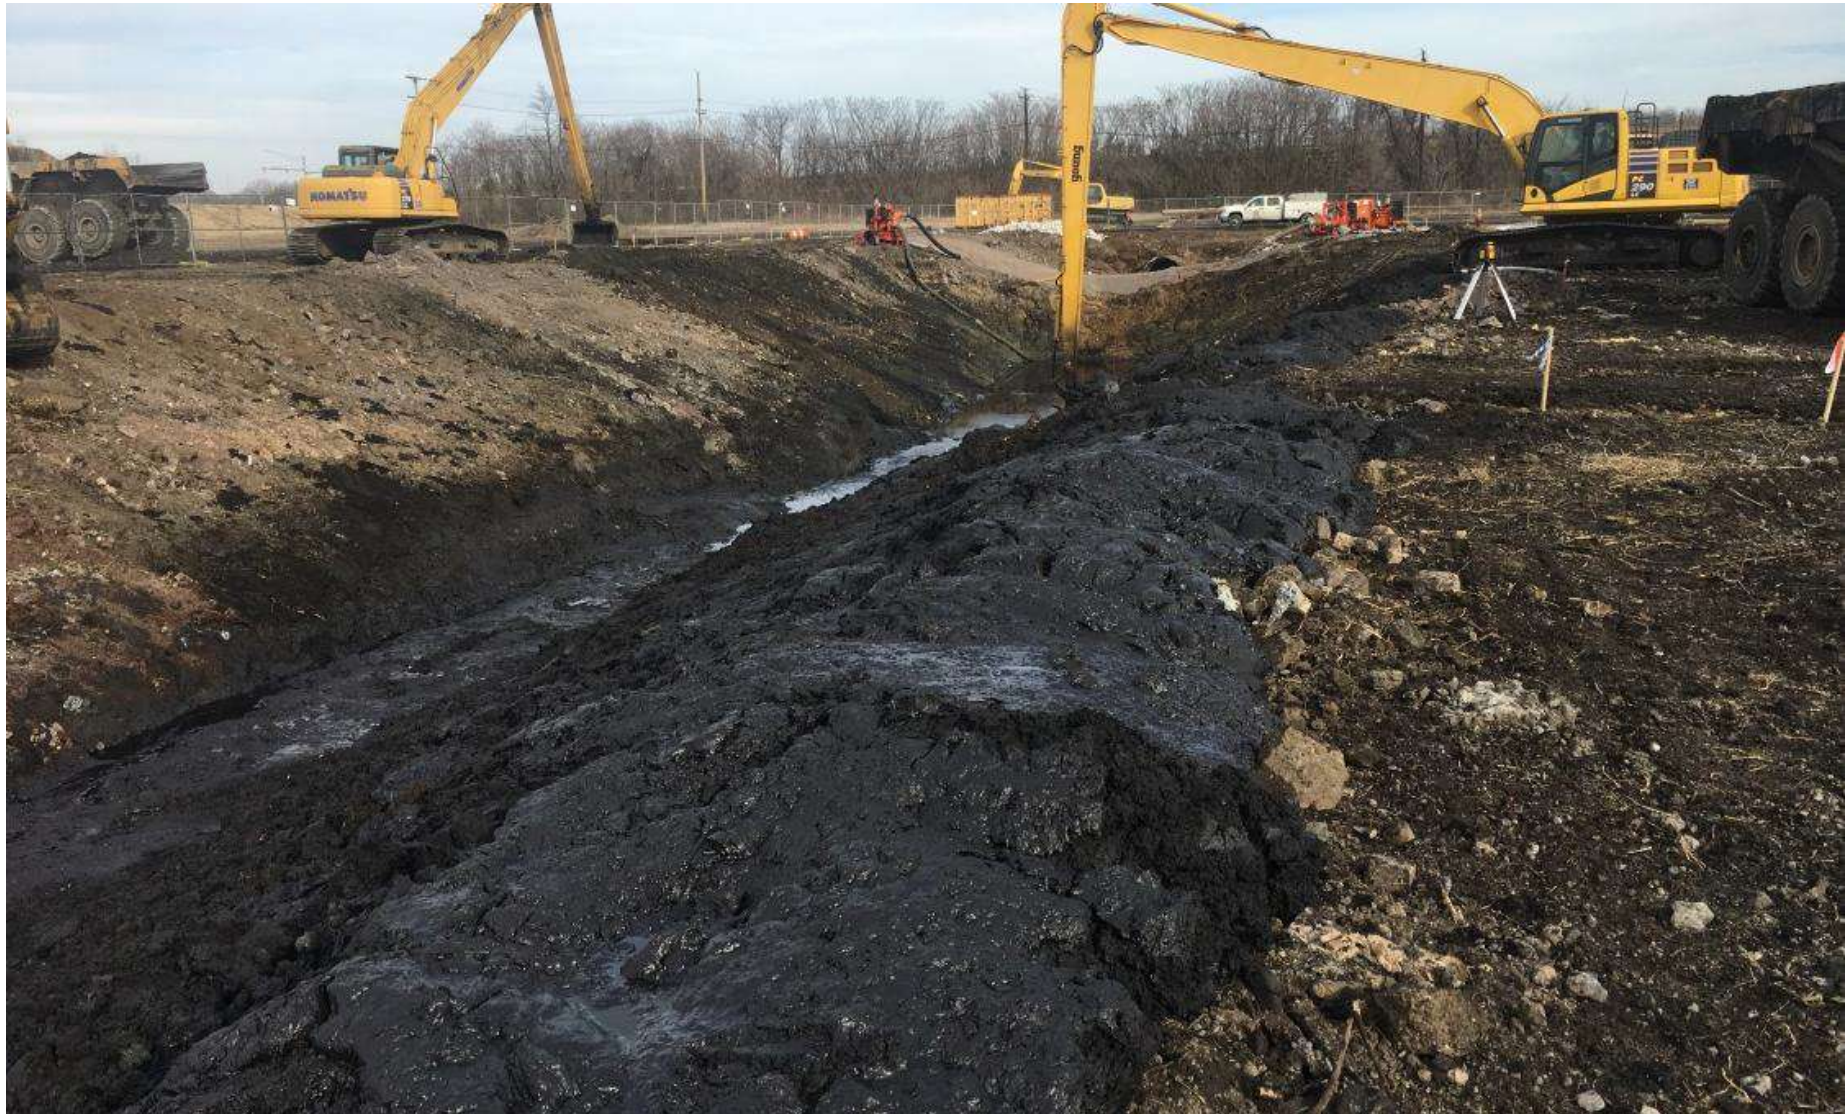
Sediment Removal

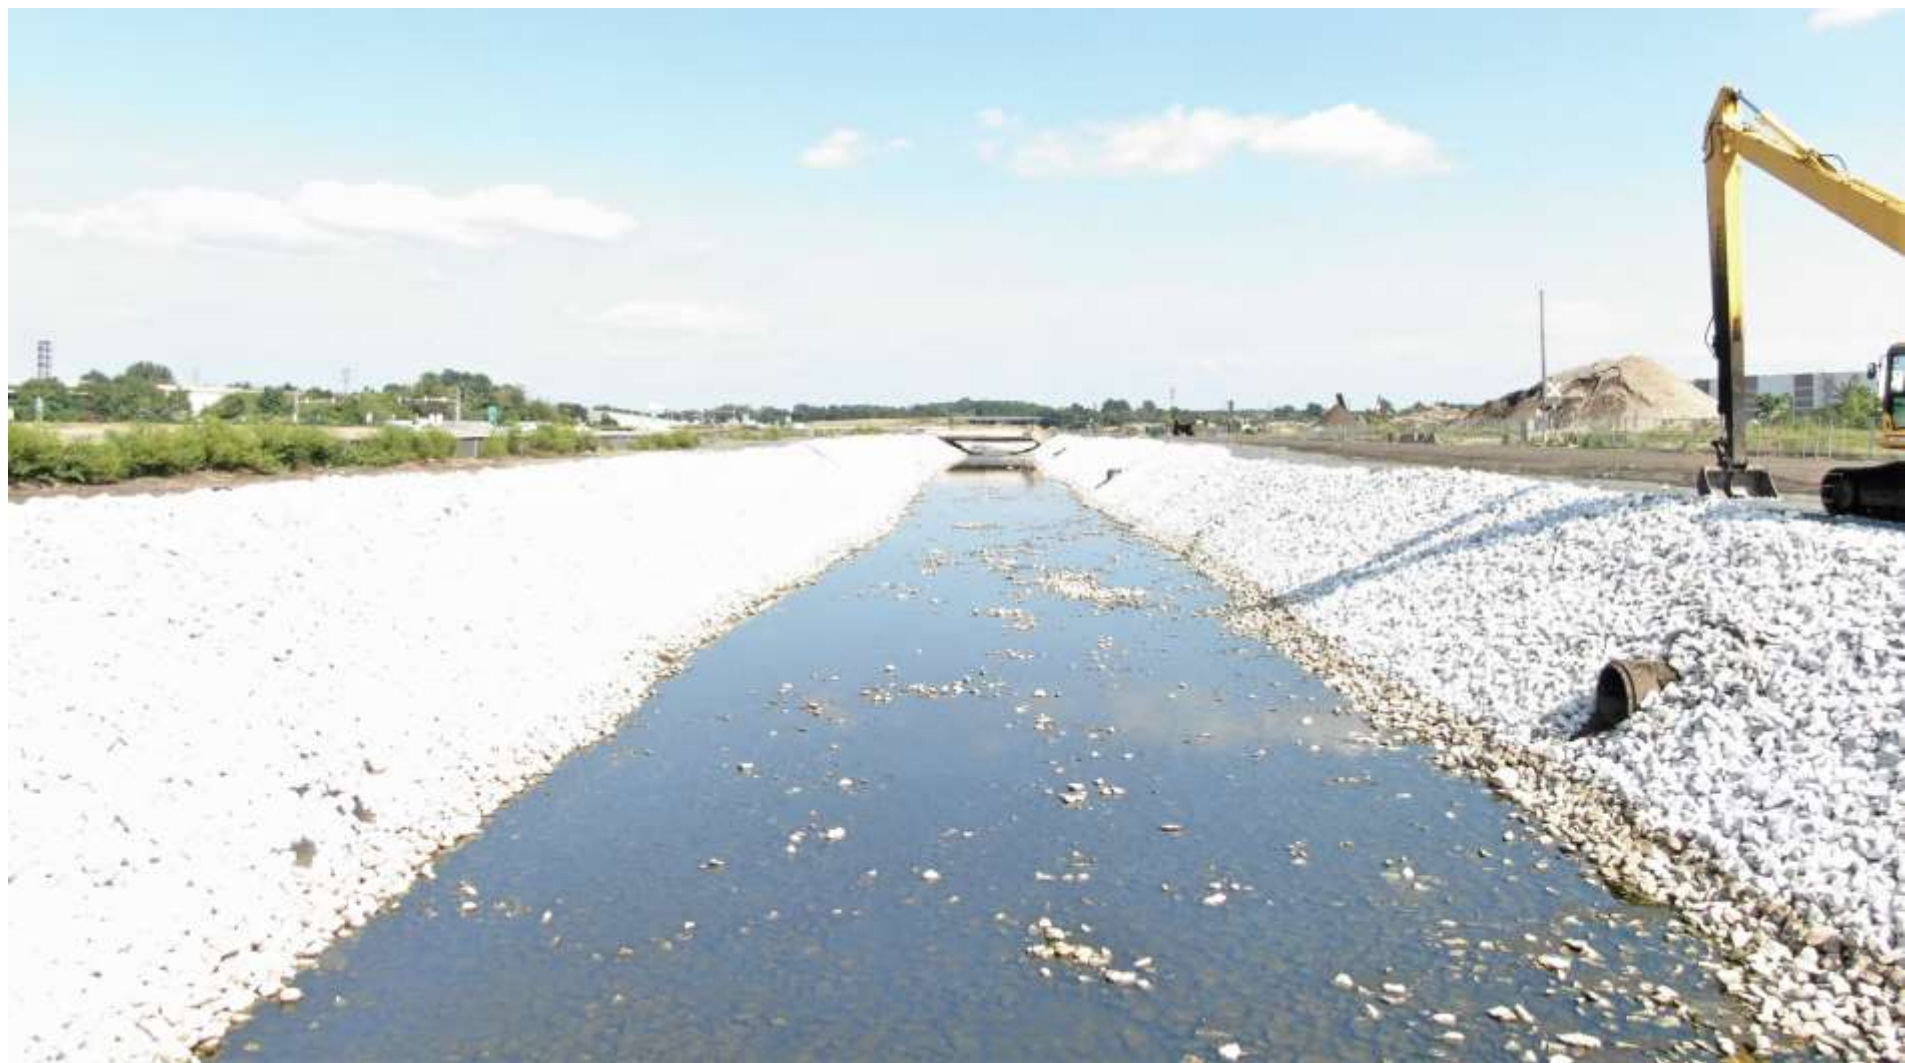
Completed Section

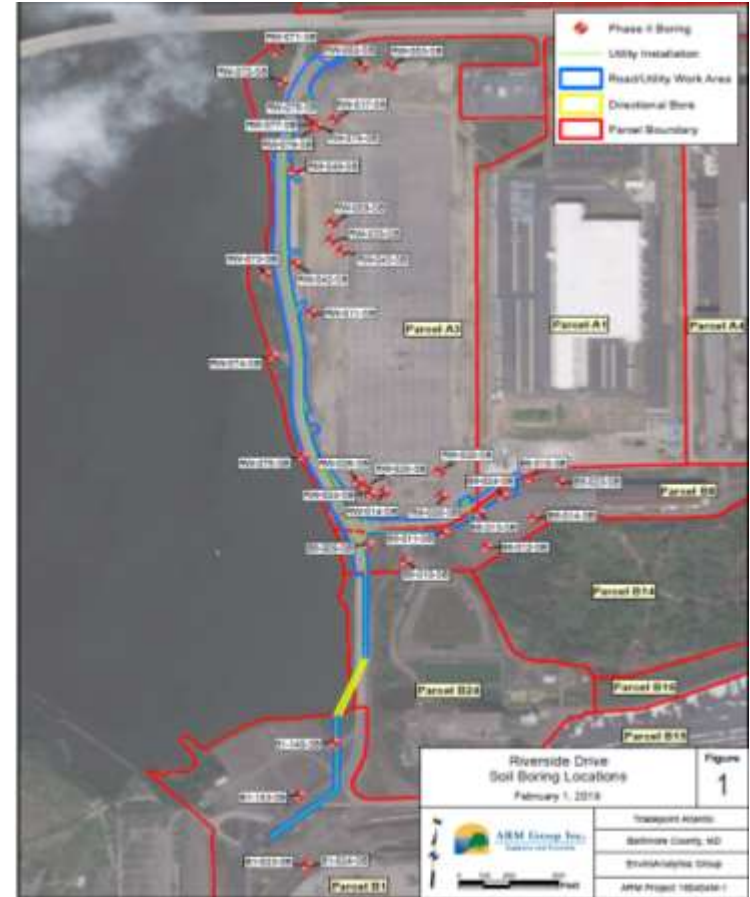
Example: Riverside Drive Utilities LSPP  
 Boring Location Figure

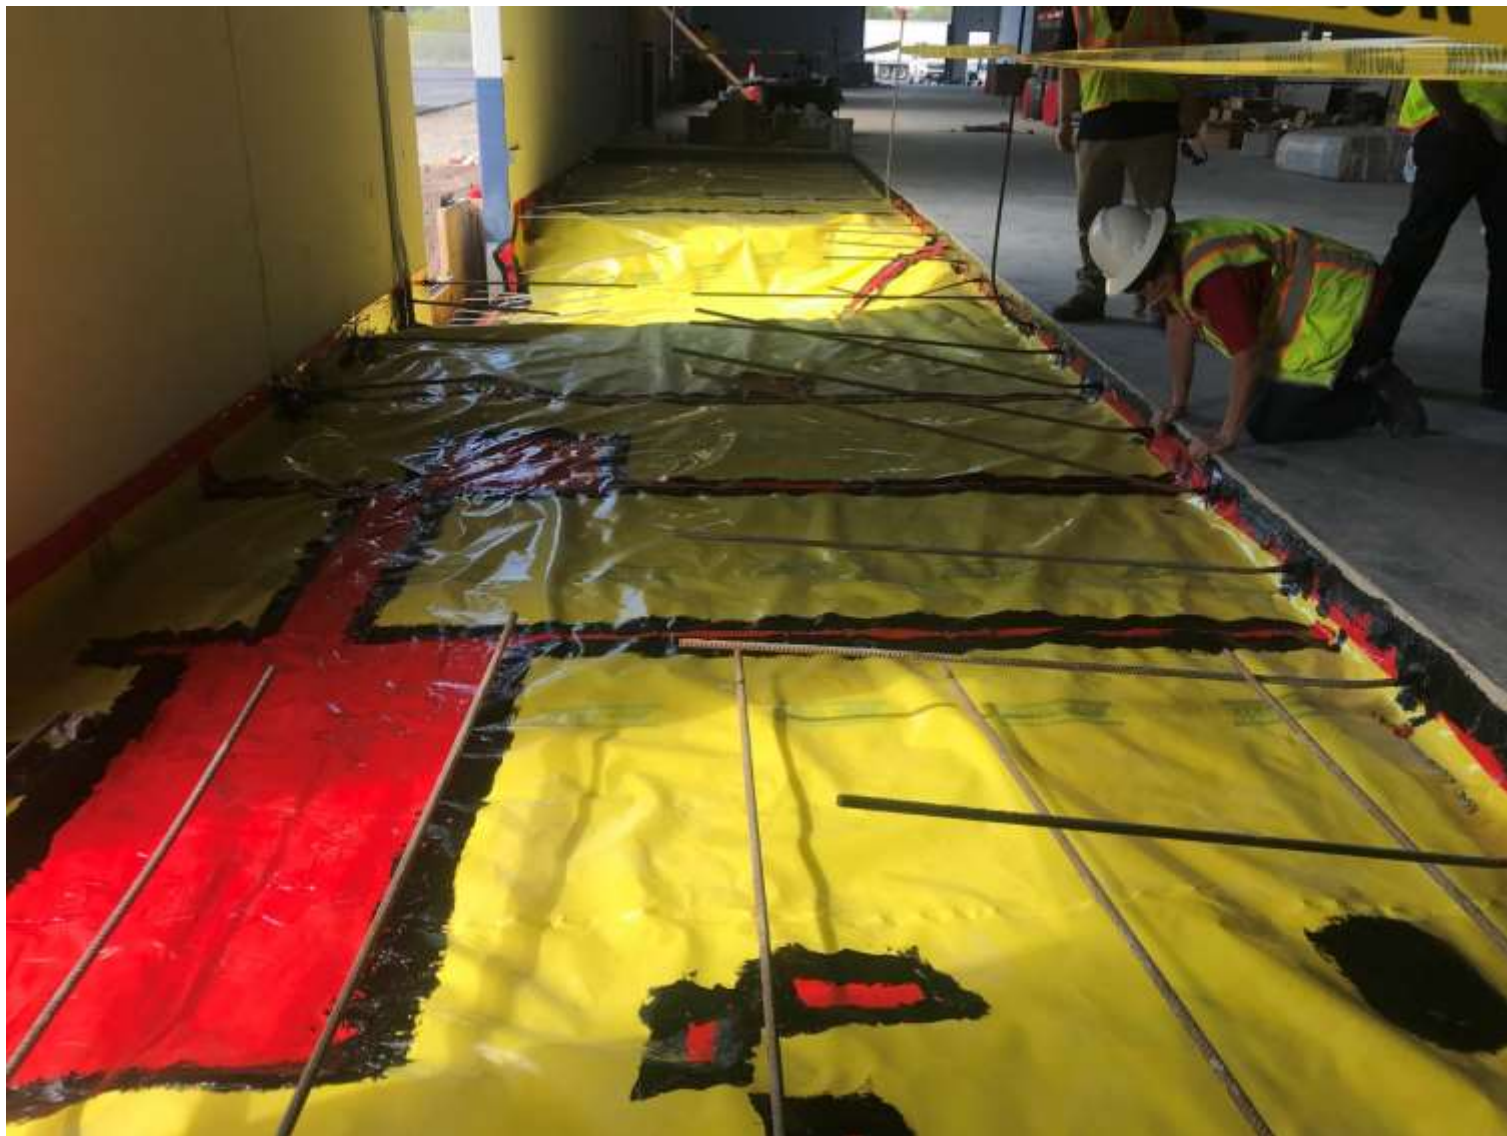
Vapor Barrier

- The warehouse building will be constructed with a sub-slab vapor barrier and a passive/active piping system. Sub-slab and indoor air testing will be required to verify the installation prior to occupancy.

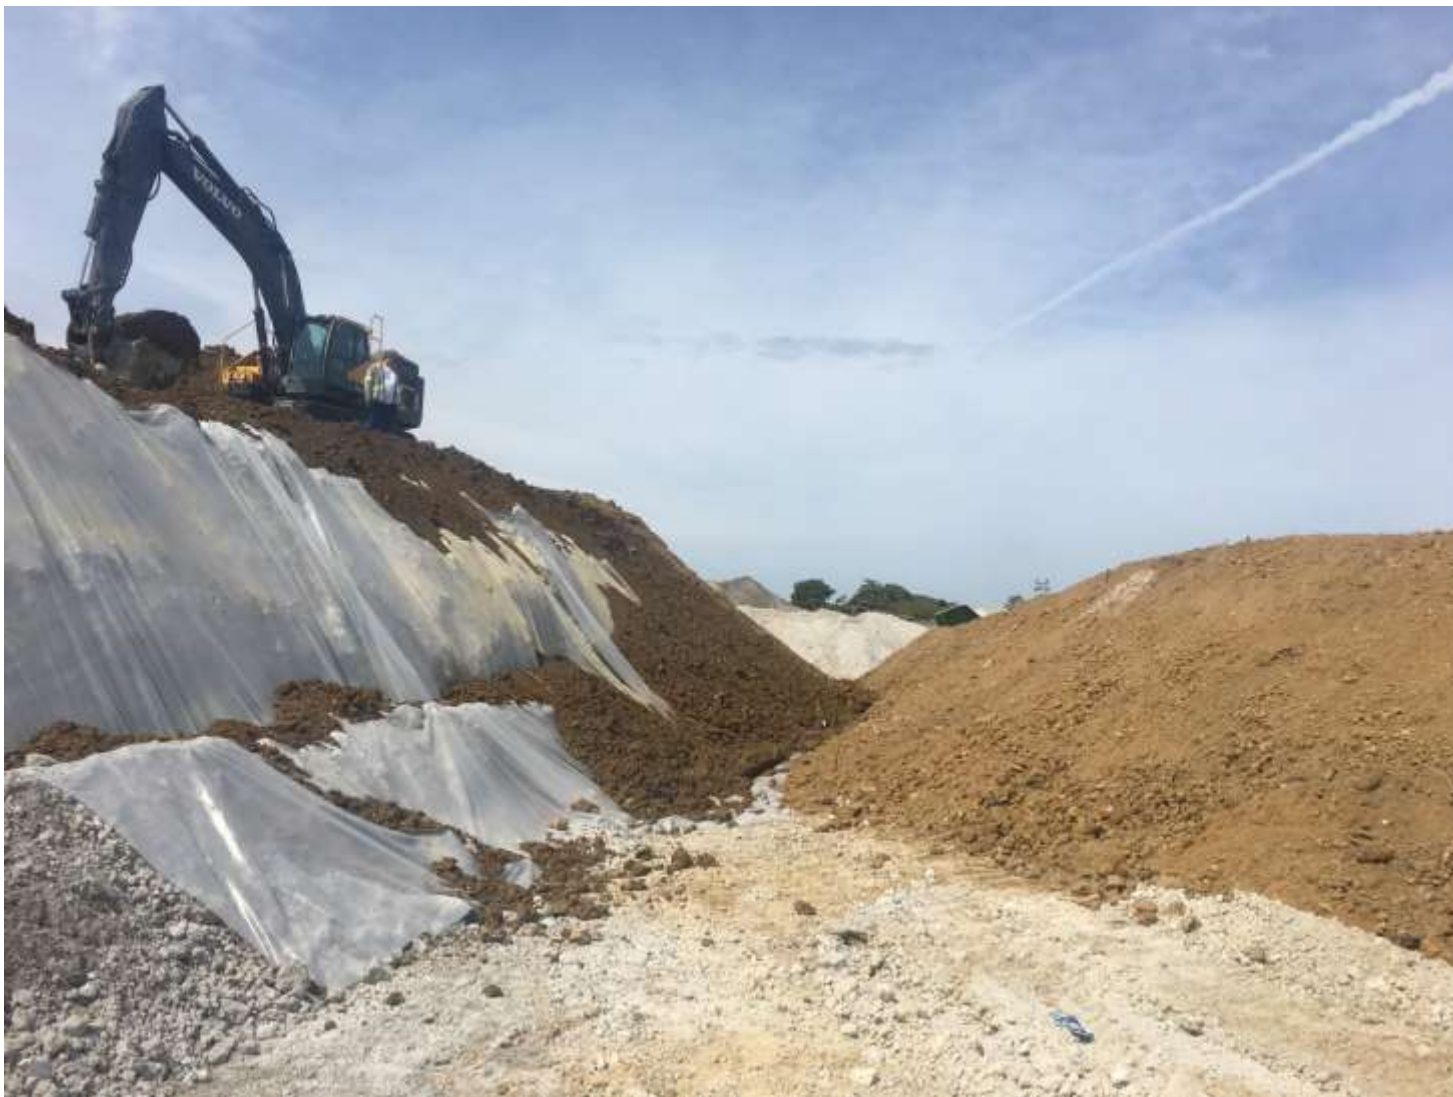
Capping slag excavation face and contaminated slag pile with plastic and clean fill

May 21, 2019 MDE's Land Restoration Program (LRP) visited site and required the face of the slag excavation and small slag stockpile to be capped with plastic and clean fill material.

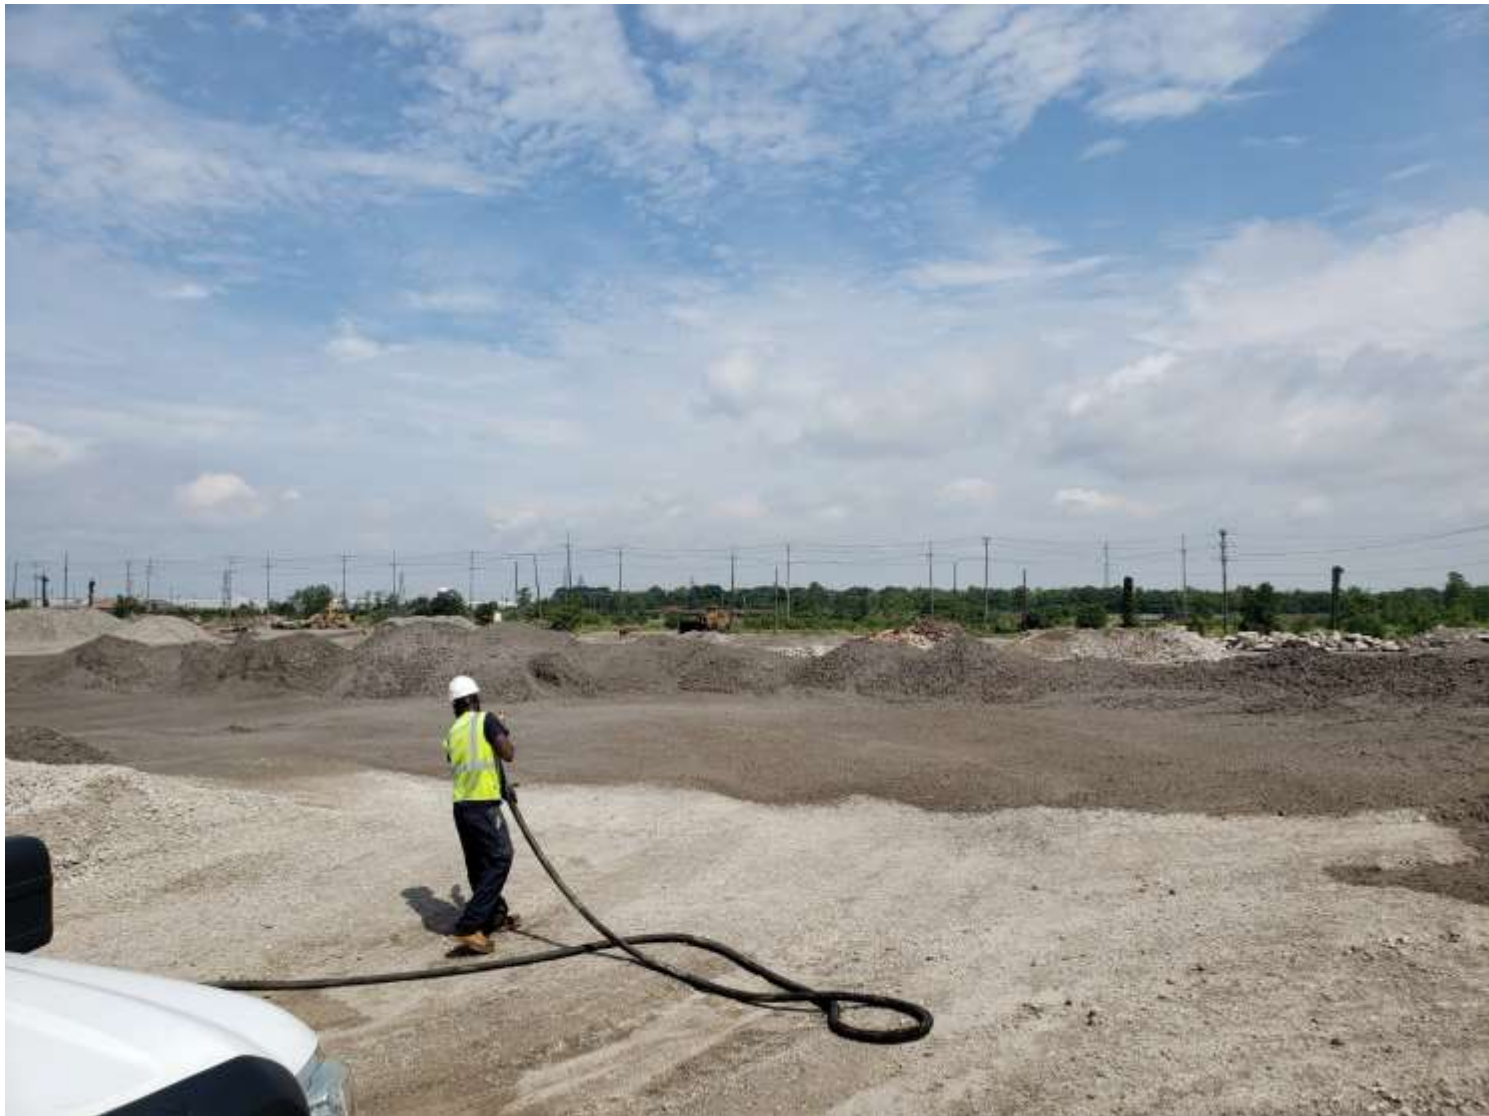
Application of Posi-Shell

June 13, 2019 LRP receives proposal to coat slag piles with Posi-Shell-The plan was approved and the coating process began June 20, 2019.

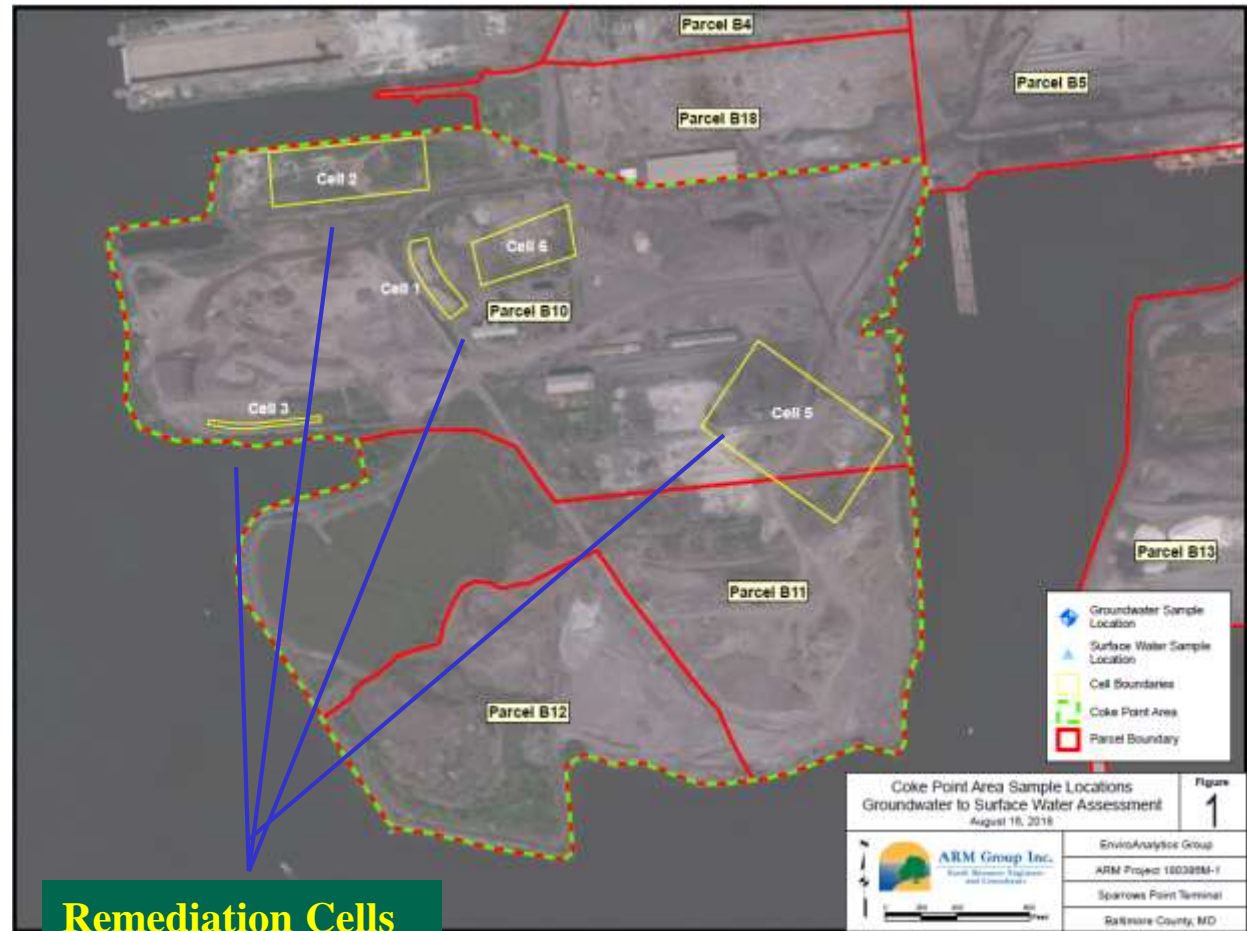
- Five operating remediation cells
- Consists of Groundwater Extraction, Free Product Recovery, Dual-phase Extraction
- Approx. 20,000lbs of hydrocarbons removed to date
- SIR submitted August 2019
- SIR - contaminants in surface water exceeded water quality criteria; however, concentrations are below MDE's recreational human health based concentrations for direct contact exposures.
