Maryland Department of the Environment Sample UST Closure Report Guidance

MDE Sample UST Closure Report

RE: Underground Storage Tank System Closure Report Case No. 2007-7777HO Doe Property 1234 Main Street Hampton, Maryland Facility I.D. No. 1111

I. Underground Storage Tank System Closure Report

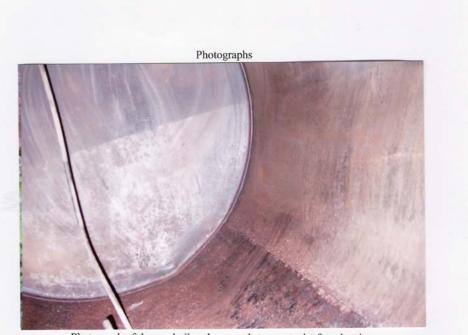
Five perforations were observed in the gasoline underground storage tank ranging from a pinhole to ½- inch in diameter. No perforations were observed in the gasoline underground storage tank system piping. No perforations were observed in the diesel underground storage tank. A single perforation measuring 1/8-inch diameter was observed in the diesel product piping approximately two feet from the dispenser. No perforations were observed in the used oil tank following cleaning.

Photograph of the used oil underground storage tank after cleaning.

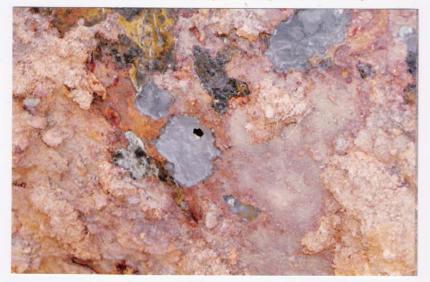
Photograph of a hole in the gasoline underground storage tank.

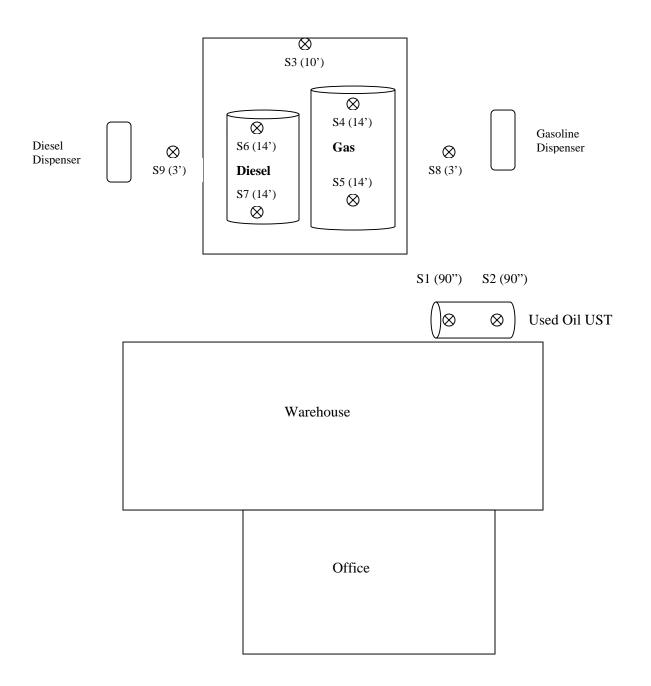
Sample Location Diagram

A total of nine soil samples labeled S1 through S9 were collected from the site for analysis. Two soil samples, S1 and S2, were collected with a clean auger from two feet below the used oil underground storage tank from opposing ends after drilling access holes through the bottom. Five soil samples, S3 through S7, were collected from the shared gasoline and diesel underground storage tank excavation. S3 was collected at ten feet below grade surface along the center of the north wall of the excavation in the area exhibiting the most significant subsurface contamination remaining after removal of soil. Samples S4 through S7 were collected to address subsurface conditions along the piping trenches. S8 was collected midway between the gasoline dispenser and the gasoline tank at three feet below grade surface. S9 was collected between the diesel dispenser and tank, two feet from the dispenser, at three feet below grade surface, the area where the perforation was observed in the piping. Soil samples were collected utilizing sterile gloves. All soil samples were placed in four-ounce wide mouth laboratory supplied jars and immediately placed on ice in a clean cooler. The cooler temperature was maintained at less than or equal to four degrees Celsius.
