Maryland Department of Environment
Water and Science Administration
Compliance Program
1800 Washington Blvd, Suite 420
Baltimore, MD 21230-1719
410- 537-3510, 1-800-633-6101

Site Name: Patapsco WWTP
Facility Address: 3501 Asiatic Ave, Curtis Bay, MD 21226
County: Baltimore City County

Start Date/Time: February 21, 2024 09:30 AM
End Date /Time: February 21, 2024 12:00 PM
Media Type(s): NPDES Municipal Major Surface Water

Permit / Approval Numbers: 15DP0850
NPDES Numbers: MD0021601
Inspection Reason: Follow-up
Site Status: Active
Compliance Status: Compliance
Site Condition: Additional Investigation Required
Recommended Action: Continue Routine Inspection
Evidence Collected: Photos or Videos Taken, Record Review, Visual Observation
Delivery Method: Email
Weather: Calm, Clear, Good

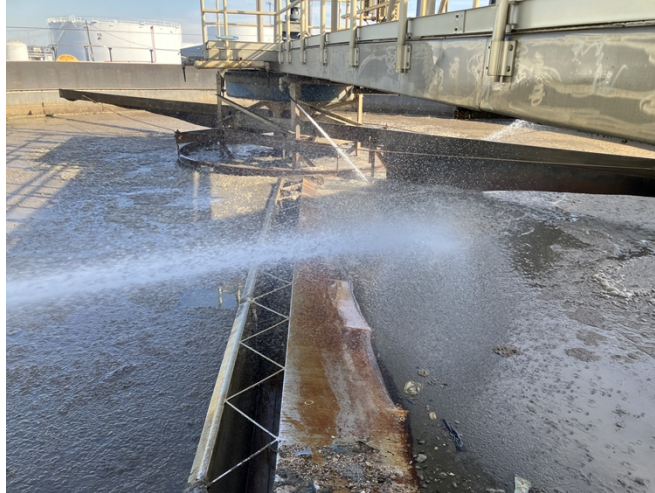
Image 01: GST #1

There are three (3) 65-ft diameter gravity sludge thickeners (GSTs) in the sludge handling area of the plant. The GSTs are numbered #1, #2, and #4. GSTs #1 and #2 are built on grade and GST #4 is elevated above grade. The skimming arms of GST #1 and #2 are missing significant portions of the rubber flaps which should extend down to the liquid surface to effectively remove surface scum. Currently, staff spray water on the surface of GST #1 and #2 in order to manually remove surface scum. Repairs for the skimming arms are reportedly planned and a vendor has been selected to complete the repairs.

At the time of the site inspection, GSTs #1 and #2 were observed as having a heavy film of floating scum on the surface. It was reported that Synagro’s sludge processing operations has been keeping up with the plant’s sludge production; however, at the time of the site inspection, Synagro was reportedly down due to an issue with a lift station. The vertical sludge storage tanks are empty and Synagro is able to pull directly from GST’s #1 and #2. The scum troughs on GST #1 and GST #2 were clear and operational.

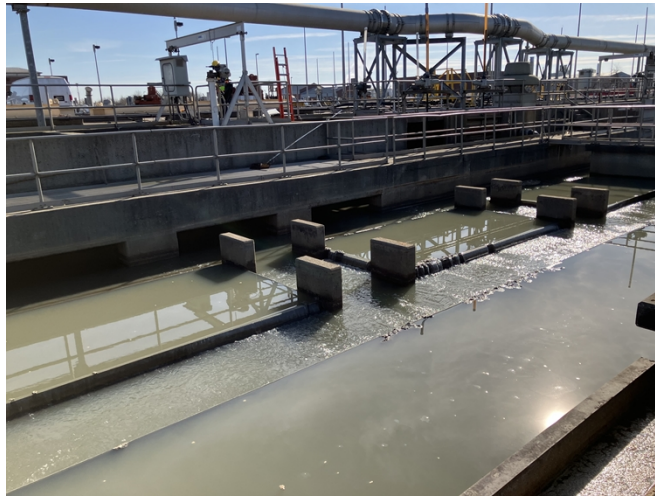
Image 02: PST # 4, Effluent.

The primary treatment system consists of six (6) large, rectangular Primary Settling Tanks (PSTs), each equipped with a chain and flight sludge conveyance mechanism, scum logs, and screw sludge collector.

At the time of the site inspection, PST #1 was in the process of being drained for cleaning. PST #2 and #3 were operating as flow-thru until they can be drained and cleaned. PST #4 and #6 were in service. PST #5 is out of service for mechanical repairs to the chain and flight system. The facility is still dealing with the effects of significant rainfall events.

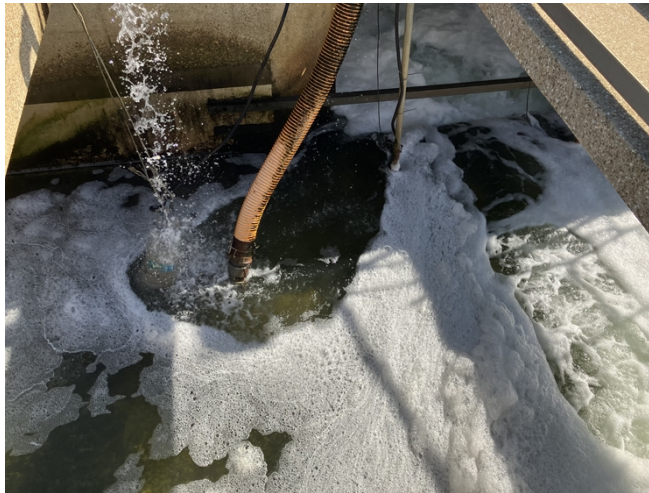
Image 03: Final effluent.

Foam was observed on the surface of the final discharge channel which appeared to disperse rapidly. BAF media and FOGs were not observed to be leaving the site via the effluent channel.
